From: Transportation Advisory Committee (TAC)

Subject: Hemlock@Yerxa, Winchester@Hutchinson, and Morningside@Hutchinson

Date: 21 September 2009

Stop Signs at Yerxa Road/Hemlock Street, Winchester Road/Hutchinson Road, and Morningside Drive/Hutchinson Road

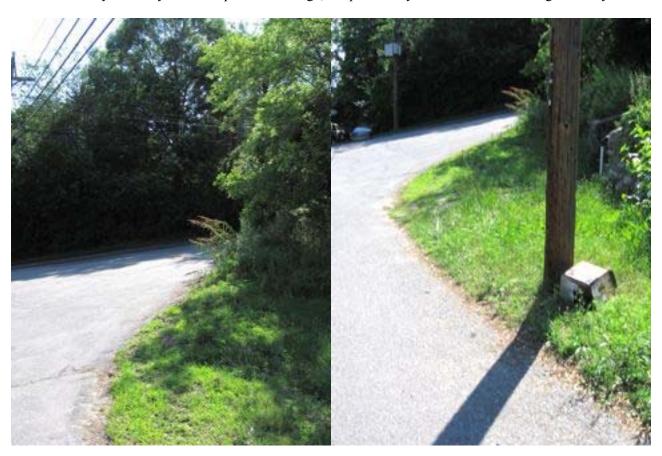
Referring to the TAC Guidelines for a Two-Way Stop, an important reason to consider a two way stop here is lack of visibility. Approaching Hemlock from Yerxa, the sightlines are block by trees and bushes. See photos below. Given the incline, vehicles often go down the hill very quickly. If you drive this often, you approach this intersection very carefully. Without prior knowledge, the probability of a crash increases significantly.

View from Yerxa at Hemlock, roughly 30 ft

Roughly 50 ft

The American Association of State and Highway Officials (AASHTO) gives guidelines for stopping sight distances as follows: 20 mph = 115 feet; 25 mph = 150 feet. Visibility here is 50 ft or less.

We recommend placing a stop sign on Yerxa at this intersection, and if possible trimming some of the foliage. The placement of the sign and decision about foliage should be made at site with TAC and DPW Personnel.

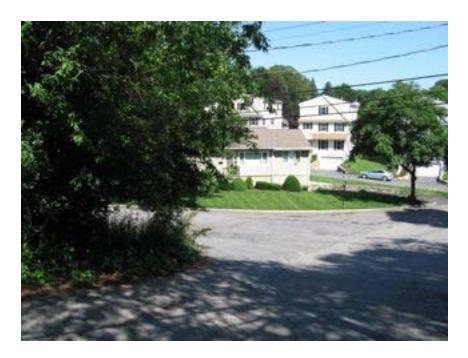
Hemlock southbound looking at Yerxa intersection – about 50 ft.

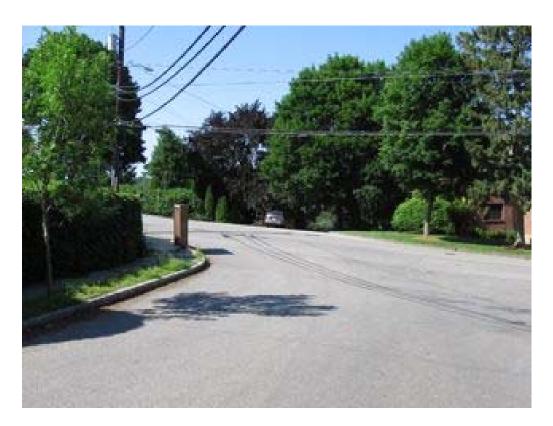
At the Winchester intersection from the south, the sight lines allow visibility of roughly 30-40 feet for vehicles approaching on Hutchinson from the west and on Hutchinson approaching Winchester due to a stonewall. See photos. A stop sign is recommended.

Winchester northbound looking at Hutchinson to the left – about 50 ft from intersection

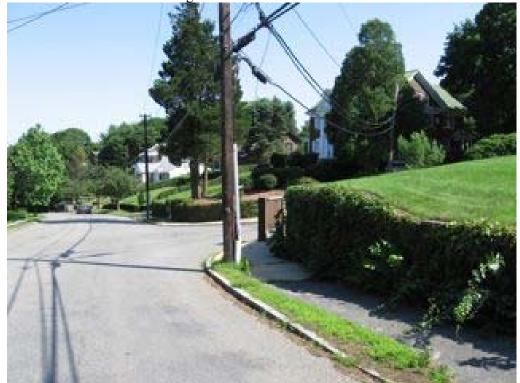
Hutchinson eastbound looking towards Winchester southbound – about 50 ft from intersection

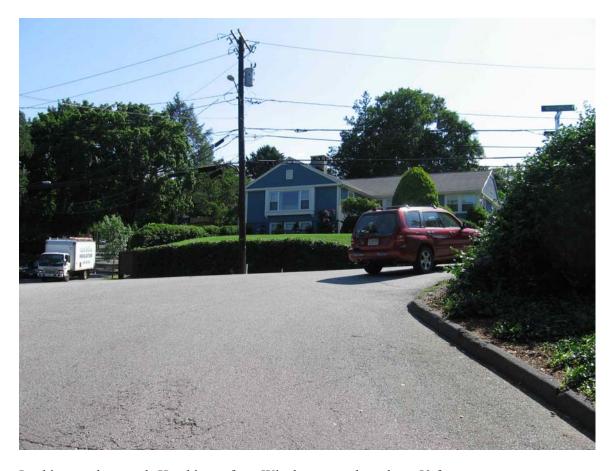
At the Winchester intersection from the north, the sightlines again allow visibility of only 30-40 feet for a vehicle approaching on Hutchinson from the west and for a vehicle on Winchester approaching Hutchinson from the north. The major blockage is from professional landscaping with large bushes. See photos. A stop sign is recommended.

Looking south towards Hutchinson from Winchester north at about 50 ft

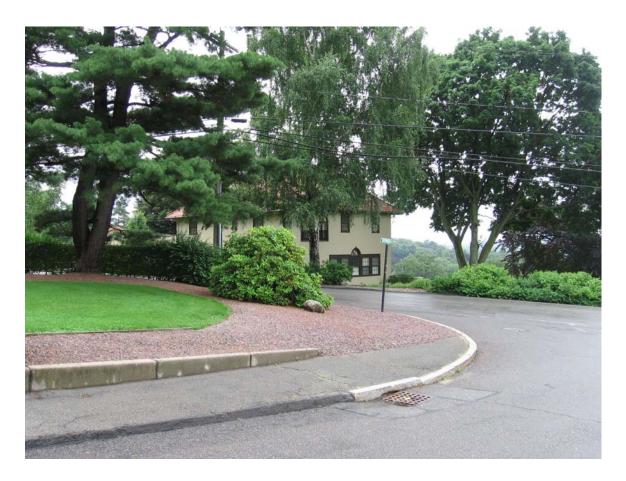
Morningside Drive and Hutchinson Road: We also recommend that a stop sign be placed at Morningside and Hutchinson for sightline reasons. Although not as severe as Winchester, visibility of a vehicle traveling down Hutchinson of Morningside is severely restricted. A stop sign is recommended.

Morningside looking north at Hutchinson from about 50 ft

The corners at each of all of these sites is rounded and the selection of the specific location of the stop sign should be determined at a site visit with TAC and DPW personnel.
