ARLINGTON TRANSPORTATION ADVISORY COMMITTEE

Memorandum

To: Board of Selectmen, Arlington, Mass
From: Transportation Advisory Committee
Subject: Cedar/ Waverley Road
Reference: Board of Selectmen Letter: 6 July 2004
Date: 8 November 2004

Recommendations at Cedar Avenue/Waverley Street/Park Avenue, Cedar Avenue/Renfrew Street, and Renfrew Street/Hillside Avenue

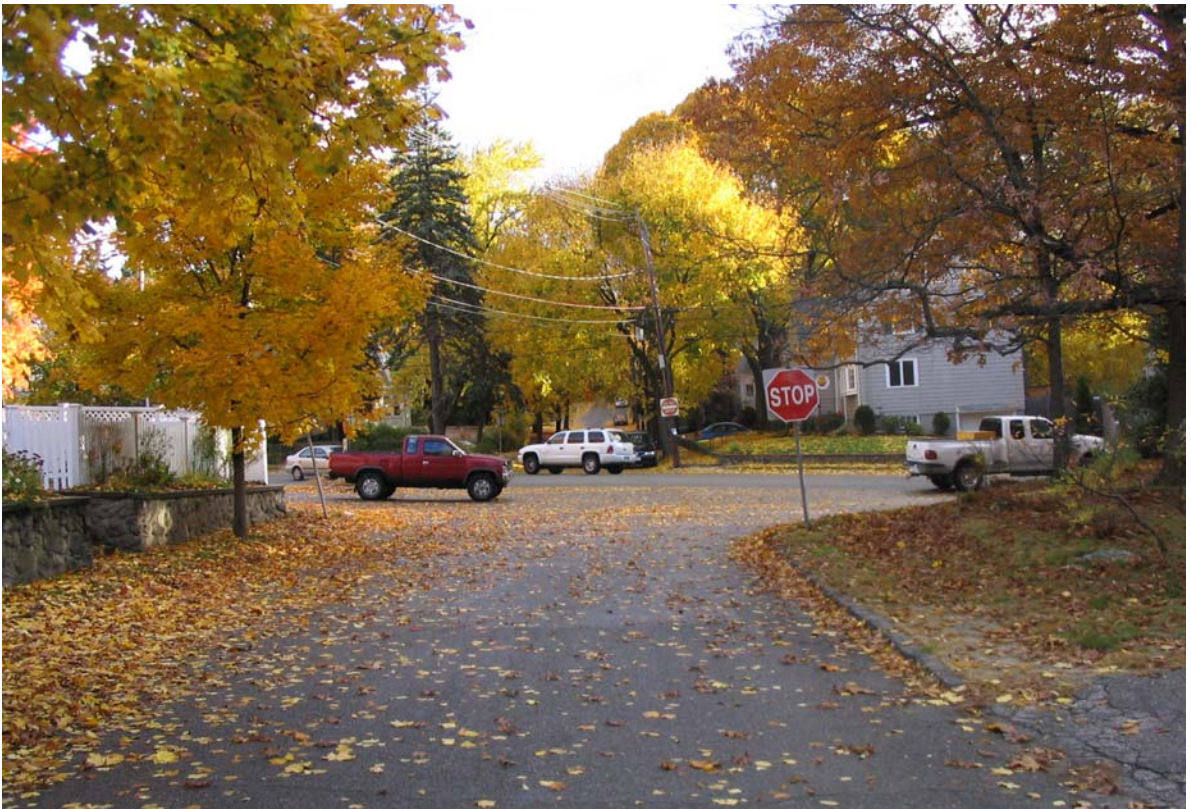
Cedar Avenue Eastbound

- Both the Cedar Avenue and Waverley Street STOP signs are confusing and poorly located. It is unclear whether Waverley Street is STOP controlled at Cedar Street or at Park Avenue. The STOP sign on Cedar Avenue is set too far back from Waverley Street. Motorists universally ignore this STOP sign and conflict with Waverley Street motorists traveling southeast toward Park Avenue. Sight distance is poor for southeast-bound Waverley Street motorists.

- Remove existing stop sign on Cedar Avenue (west) approach to Waverley Street. Install new STOP sign and pole at the corner Park Avenue and Cedar Street (west). Paint new STOP line across approach. Trim branches of tree of #361 Park Avenue that fall within town right-of-way and obscure visibility.

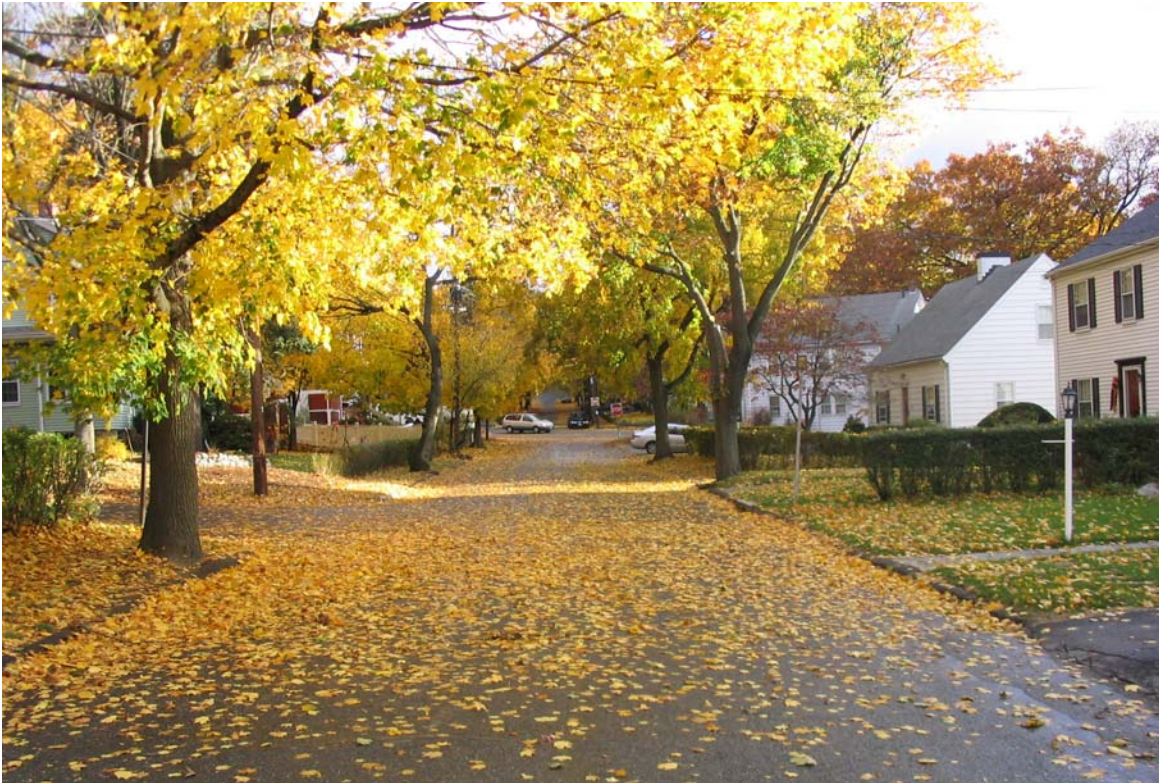
Cedar Avenue Eastbound

- Although it is evident that motorists on the eastbound Cedar Avenue approach have the right-of-way at this intersection, most of the vehicles observed traveling southbound on the Renfrew Street approach did not stop at the intersection with Cedar Avenue. Vehicles travel on the wrong side of the road on the Renfrew Street and Cedar Avenue approaches to the intersection.

- Install a new STOP sign for the Renfrew Avenue approach on the existing street sign pole on the northwest corner of Renfrew Street and Cedar Avenue.
- Replace faded One-Way sign on Cedar Avenue.

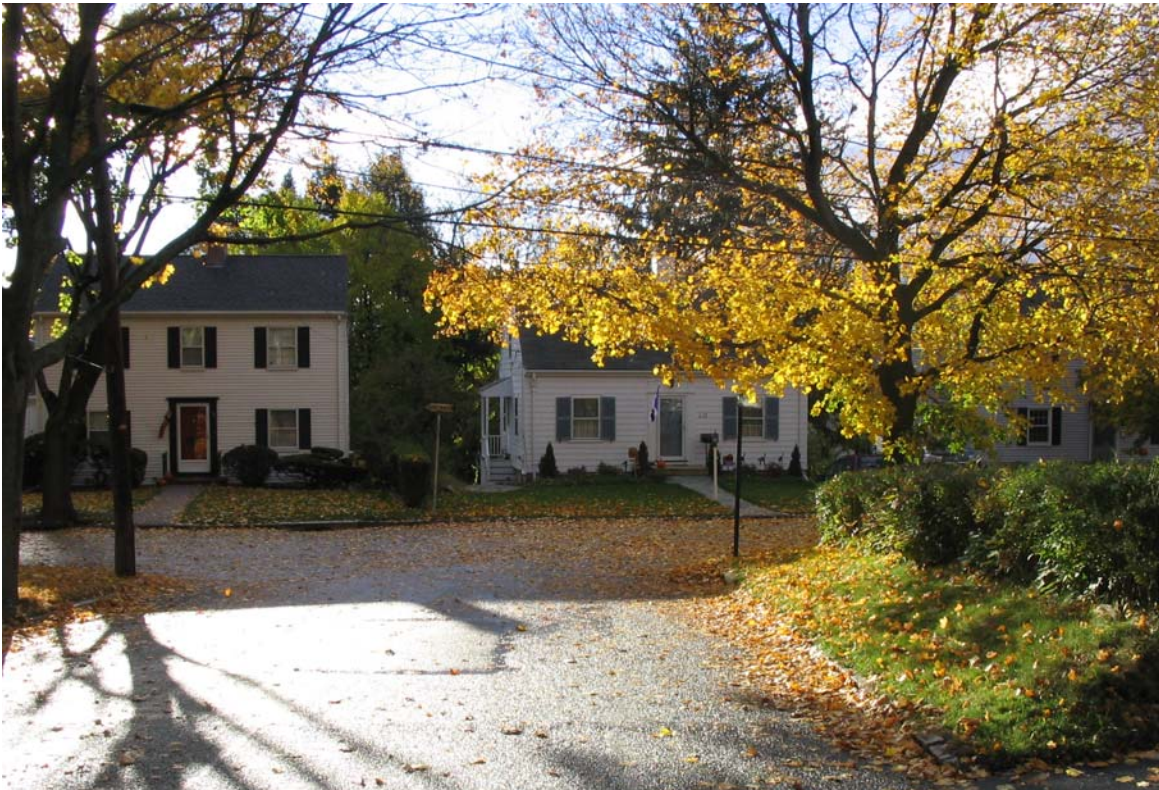
Renfrew Street Southbound

Although Cedar Avenue motorists have the right-of-way at this unsignalized T-intersection, most motorists on the Renfrew Street approach do not stop at the intersection. The sight line for these motorists is restricted due to trees. While no collisions have been reported between 1990 and 2001, residents have indicated near misses.
