**Community Preservation Committee
Request for Funding
Rehabilitation of the Whittemore-Robbins Carriage House**

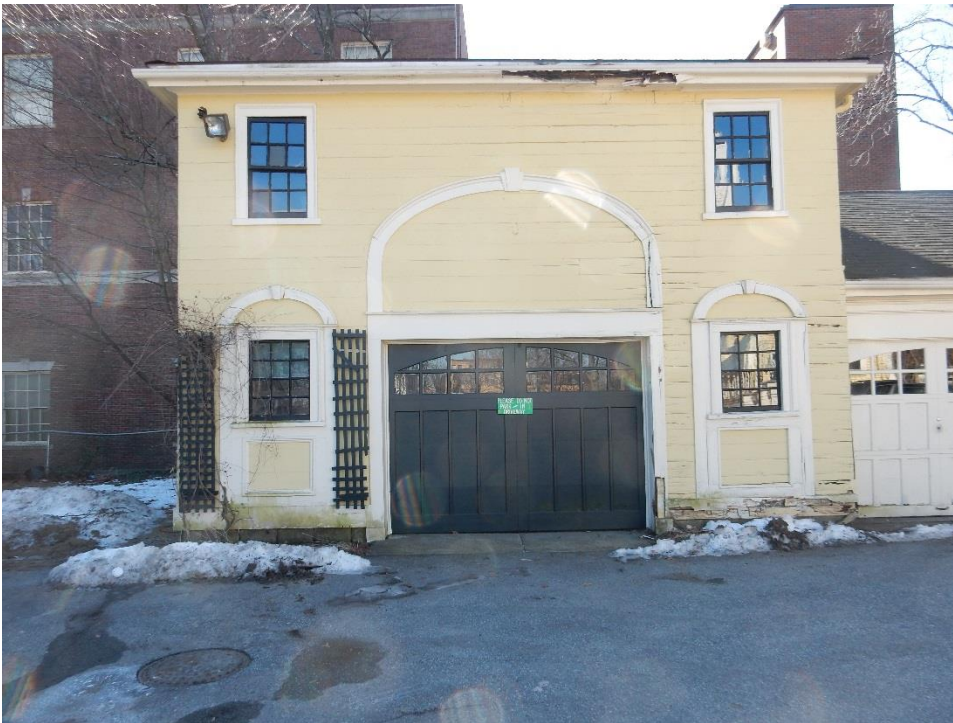
6. North face of two story section. Significant rot is present in gutter, door jamb trim and architrave, skirt trim, and siding around lower right window. Ivy suckers will anchor into siding promoting conditions favorable for rot.

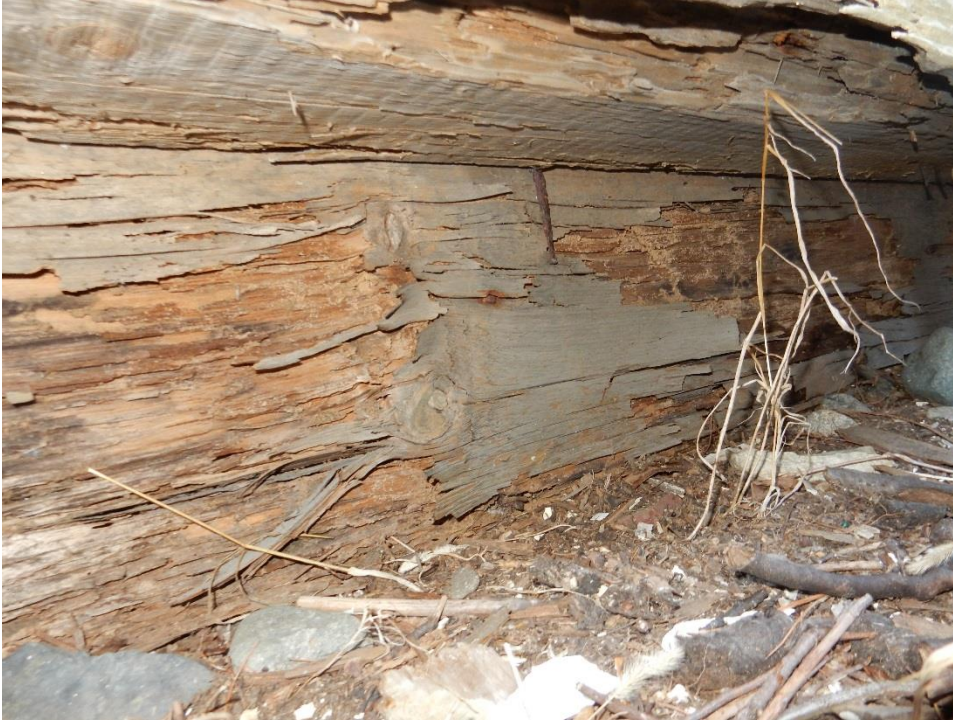
9. At south face of one-story area, cinder block foundation which caps rubble foundation and supports wood sill is missing. The vertical board appears to be the backside of a nailer that supports interior board finishes.

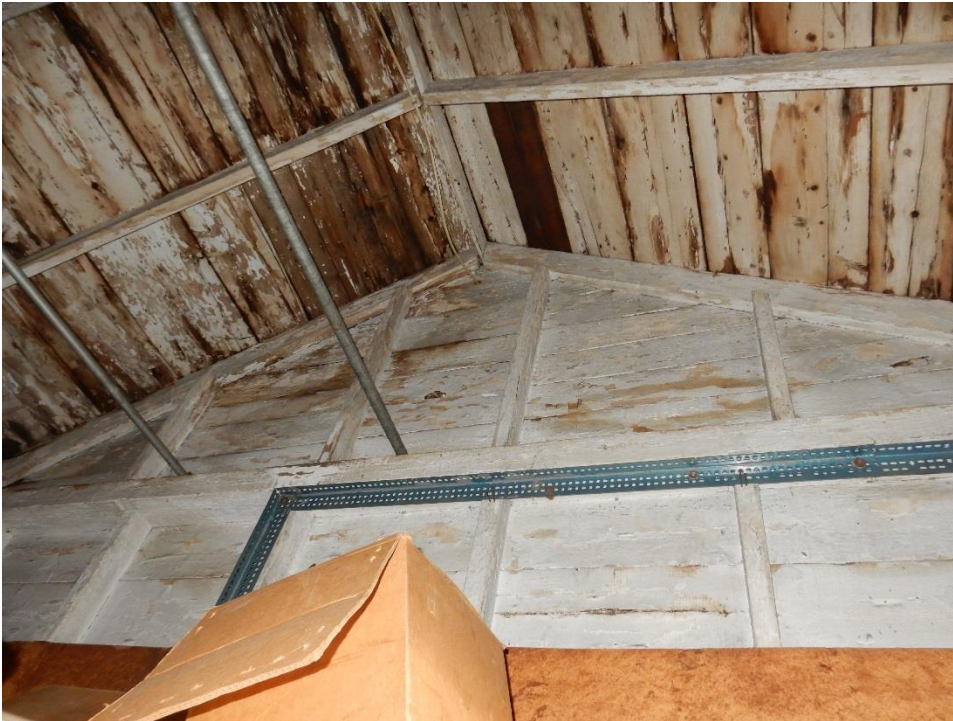
16. Gable wall and roof framing over aforementioned bay. Rafters appear intact. Board sheathing is stained from past moisture.

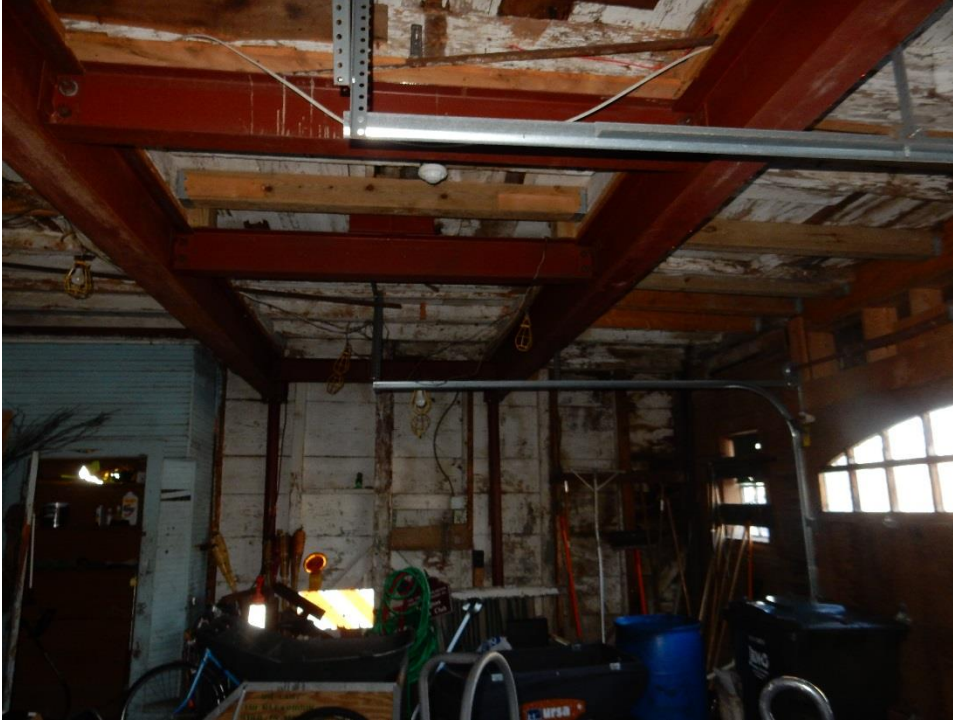
17. Underside of second floor framing in two-story building. Steel beams supported on pipe columns which shore second floor. Existing wood beams are piggybacked on top of the steel beams.

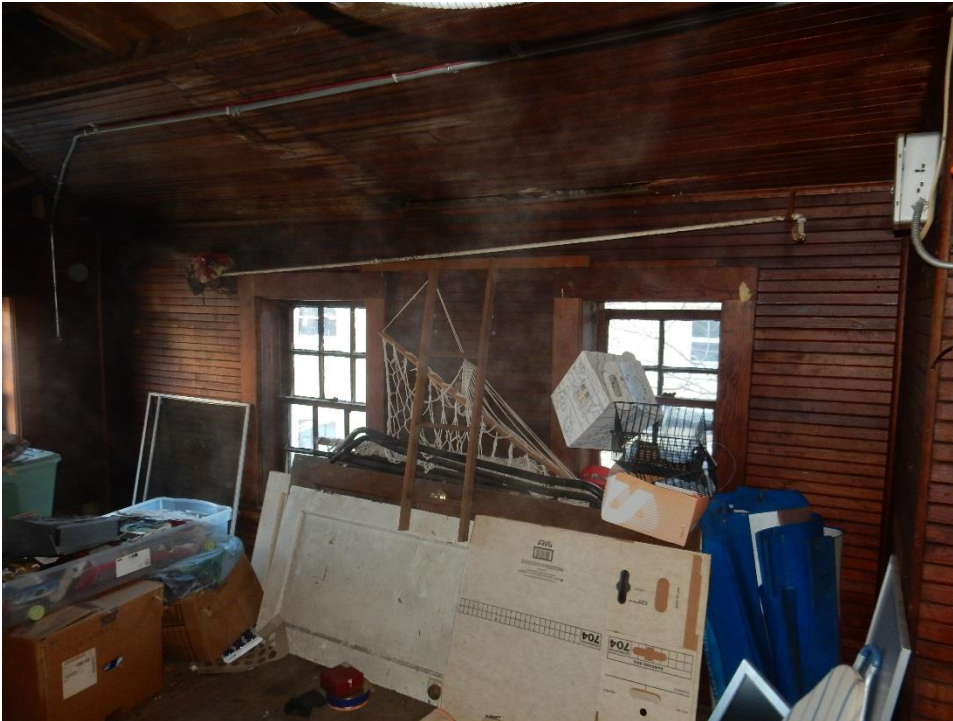
24. Storage on second floor.

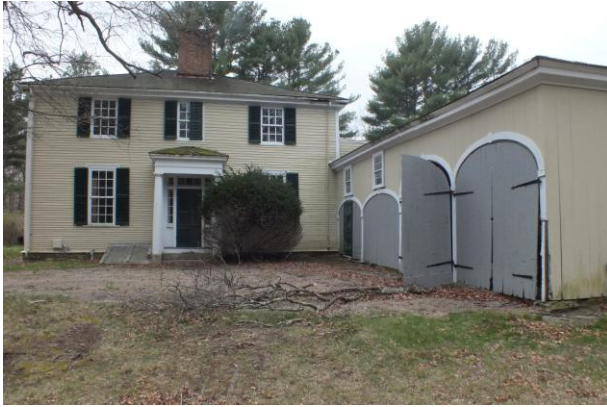
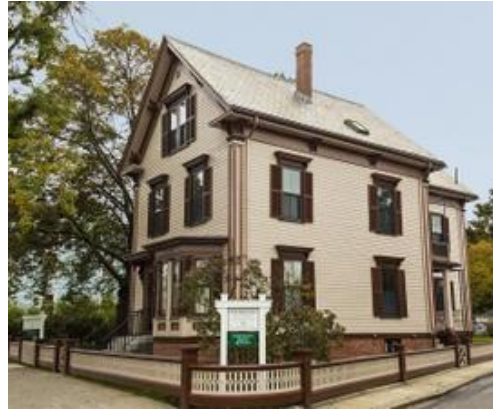
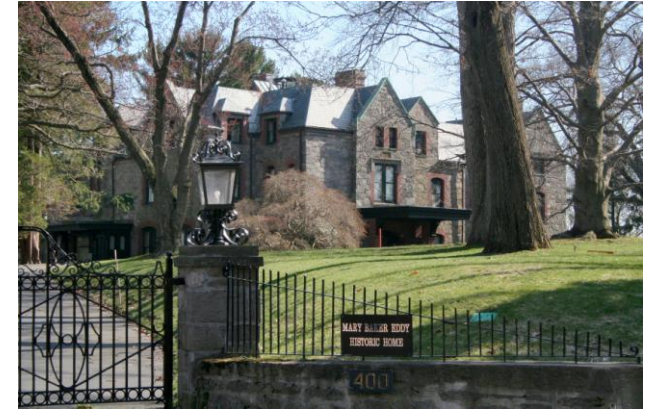
<http://www.b-ase.org/Publications.html>.

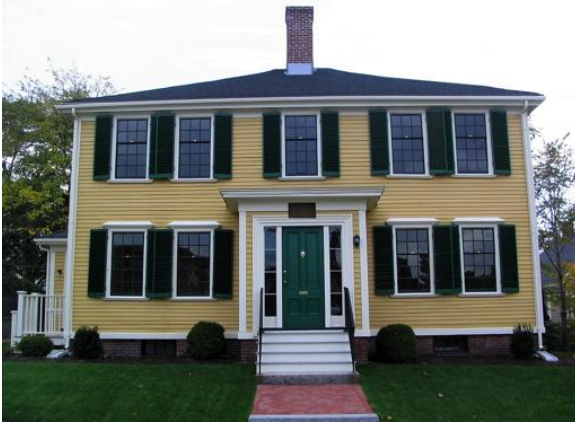
Edmund Fowle House
2006

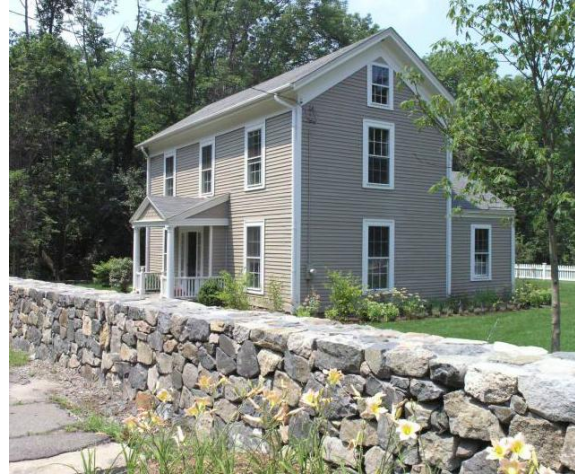
Reference: Wendall Kalsow (Architect) McGinley Kalsow & Associates, Inc. (617) 625-8901

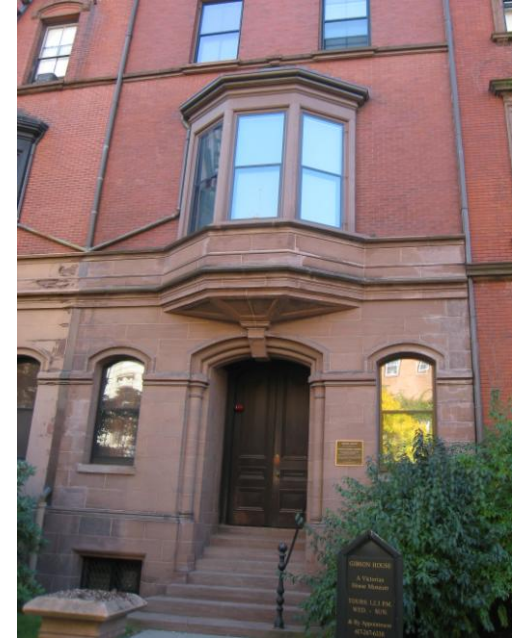
Reference: Gary Wolf. Architect; Gary Wolf Architects, Inc. (617) 742-7557

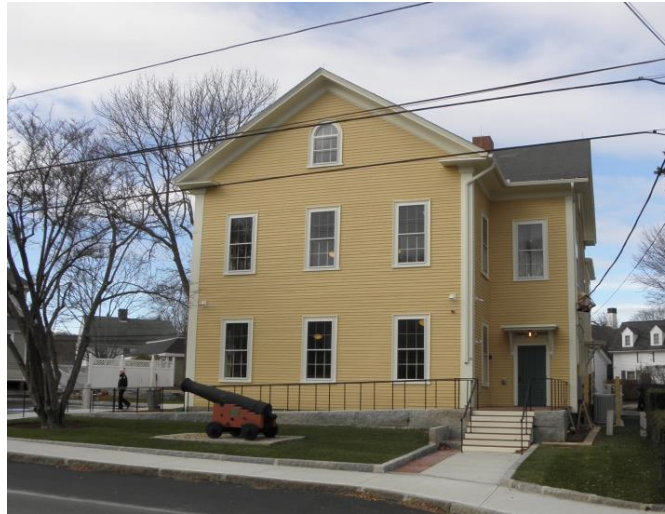
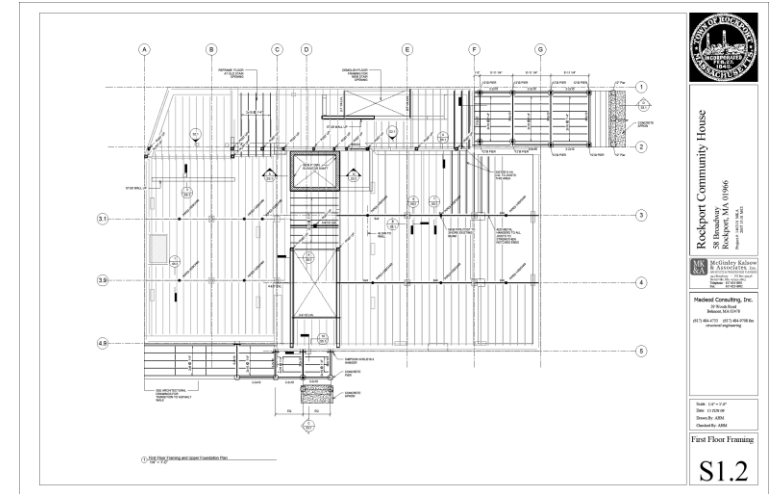
Provincetown Public Library

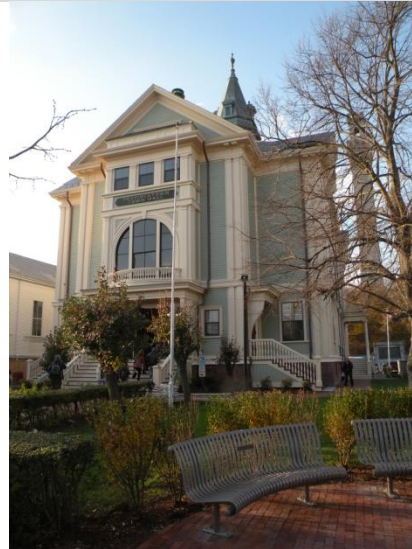
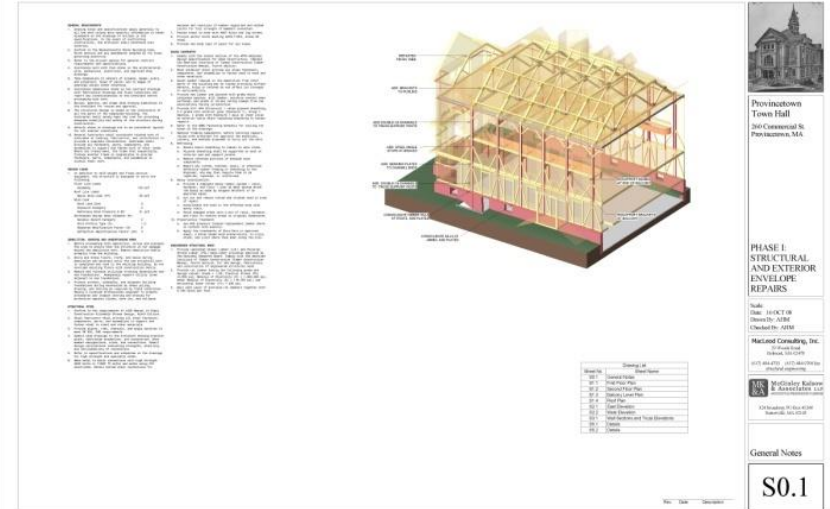
Reference: Wendall Kalsow, Architect, McGinley Kalsow & Associates, Inc. (617) 625-8901

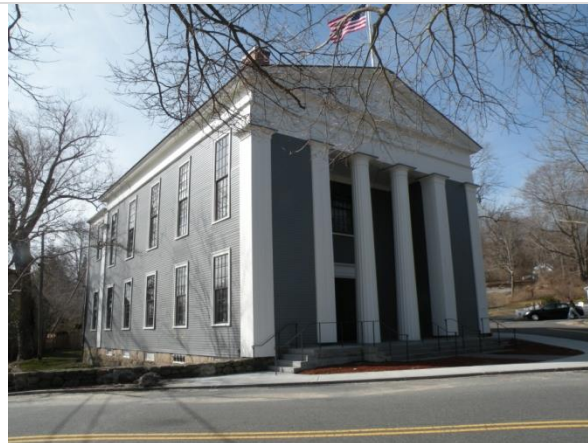
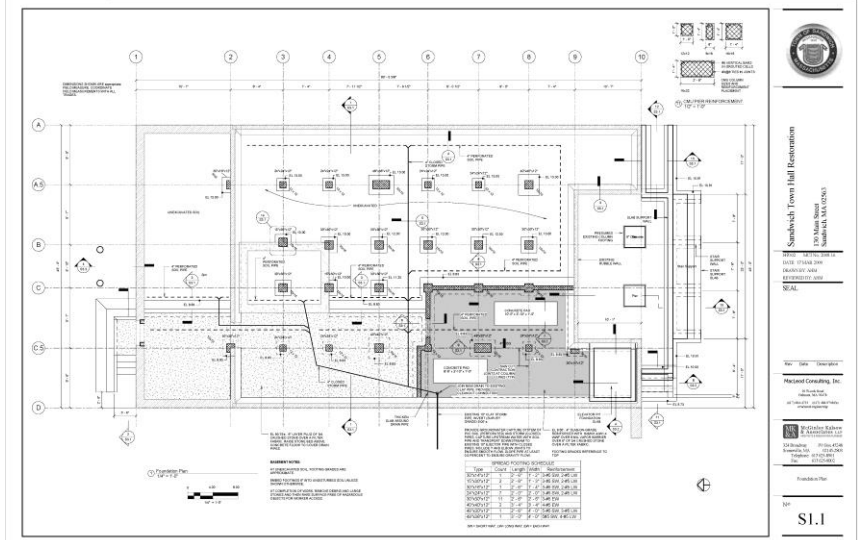
Reference: Wendall Kalsow, Architect, McGinley Kalsow & Associates, Inc. (617) 625-8901

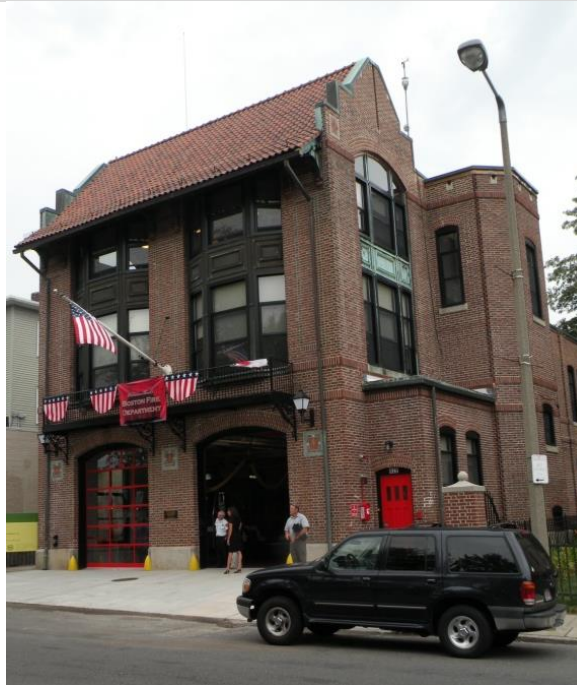
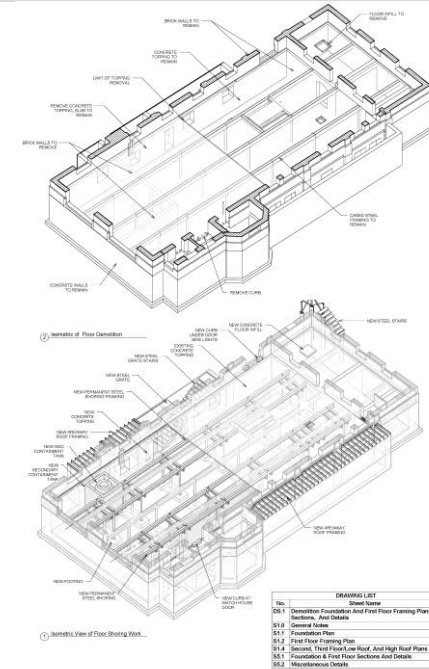
Reference: Ted Galante, Architect, The Galante Architecture Studio (617) 576-2500

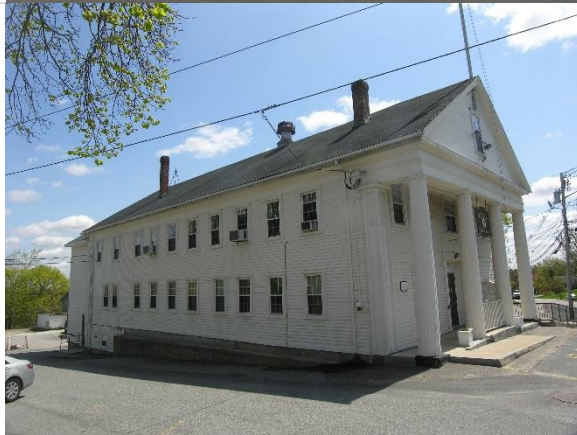
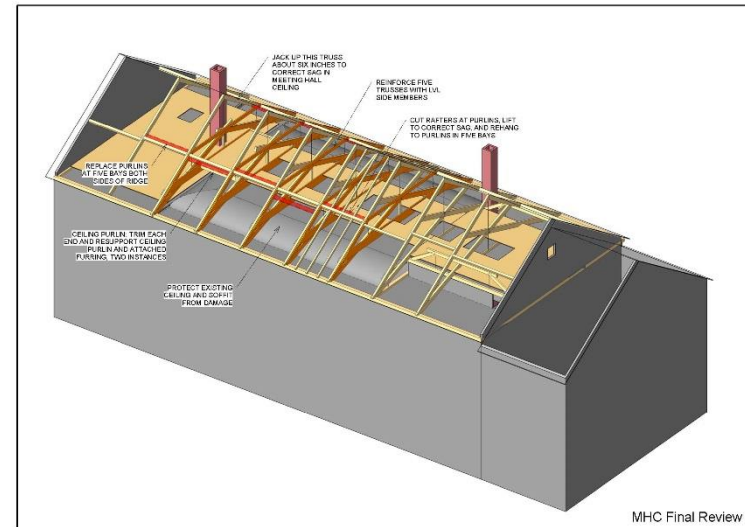
MacLeod Consulting, Inc.
1000 Main Street
Mendon, VT 05756
Tel: 802-247-6924
Fax: 802-247-6924
www.macleodconsulting.com
