SUBJECT: Project Manager/DPW Facility Renovation

ADDENDUM NO. 1

Town of Arlington, Massachusetts Department of Public Works Town Yard - Existing Conditions Study

Revised Report

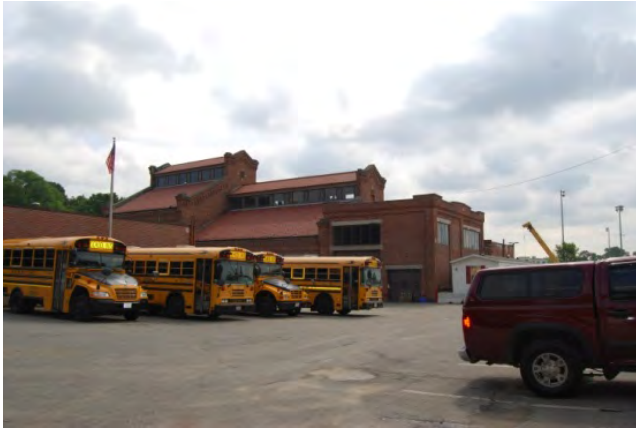
School buses parked on the site.

Location of School Department vehicles on the DPW yard site has a significant negative impact of the operations of DPW. As a first priority we recommend that all School Department use of the DPW Yard be relocated to another site.

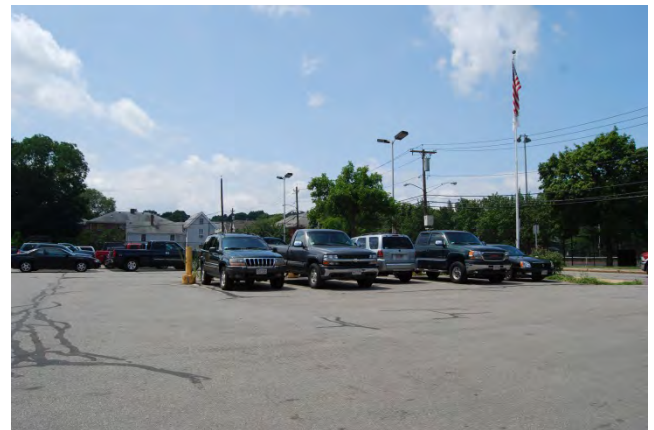
Employee parking area used as a student drop-off.

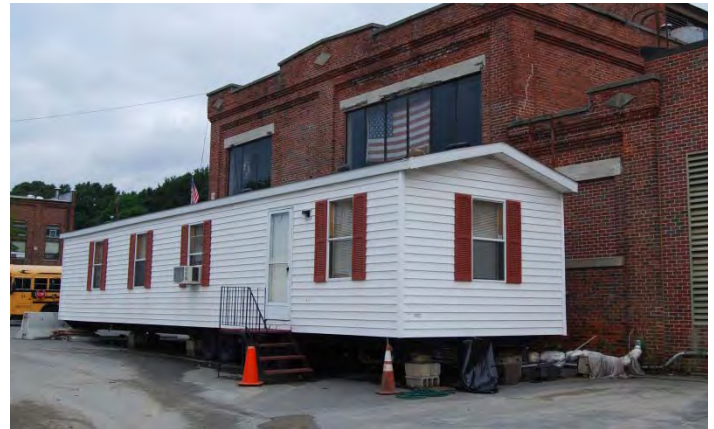
Trailer attached to DPW plumbing and utilities.

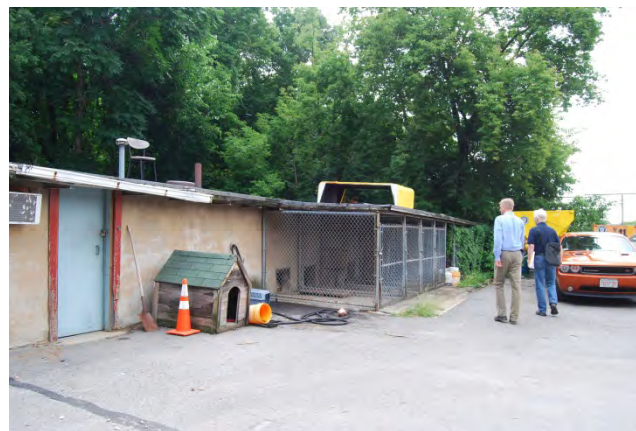
At the South East corner of the site is a building that houses the town's animal control department. The building's current condition renders it unusable, though the exterior enclosures are still used at times for holding pens. Currently the animal control officer uses the construction trailer left behind by the fire department as his office, a solution that is not permanent. The Animal Control building also takes up valuable space that should be used for DPW operations or material storage. There also is a legitimate question regarding whether this function is compatible with the activities of a DPW Yard.

Animal Control Facility impedes DPW functions.

H. Address the deteriorated Animal Pound:

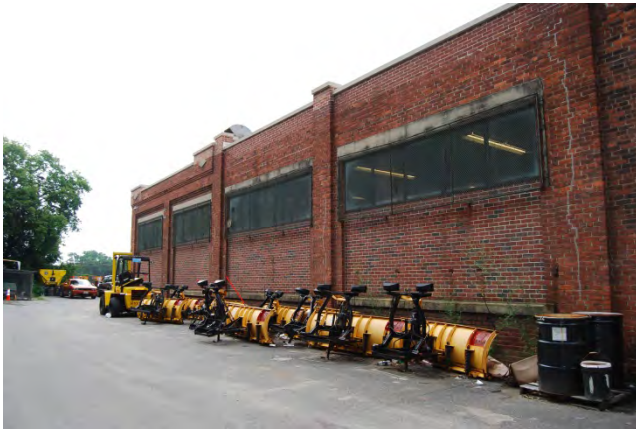
Snow plows stored outside along Building D.

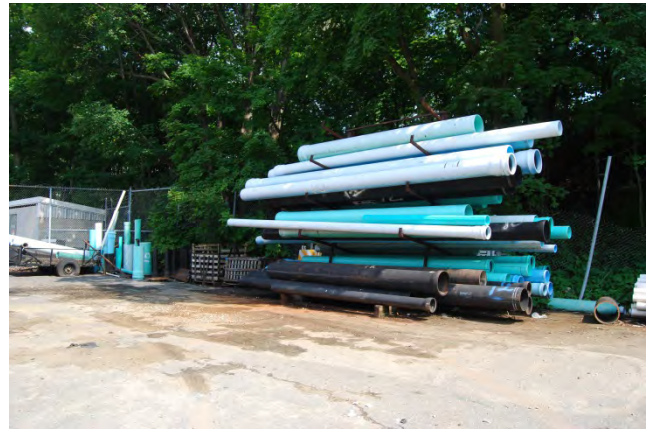
Supplies left exposed to the weather rapidly deteriorate.

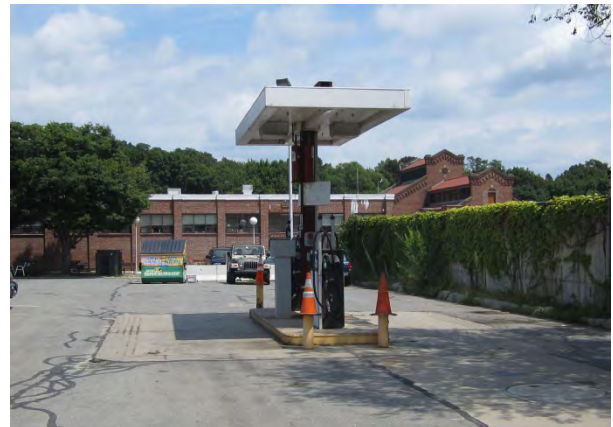
Small canopy provides inadequate weather protection.

It is recommended that the existing canopy be substantially enlarged to provide better protection for users and the surrounding pavement during storm events. A new canopy should be sized to cover the entire concrete pad, all the way back to the existing wall adjacent to the salt shed, and be sloped to shed storm water to the shed side of that wall, thus eliminating the need for new catch basins around the fuel island.

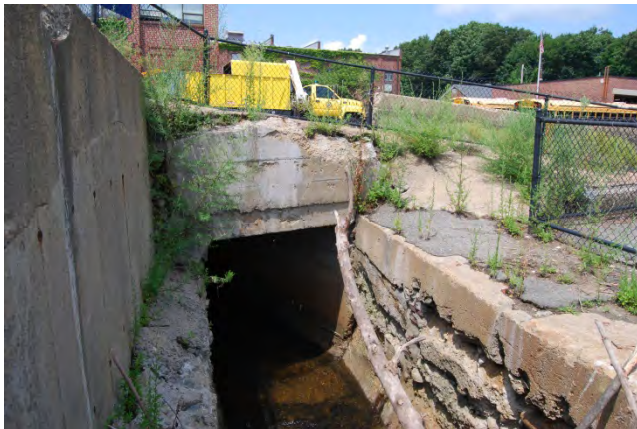
Open portions of the culvert show signs of significant deterioration.

Mill Brook passing through the middle of site.

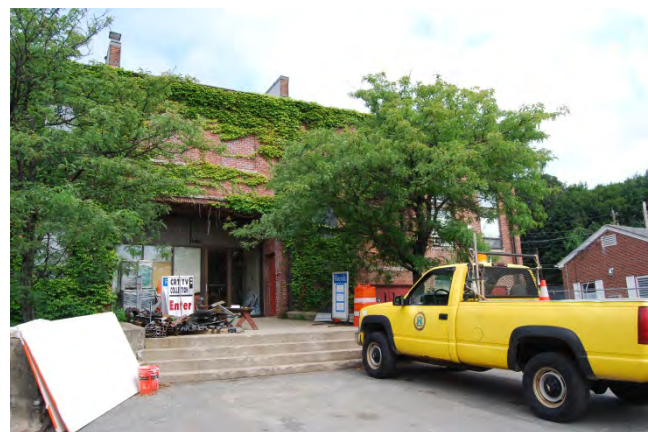
Aggressive plant materials on rear facade.

Very little has been done to the building's exterior since original construction to alter its appearance. The exiting windows, which were replaced a number of decades ago, are experiencing failures of their insulated glass unit seals. The building's masonry is in need of repointing though the bricks themselves appear to be in relatively good condition. In addition, some areas of masonry require immediate attention. The rear façade of the building which faces into the Town Yard is significantly overgrown with vegetation, which should be removed.

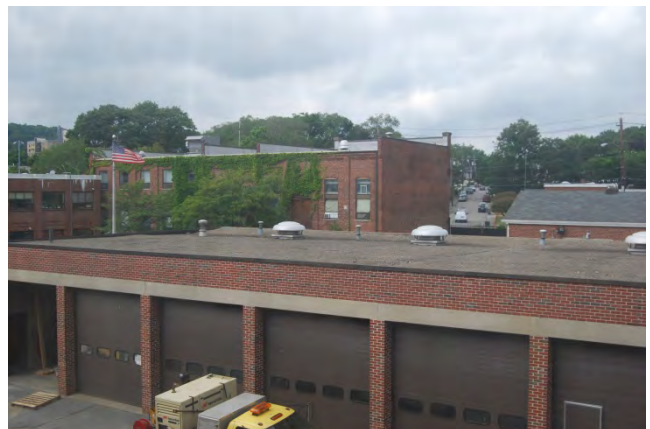
Building C roof after a rainstorm, viewed from Building D roof.

The roof of Building C is reported to be original. Given the membrane's age, the probable minimal thickness of insulation, replacement of the insulation, membrane and flashing at this time is prudent.

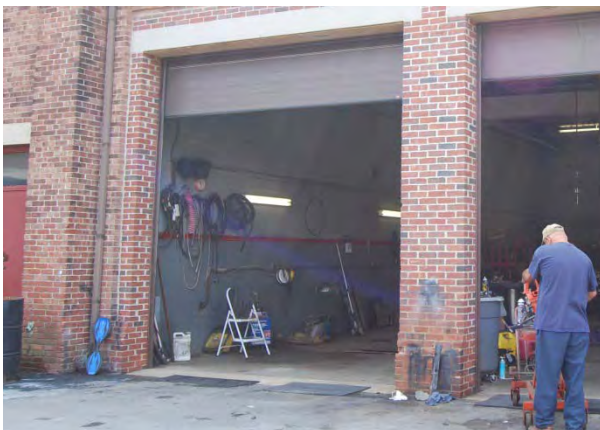
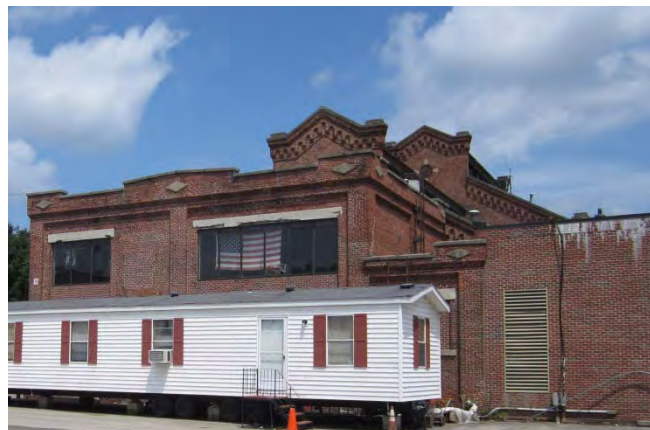
Building D: This large garage building on the site is comprised of the original 1914 “Power Building” and a number of later additions, the most recent being constructed in 1977. The building is constructed of brick masonry with concrete trim. The masonry appears to be in relatively good condition except for some efflorescence. There is a fair amount of exposed concrete cracking and deterioration, particularly around the windows, and at the top of exterior walls. There exists some damage to the brickwork around the garage bay openings, most likely caused by vehicle impacts.

Damaged brick at the maintenance bays of Building D. Concrete window headers show wear; signs of water damage evident.

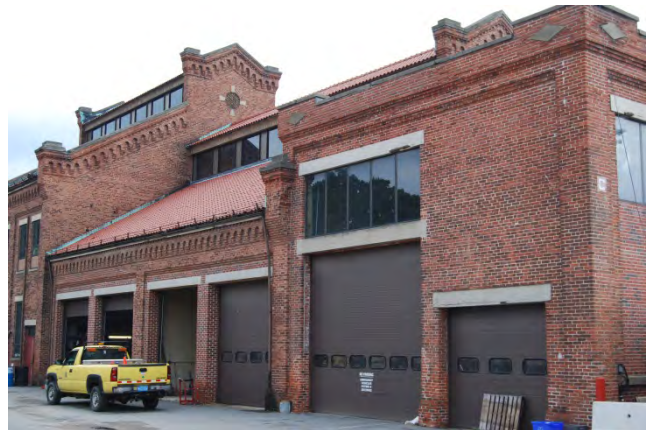
Good tile condition on the North side of the building.

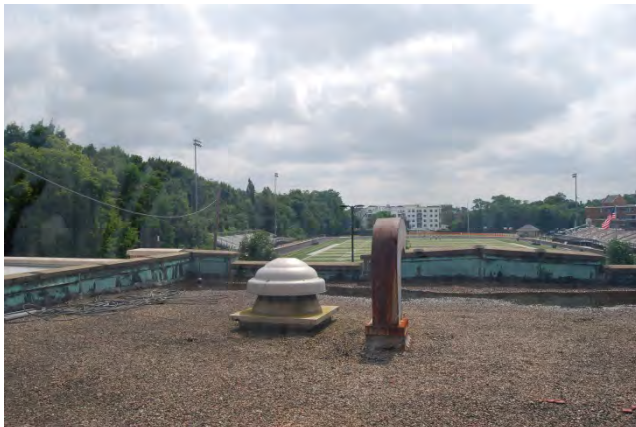
Ponding water on the old roof.

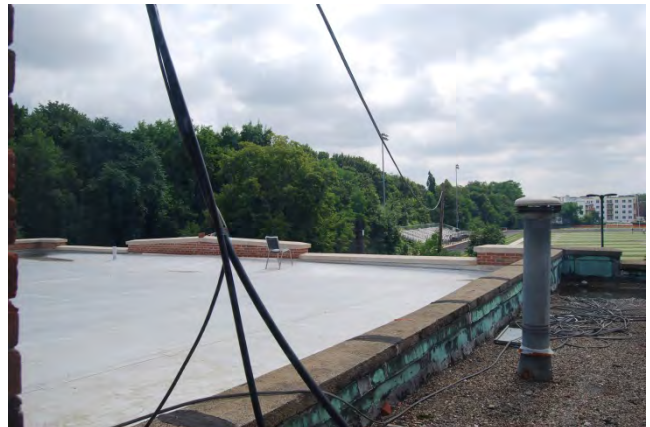
A new elastomeric roof membrane was recently installed on the flat roof over bays 7-12, at which time the adjacent deteriorated masonry wall concrete coping was replaced. Limited masonry repointing has been completed.

Recently replaced roofing and coping.

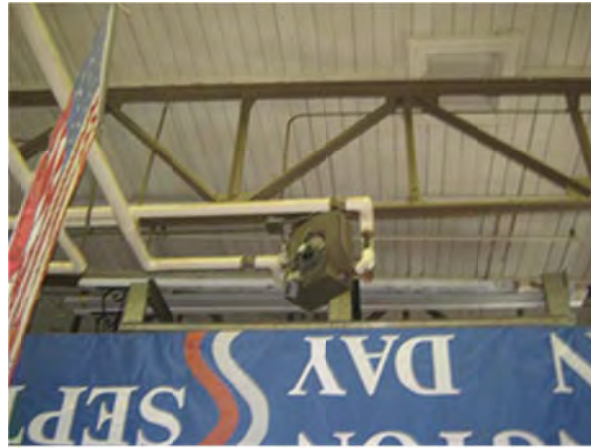
Heaters located in the Sign Shop of Building A

The sign and sewer shops are not equipped with any kind of ventilation system for adequate exhaust of shop dust or paint fumes. Storage areas are partially below grade, with noticeably high humidity and are also not equipped with ventilation.

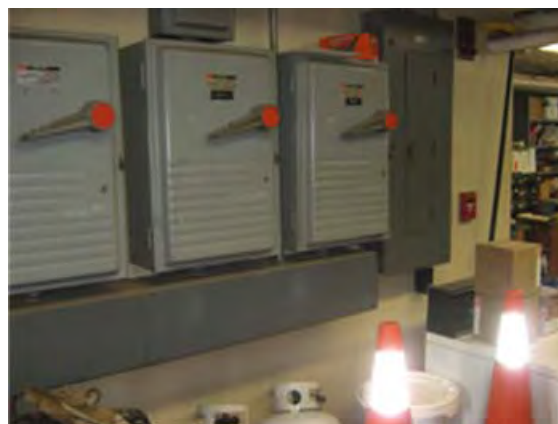
The main service fused disconnect switch of Building A is manufactured by Federal Pacific and is rated at 400A, 208Y/120V, 3-Phase 4-Wire. There is a utility CT cabinet adjacent to the main service disconnect switch with the utility meter located in the same room on the adjacent wall. The area in front of the main service disconnect and distribution was blocked by work cabinets and tables in violation of Massachusetts Electric Code (MEC) Article 110.26(A)(1). See picture below:

Building A electrical panels in entrance of Sewer Shop.

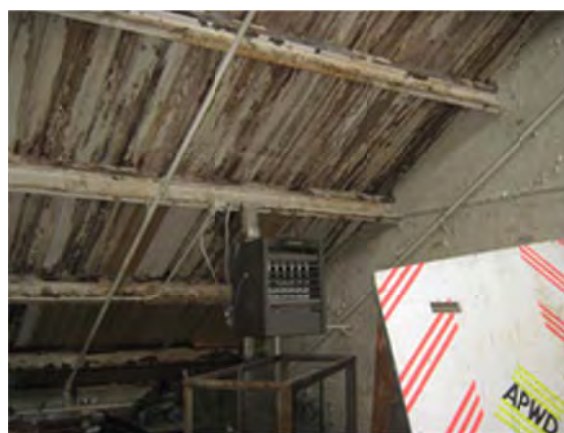
HVAC: The maintenance garage is broken into several work areas with varying levels of HVAC equipment and needs. The building is primarily heated via gas fired unit heaters. However, a waste oil recovery heater similar to the one used in Building C is also utilized and provides a substantial amount of heat to the vehicle maintenance area. Some unit heaters are located close to combustible materials.

Unit heater on level two of Building D.

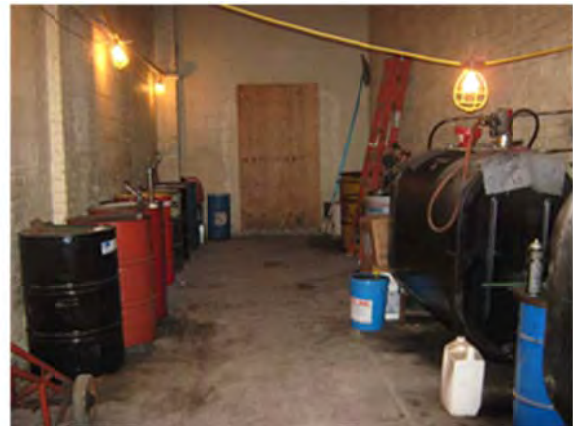
Oil/hazardous material storage lacks an exhaust system or explosion-proof fixtures.

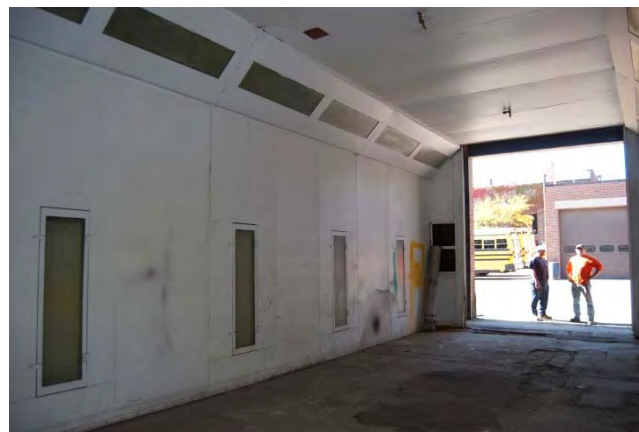
An existing paint bay exists within Bay 3 of Building D that requires decommissioning. The room is not properly ventilated for current paint safety requirements and has not been used in many years.

Existing decommissioned paint bay (3) located in Building D

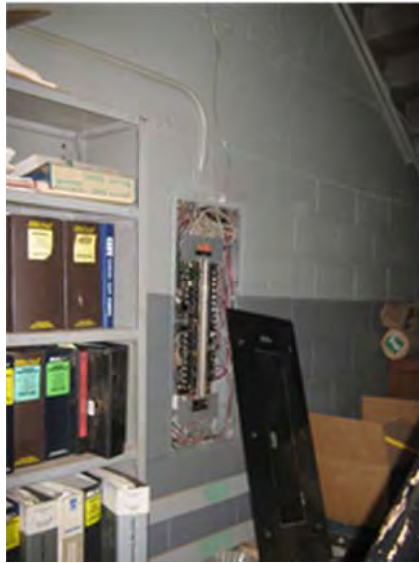
Electrical: Building D's electrical system is tied to the other buildings on the site as described in section *Building A: Electrical*. The electrical distribution is comprised of panel boards of several different manufacturers (i.e. Yankee Electric, General Electric and Federal Pacific). In all the buildings power distribution is in poor condition and has reached the end of its useful life. Many circuits are overloaded, mislabeled, and exposed Romex (non commercial code) wiring is located throughout the facility. No evidence of GFI, arc flash or updated breakers were present. Many panel covers were removed or missing, which is a code violation. See picture below:

Building D electrical panel under first floor central stairs.

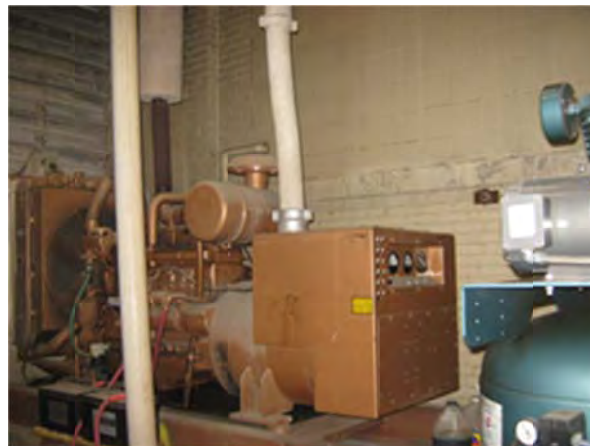
The maintenance facility in Building D does contain an emergency generator. The generator is gas fired and is an indoor unit, 150Kva. Although it is not large enough to back-up the entire facility, many circuits are connected to “critical” loads, such as site lighting, building lighting, and shop power. Based on the information available, the generator did not appear to provide any backup power to the office buildings. The generator is estimated to be 25-30 years old. See picture below:

Building D's gas fired generator.

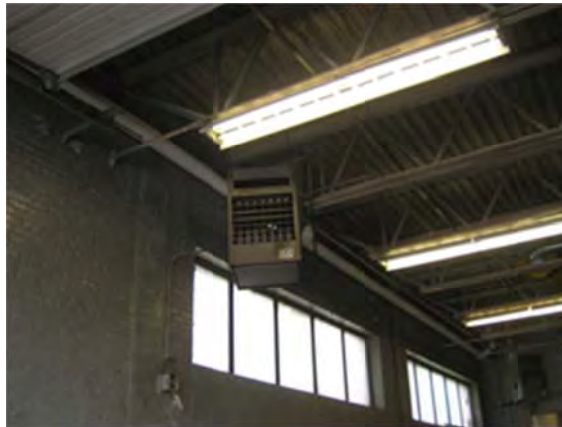
Lighting: Building D's lighting consists primarily of fluorescent, high-bay type fixtures. In general, light levels appear insufficient for the function and activity of the areas served. The overall condition of the interior lighting is poor and proper switching and control was not present; the lighting is controlled by breakers in several areas, which is a code violation. See picture below:

Local heating units mounted in Building D.

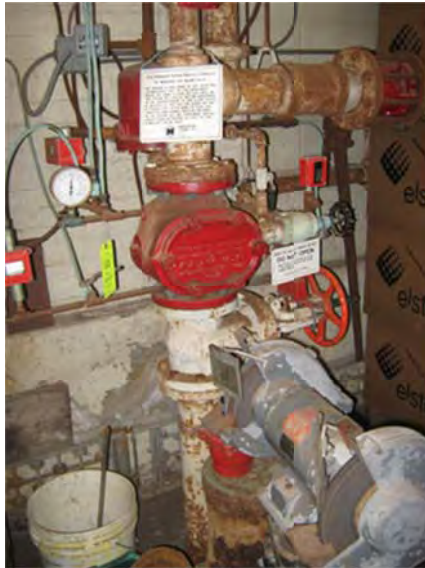
The buildings are equipped with an automatic fire protection sprinkler system. It appears that all areas of the facility have sprinkler coverage. The sprinkler risers are not equipped with code required backflow preventers. The piping systems are antiquated, and contain many $\frac{3}{4}$ " run outs no longer allowed by code, especially in Building D. No evidence of proper drain down piping could be found in Building D; routine maintenance to keep the pipe free and clear was not evident. Certain areas of Building D, such as sprinkler heads, have been painted.

Building D's sprinkler system is in need of updating.
