TOWN OF ARLINGTON
REQUEST FOR DESIGNER Qualifications (RFQ)

RFQ #17-43
Department of Public Works Renovation/Addition
AUGUST 3, 2017

Town of Arlington, Massachusetts Department of Public Works Town Yard - Existing Conditions Study

Re: Arlington DPW Facility Existing Conditions Study
51 Grove Street

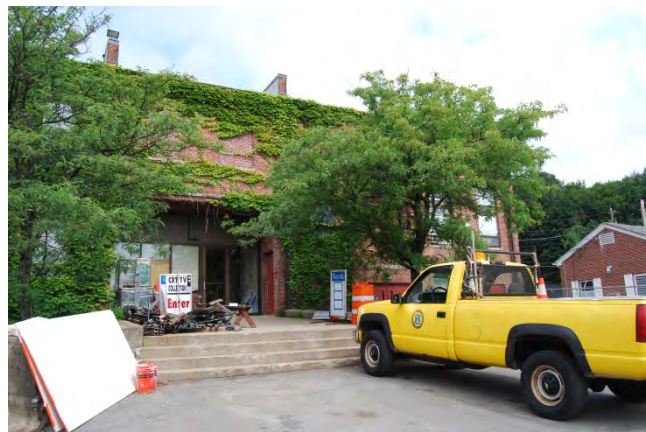
Aggressive plant materials on rear facade.

Very little has been done to the building's exterior since original construction to alter its appearance. The exiting windows, which were replaced a number of decades ago, are experiencing failures of their insulated glass unit seals. The building's masonry is in need of repointing though the bricks themselves appear to be in relatively good condition. In addition, some areas of masonry require immediate attention. The rear façade of the building which faces into the Town Yard is significantly overgrown with vegetation, which should be removed.

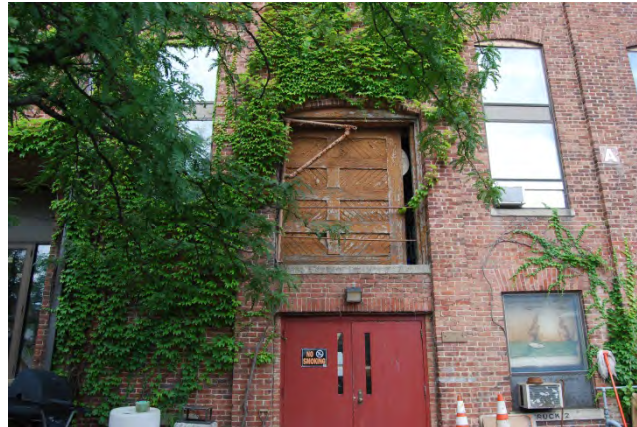
Deteriorated wood sign shop door still in use.

The street (or intermediate) level of Building A was renovated to create a public entrance and office space to accommodate the Building Department. In 1977 the exterior windows were replaced, according to documents provided by the Department. This renovation added an enlarged storefront entrance along the Grove Street façade. The windows on this building were installed when the building changed hands from the Gas Company to the Town. The newer storefront doors on this building are in good condition though the original wooden loft door used by the sign workshop is in need of repair or replacement.

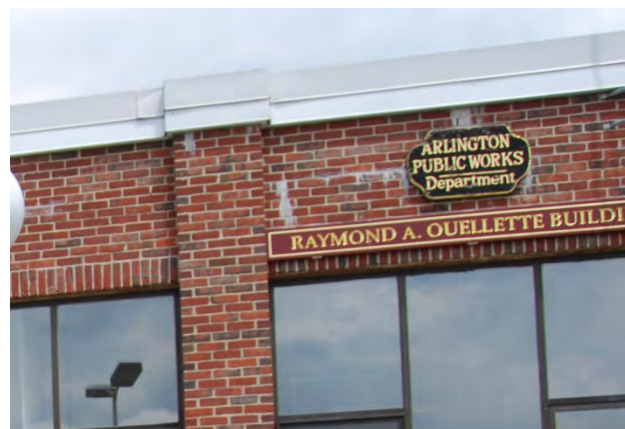
Leaching on the front of the building.

The masonry and its mortar are in good condition though instances of efflorescence indicate moisture within the walls, typically at copings or roof flashing. The DPW is currently working to remediate this issue.

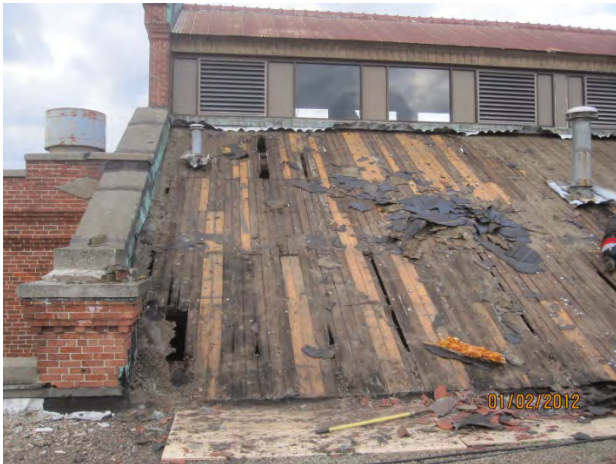
plank sheathing underneath the tiles is severely deteriorated. The South side of the roof was recently replaced for this reason. During that repair the sheathing was replaced and the terra cotta tiles were replaced with an elastomeric roofing membrane.

Split and cracked boards under the historic tile roof.

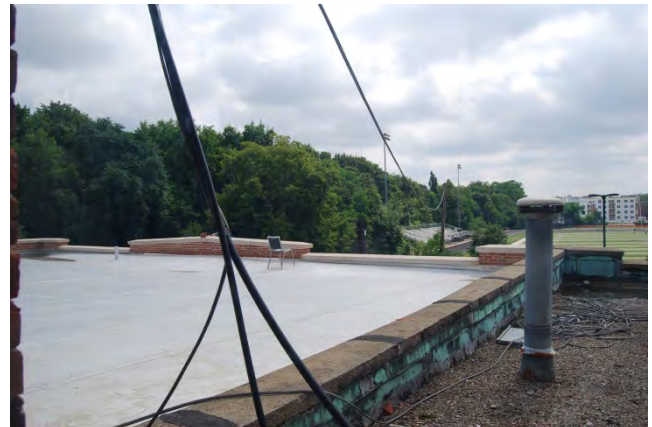
A new elastomeric roof membrane was recently installed on the flat roof over bays 7-12, at which time the adjacent deteriorated masonry wall concrete coping was replaced. Limited masonry repointing has been completed.

Recently replaced roofing and coping.

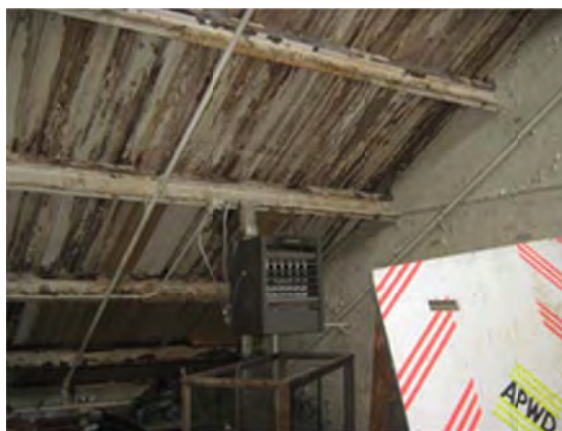
HVAC: The maintenance garage is broken into several work areas with varying levels of HVAC equipment and needs. The building is primarily heated via gas fired unit heaters. However, a waste oil recovery heater similar to the one used in Building C is also utilized and provides a substantial amount of heat to the vehicle maintenance area. Some unit heaters are located close to combustible materials.

Unit heater on level two of Building D.

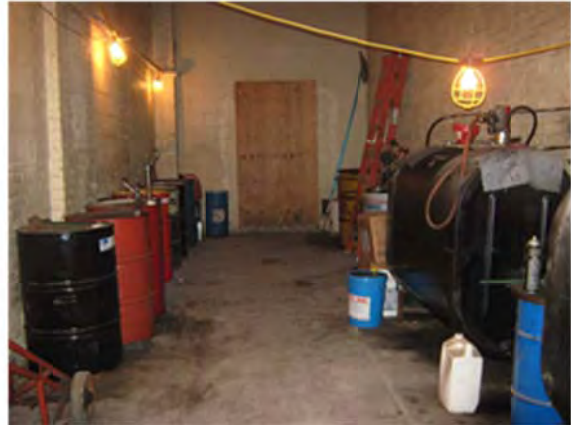
Oil/hazardous material storage lacks an exhaust system or explosion-proof fixtures.

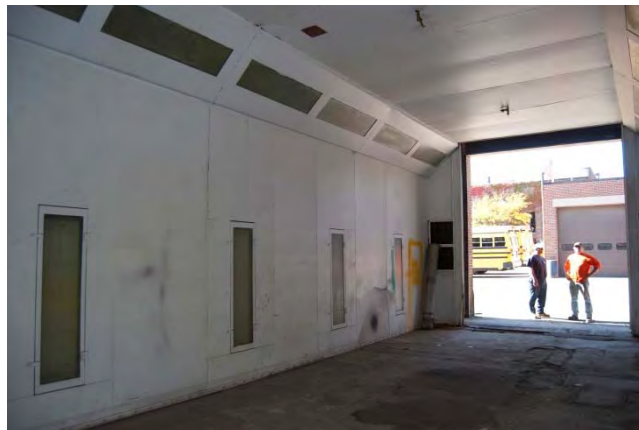
An existing paint bay exists within Bay 3 of Building D that requires decommissioning. The room is not properly ventilated for current paint safety requirements and has not been used in many years.

Existing decommissioned paint bay (3) located in Building D

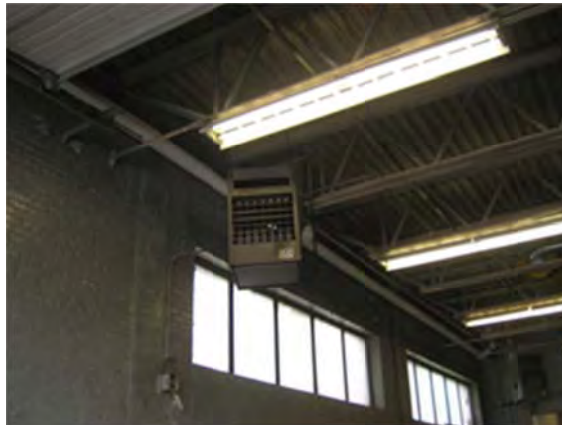
Lighting: Building D's lighting consists primarily of fluorescent, high-bay type fixtures. In general, light levels appear insufficient for the function and activity of the areas served. The overall condition of the interior lighting is poor and proper switching and control was not present; the lighting is controlled by breakers in several areas, which is a code violation. See picture below:

Local heating units mounted in Building D.
