**SKYLIGHT STUDIOS, INC.**  
**FINAL TREATMENT REPORT FOR UNCLE SAM MEMORIAL STATUE**

<h2>Uncle Sam Memorial Statue</h2> <p>Bronze and Stone</p>	
<b><u>Date:</u></b>	1976
<b><u>Sculptor:</u></b>	Theodore Cotillo Barbarossa
<b><u>Location:</u></b>	Town Center, Arlington, MA

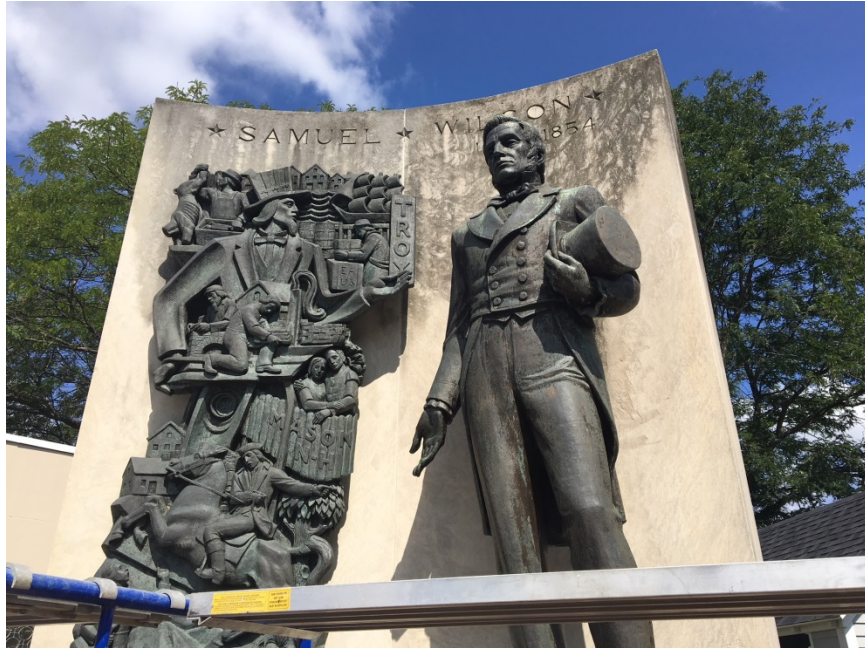
progressively corrode with time and continued exposure to acid rain, which is the primary pollutant. The corrosion will continue to accelerate. The metal is essentially eaten away and pitted, thus loss of surface detail is caused. This process is evident throughout the surface of this bronze. It is particularly eroded on many of the top or horizontal surfaces (see pictures 1 and 2).

Picture 1 – Patina before treatment

- The sculpture was isolated from the stone base by masking off the surrounding stone surfaces (see picture 5).
- Air blasting with walnut shells and fine silica sand was used as necessary to remove the existing corrosion from the surface of the bronze. It is necessary to remove all corrosion in order to successfully re-patinate a bronze (see picture 6).

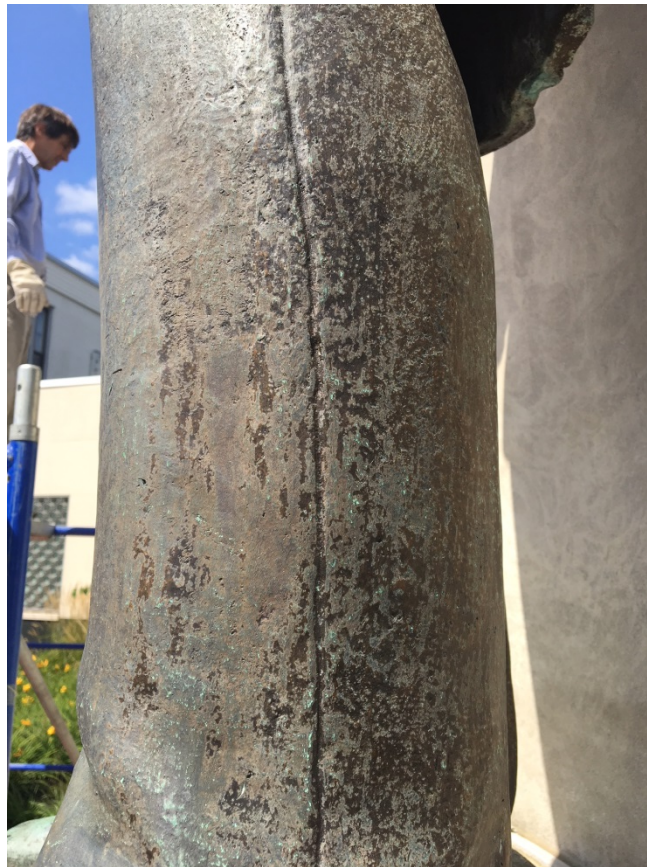
Picture 2 – Bronze corrosion

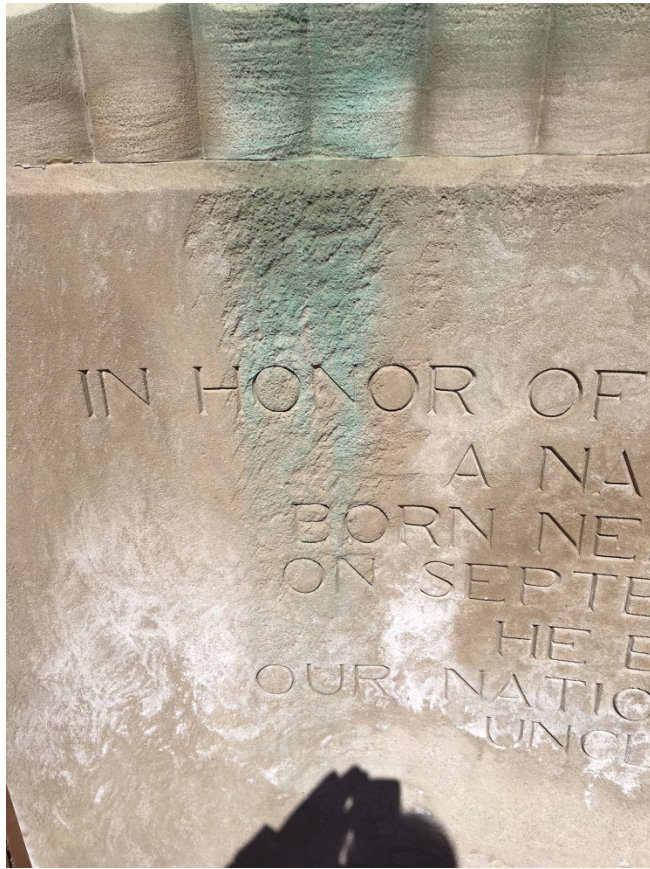
Picture 3 – Green stain

- The surface of the stone was cleaned with a mild pressure-wash and multiple applications of the environment-friendly soap D/2 Biological Solution stone cleaner.
- Additional green bronze stains on the stone were removed by using multiple applications of Sure Klean poultice (see picture 9).
- Any unstable caulk or mortar joints on the stone base were mechanically raked out, and the joints were repointed with tinted mortar or caulk as necessary (see picture 10).
- Some minor areas of loss and cracks were patched with a tinted Jahn mortar.
- The corroded area of stone above “IN HONOR OF...” was lightly flattened with a stone block to minimize the appearance of the erosion (see picture 11).

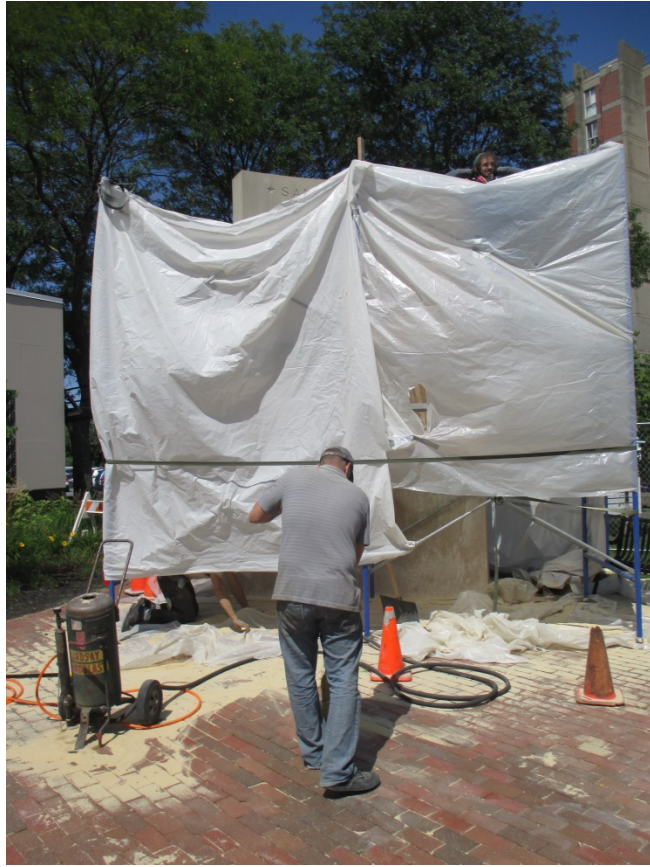
Picture 4 – Pipe staging

The Town of Arlington provided a water source and a temporary fence and barricade to surround the work site. Pipe staging was erected surrounding the stone and bronze. This was used for access to the bronze and to tent in the monument during the abrasive blasting and patination treatments (see picture 4).

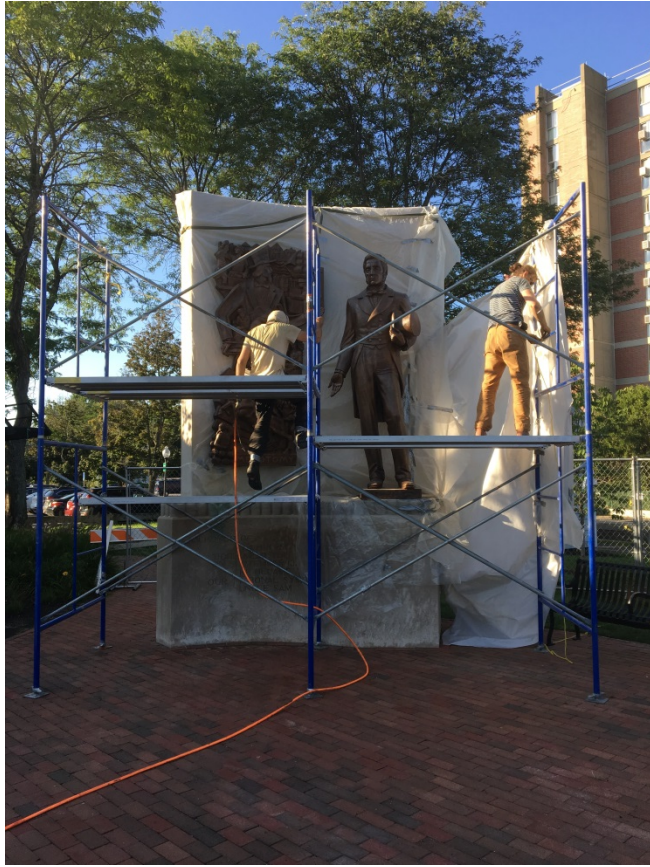
Picture 5 – Masking stone surfaces

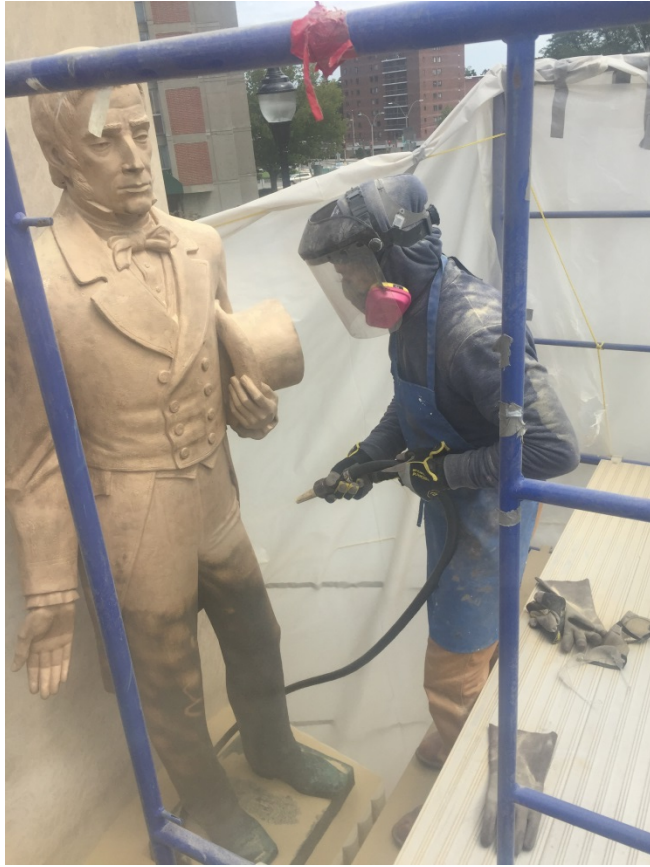
Picture 6 – Air blasting

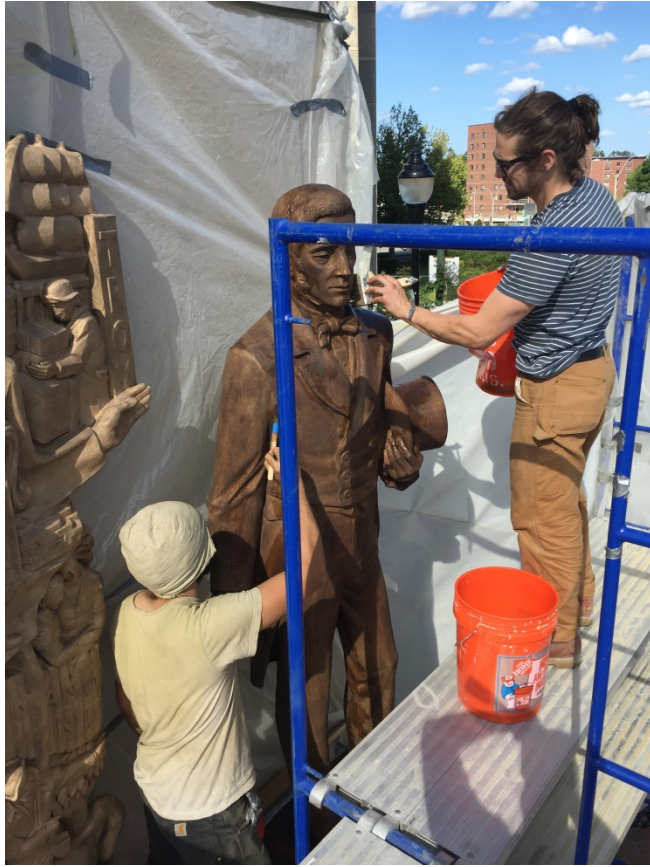
Picture 7 – Patination

- After blasting, the sculpture was re-examined for defects, holes, and cracks. There were none visible.
- The surface of the bronze was heated with a propane torch, and multiple applications of ammonium sulfide brown patina chemical diluted with water were applied by spray to chemically renew the rich brown patina. There is no documentation or archival information available at this time that indicates the formula of the original patina. It is reasonable to assume,

although, that it may have been a deep, warm brown-bronze with highlights on the top surfaces which was typical of this time and of sculptor Theodore Barbarossa (see picture 7).

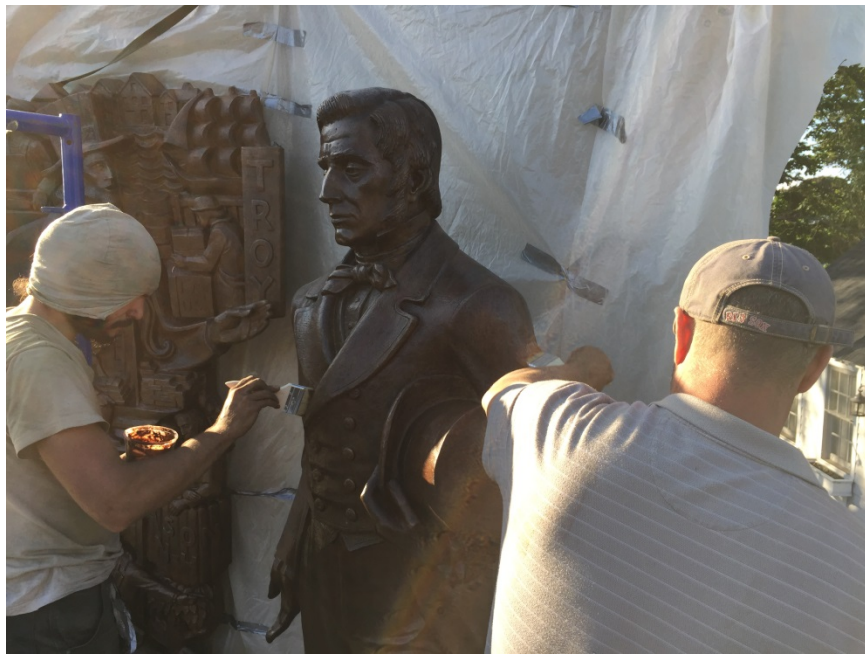
Picture 8 – Incralac coating

- After patination, the bronze was thoroughly rinsed with water.
- Fine Scotch-Brite was used to renew the bronze highlights.
- The surface of the bronze was coated twice with incralac diluted 30% with Xylene. Incralac is the coating recommended by the International Copper Association to offer the maximum protection on the surface of outdoor bronze statuary (see picture 8).
- After the incralac dried, two (2) coats of a microcrystalline paste wax were applied with a brush. The wax was lightly buffed after drying.
- The dedication plaque was removed and transported to Skylight Studios, Inc. It was restored using the same method that was used on site on the bronze sculpture. After restoration, it was reinstalled at the site with use of its original mounting pins and industrial strength anchoring epoxy.

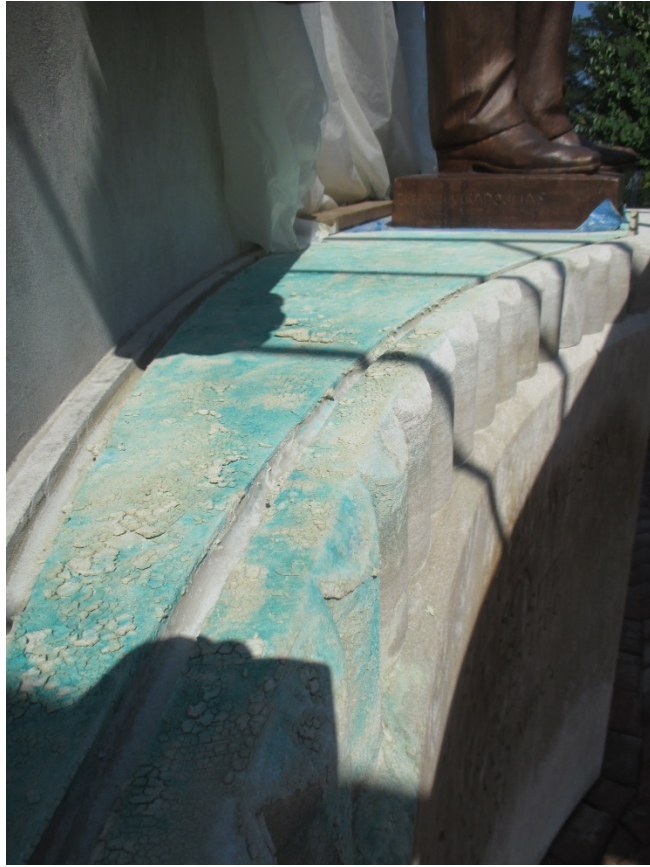
Picture 9 – Cleaning with poultice

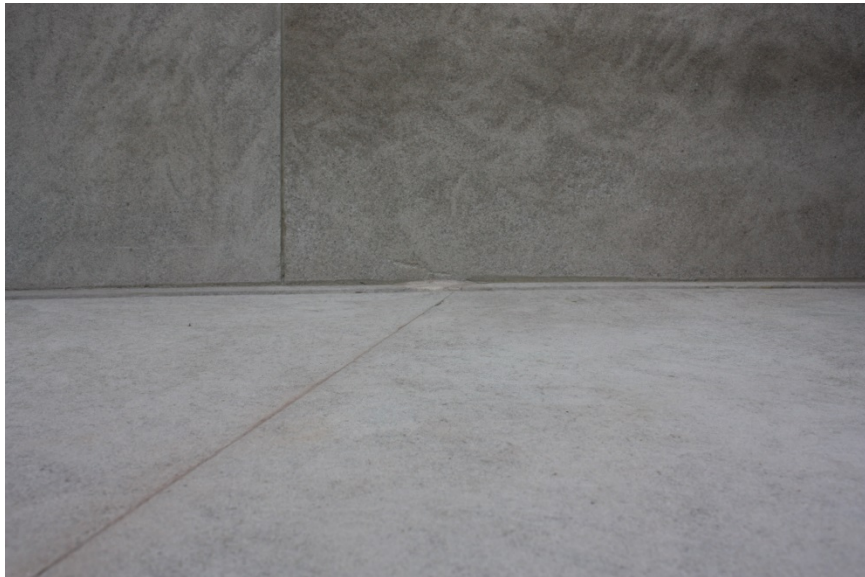
Picture 10 – Repointing

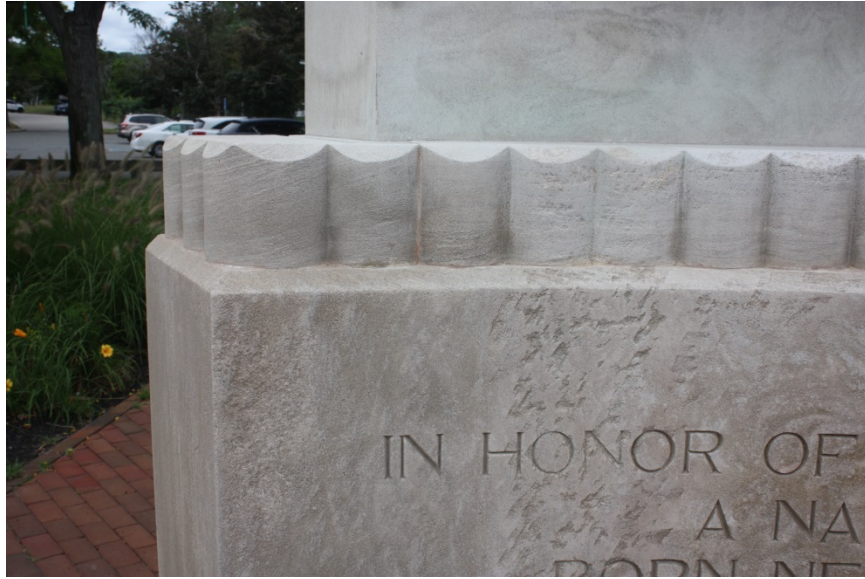
Picture 11 – Completed erosion restoration

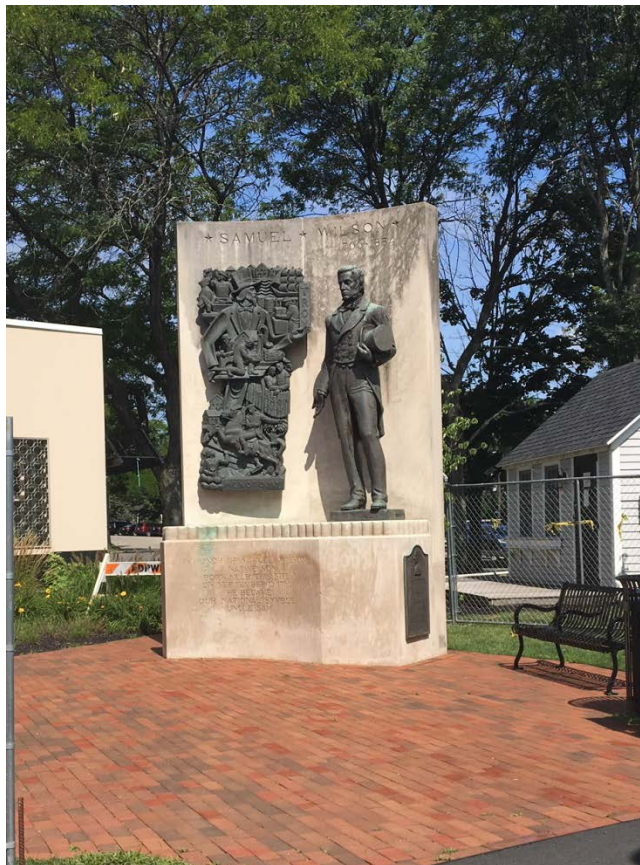
Picture 12 – Before treatment

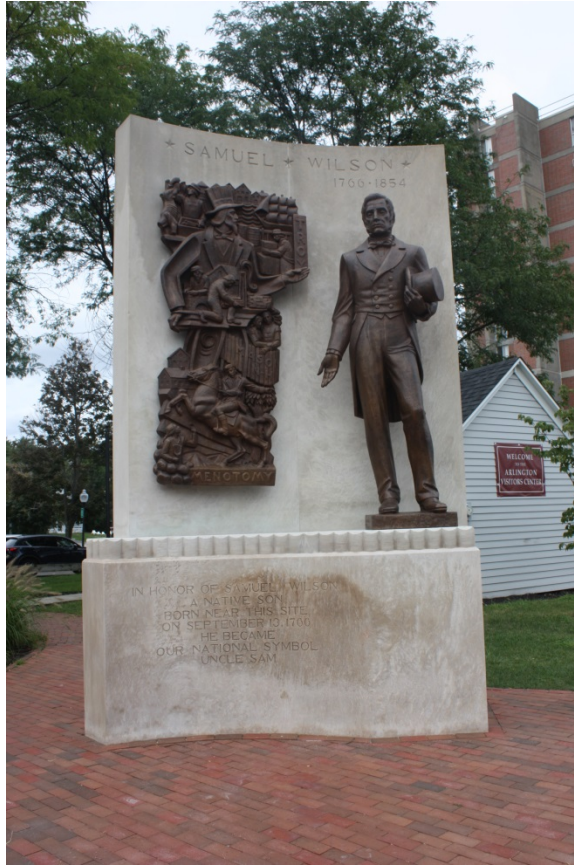
Picture 13 – After treatment
