Town of Arlington ADA Transition Plan

2020

ADA Transition Plan

Prepared by the
Institute for
Human
Centered
Design

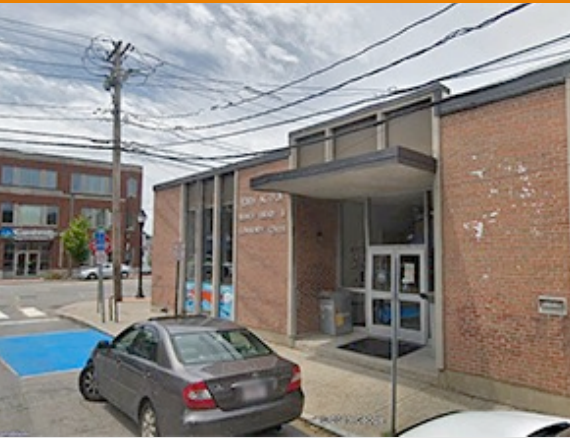
Accessible Routes to Program Areas

No accessible route to the Fox Branch Library and Community Room. No accessible route to the Reservoir Bath House and beach.

Toilet Rooms

Lack of accessible toilet facilities 23 Maple Street.

Service Counters

Service counters are located higher than allowed at the Bath House, Community Safety Building and Town Hall.

Signs

Lack of tactile egress and designation signage.

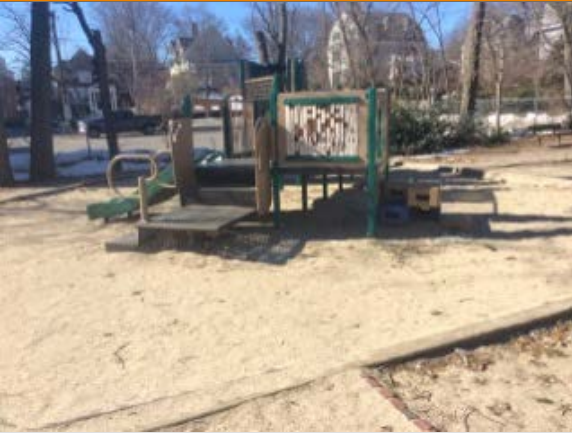
Whittemore Robbins House Playground

Play Areas

Lack of an accessible route at the playground at the Whittemore Robbins House.

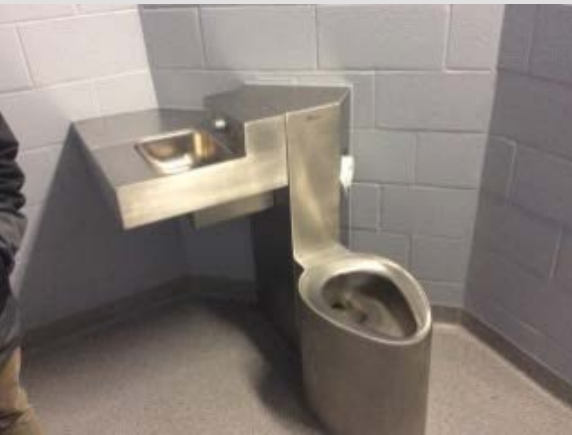
Facilities for Detainees

The Community Safety Building lacks accessible shower and toilet facilities and a bench.

Assembly Areas

Town Hall Auditorium and Robbins Library lack an assistive listening system.

Town Hall Auditorium also lacks wheelchair spaces and designated aisle seats.

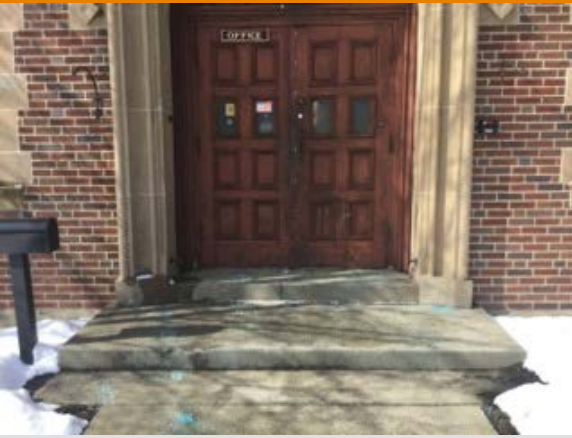
Entrances

No accessible route to entrances of Jarvis House, Mount Gilboa or the Cemetery Building.

Door Hardware

Door hardware is not operable with a closed fist.

Egress and Designation Signage

Buildings lack egress and designation signage with braille and raised characters.

Toilet Rooms

Some facilities like Jarvis House and the Cemetery Building lack accessible toilet rooms.

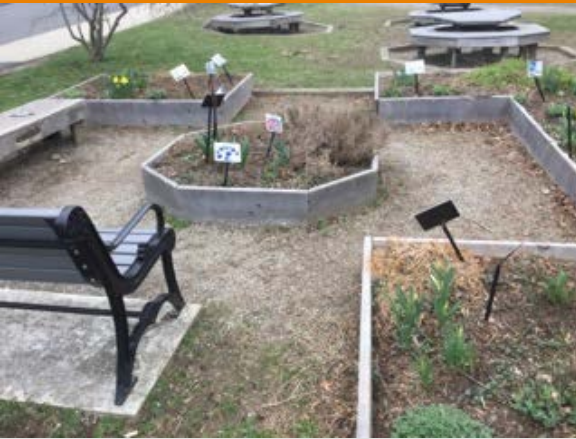
Bishop Elementary School Garden

Exterior Accessible Routes

Lack of accessible route to playgrounds, gardens, sports areas, and picnic tables.

Dining or Work Surfaces

Accessible dining or work surfaces are not provided in each program area.

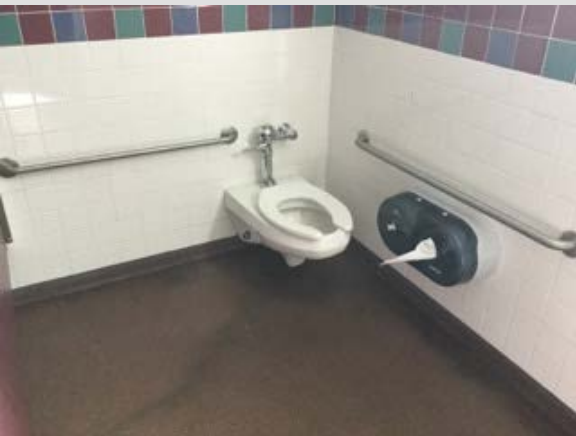
Hardy Elementary School

Toilet Rooms

Issues include unwrapped pipes at lavatories, non-compliant grab bars, and toilet paper dispensers that do not allow continuous paper flow.

Signage:

Designation and egress signage is not compliant or mounted properly.
