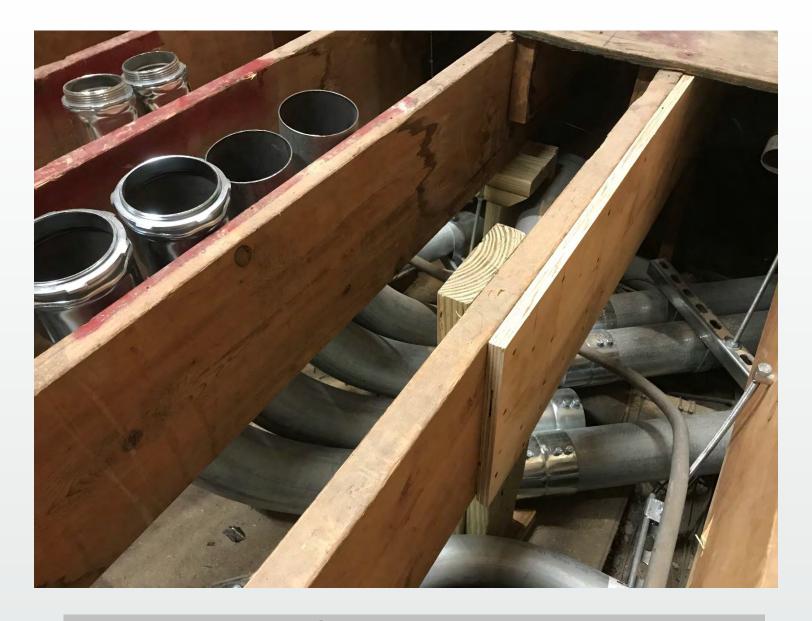
Repaired joists at raised floor at new switchgear in mechanical room

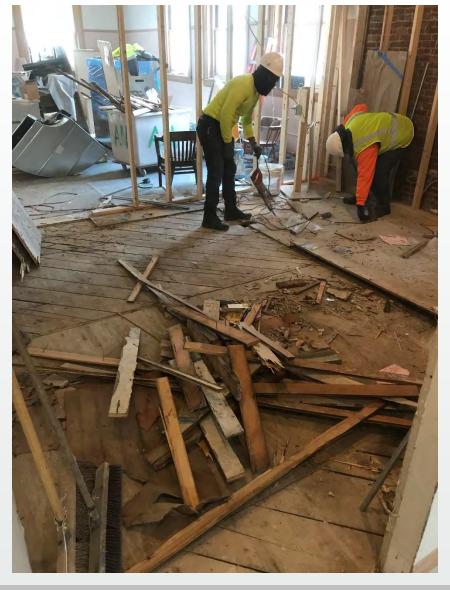
Removal of existing wood flooring to deck on 1st floor

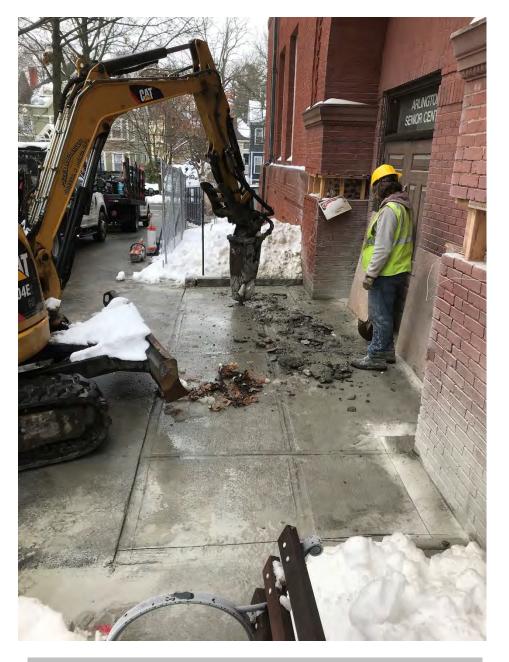
Removal of rejected east entry concrete pad

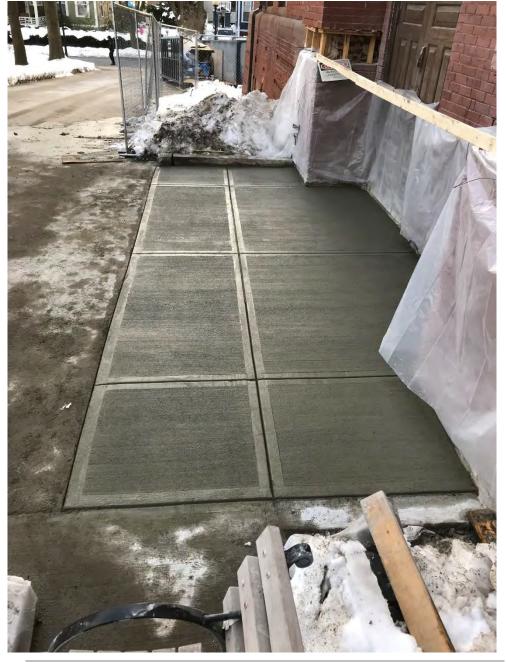
Second pour of new concrete pad at east entry

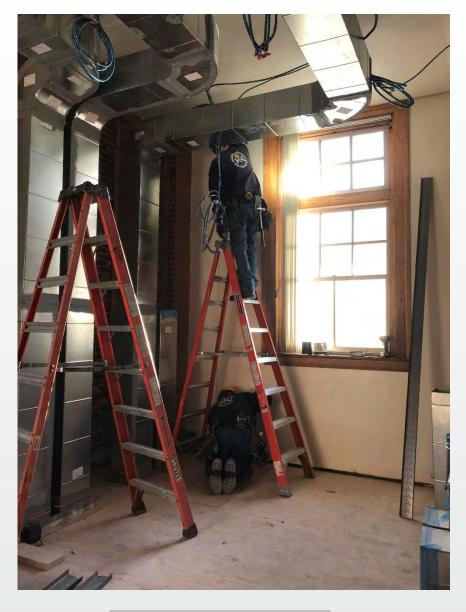
Ductwork on 1st Floor

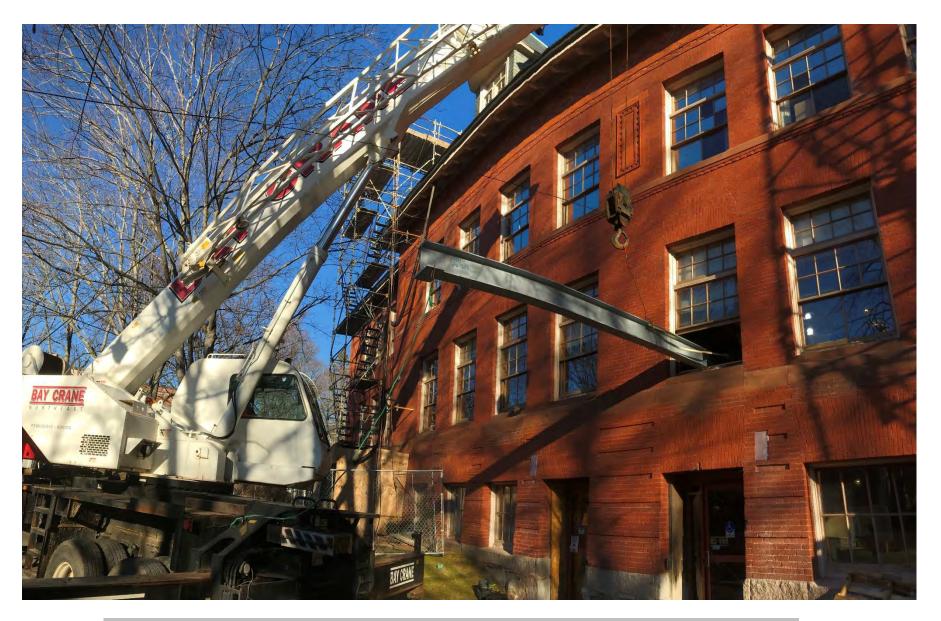
Rigging steel beam for operable partition through 1st Floor window.

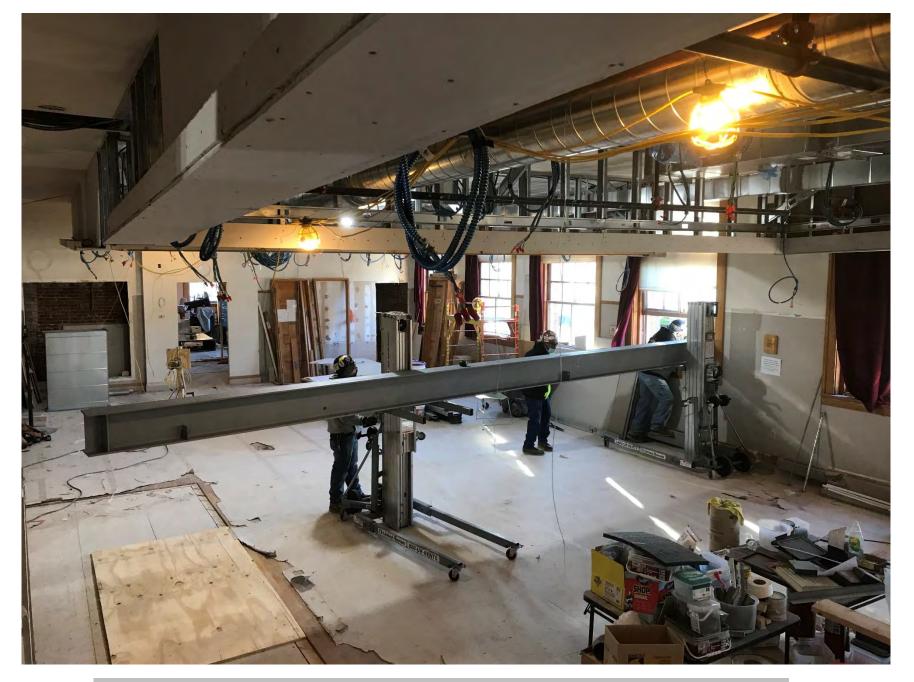
Rigging steel beam for operable partition through 1st Floor window.

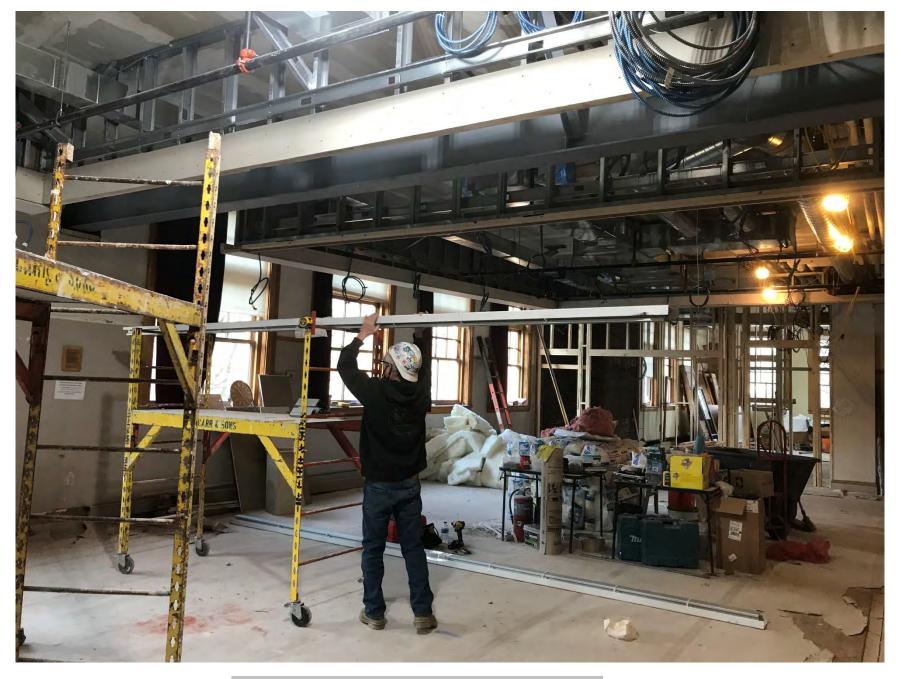
Operable partition track installation

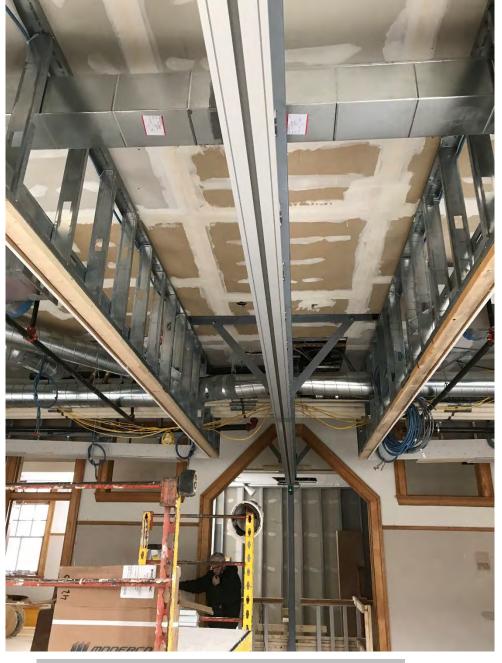
Operable partition track on 1st Floor

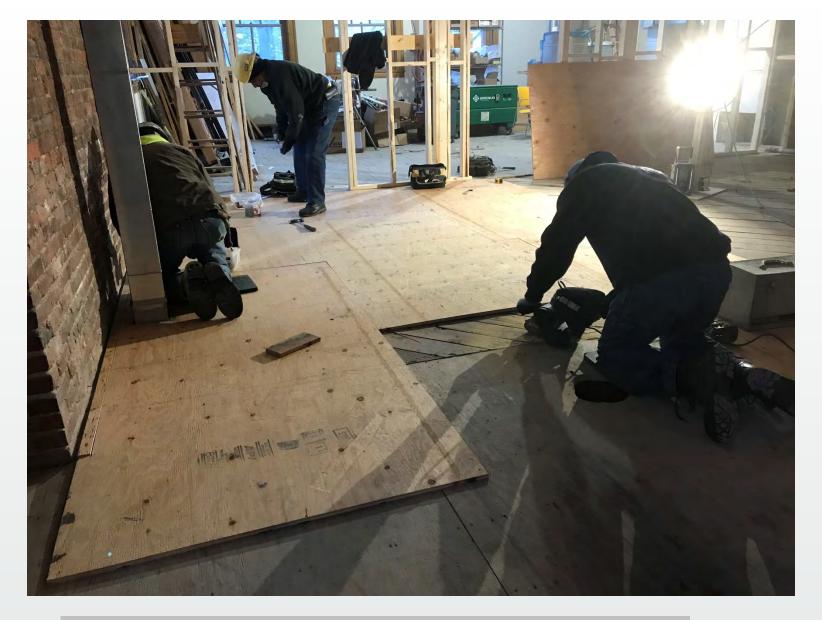
Plywood underlayment at removed wood flooring at 1st Floor

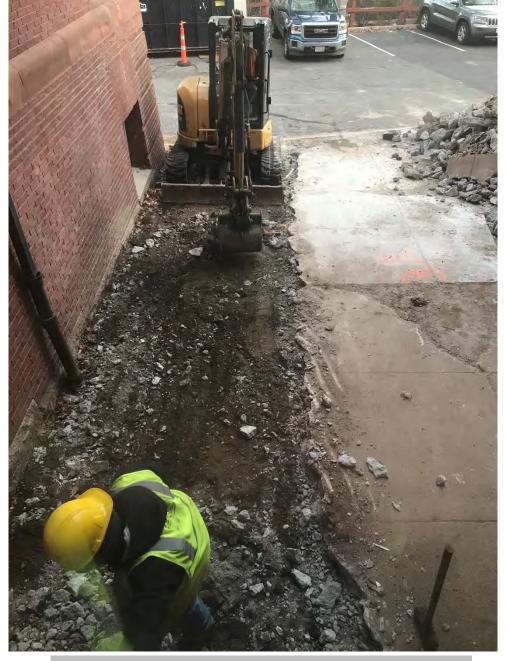
Demolition at former cooling tower pad.

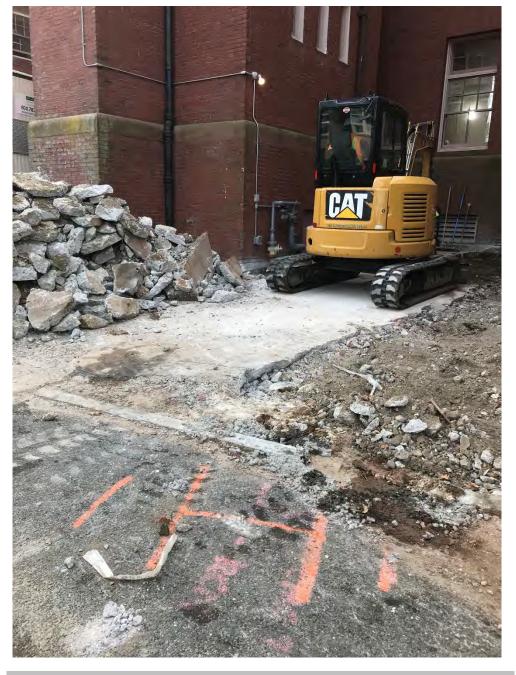
Demolition at north entry concrete walkway area

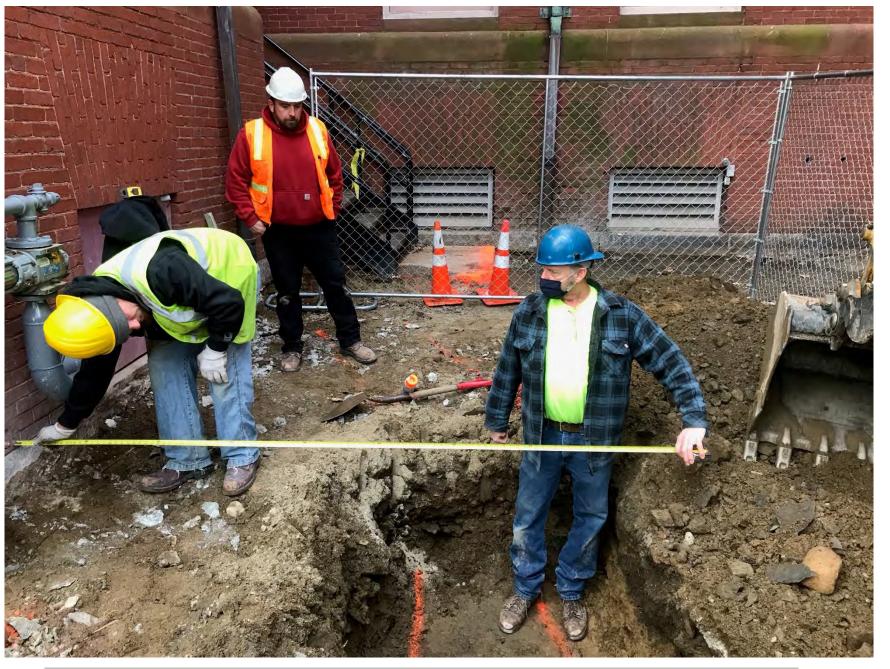
Test pit to uncover secondary wiring ductbank at new north entry canopy

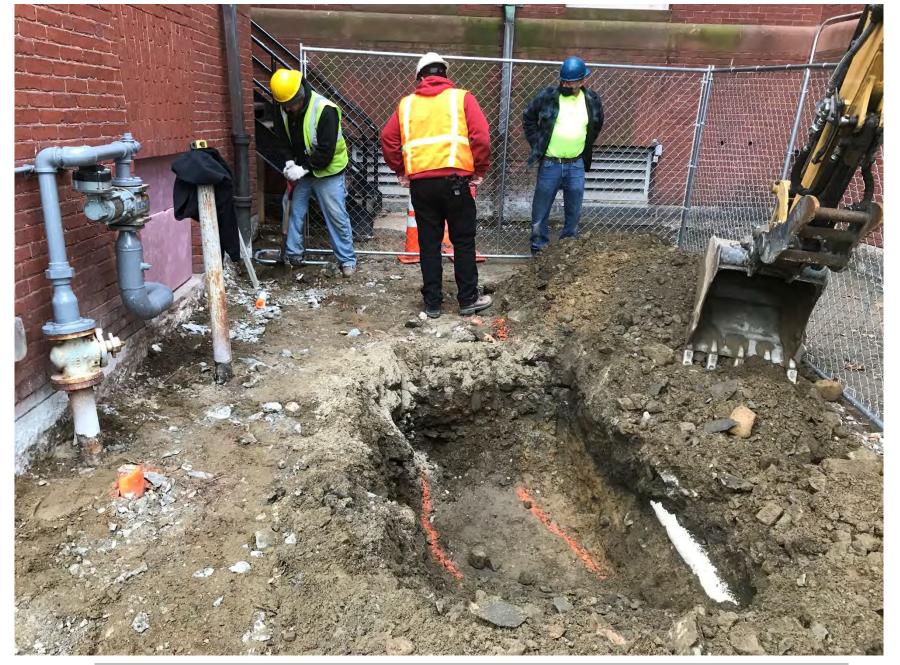
Test pit to uncover secondary wiring ductbank at new north entry canopy

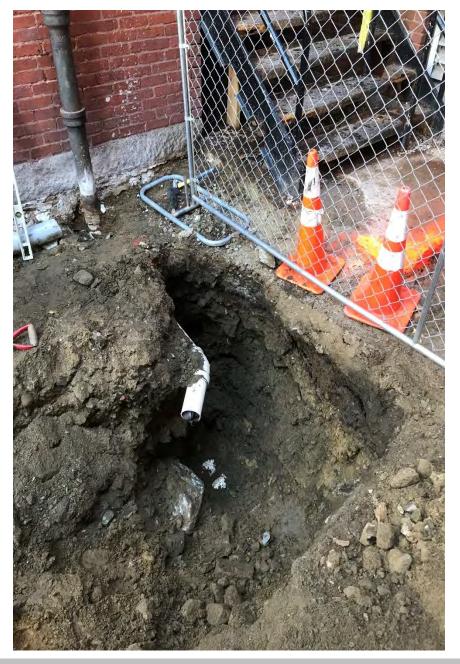
Existing downspout drainage piping at new north entry canopy
