Arlington Central School Senior Center / HHS Renovation

Progress Photo-documentation

2-2-21 PTBC Meeting

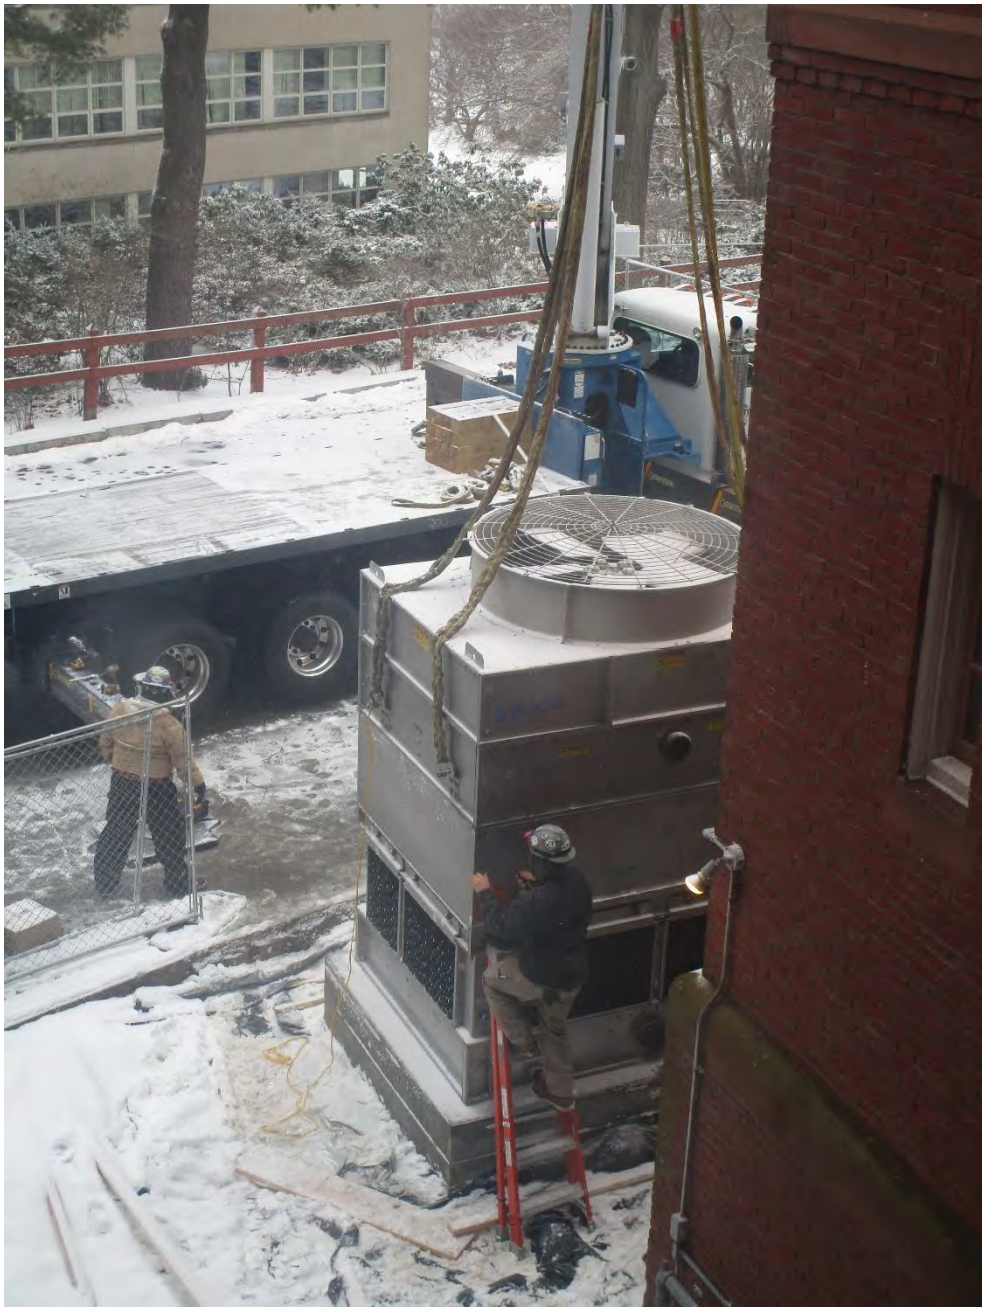
Rigging cooling tower on pad with truck crane

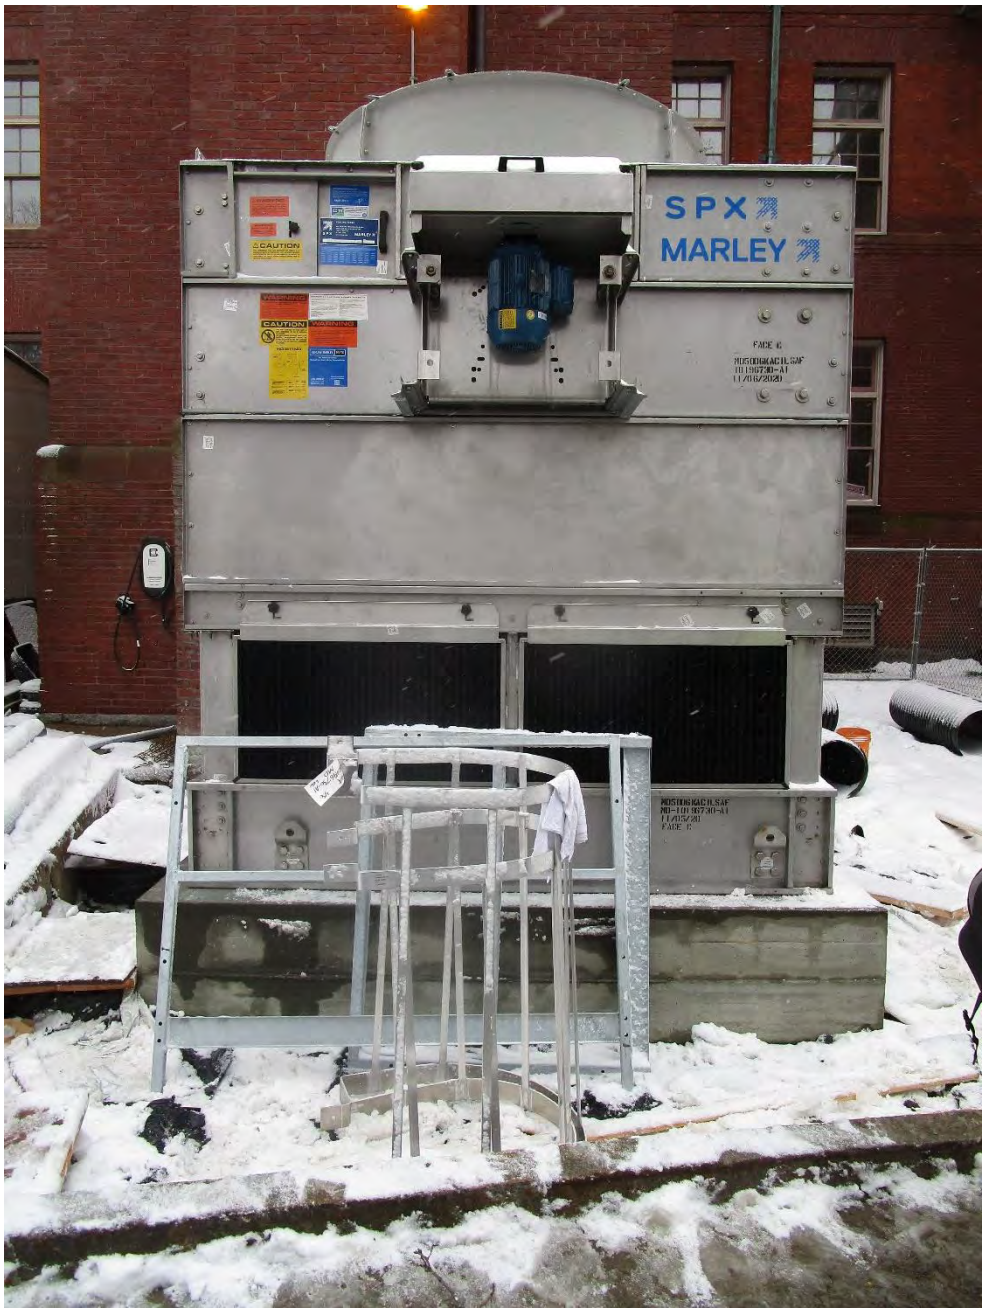
New cooling tower adjacent to north parking lot

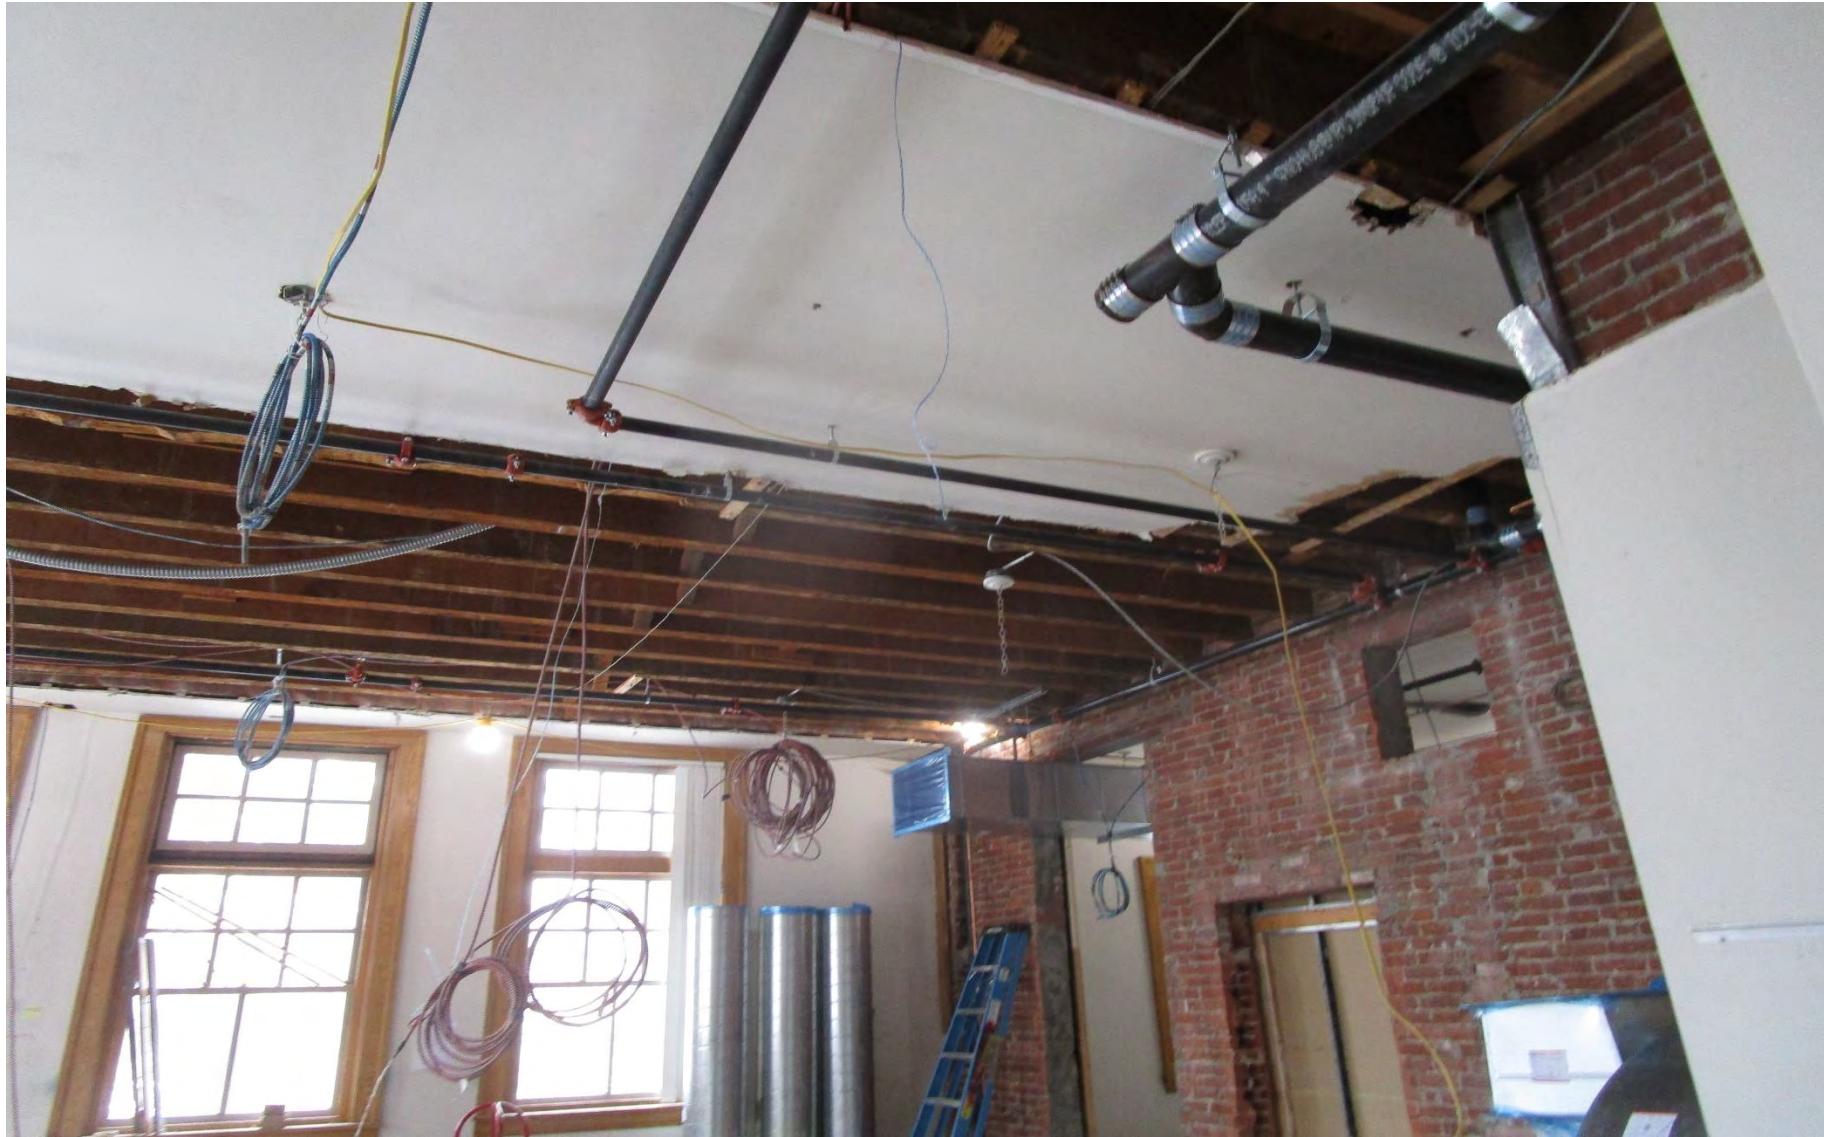
Kitchen ceiling area that requires additional LVL reinforcement framing

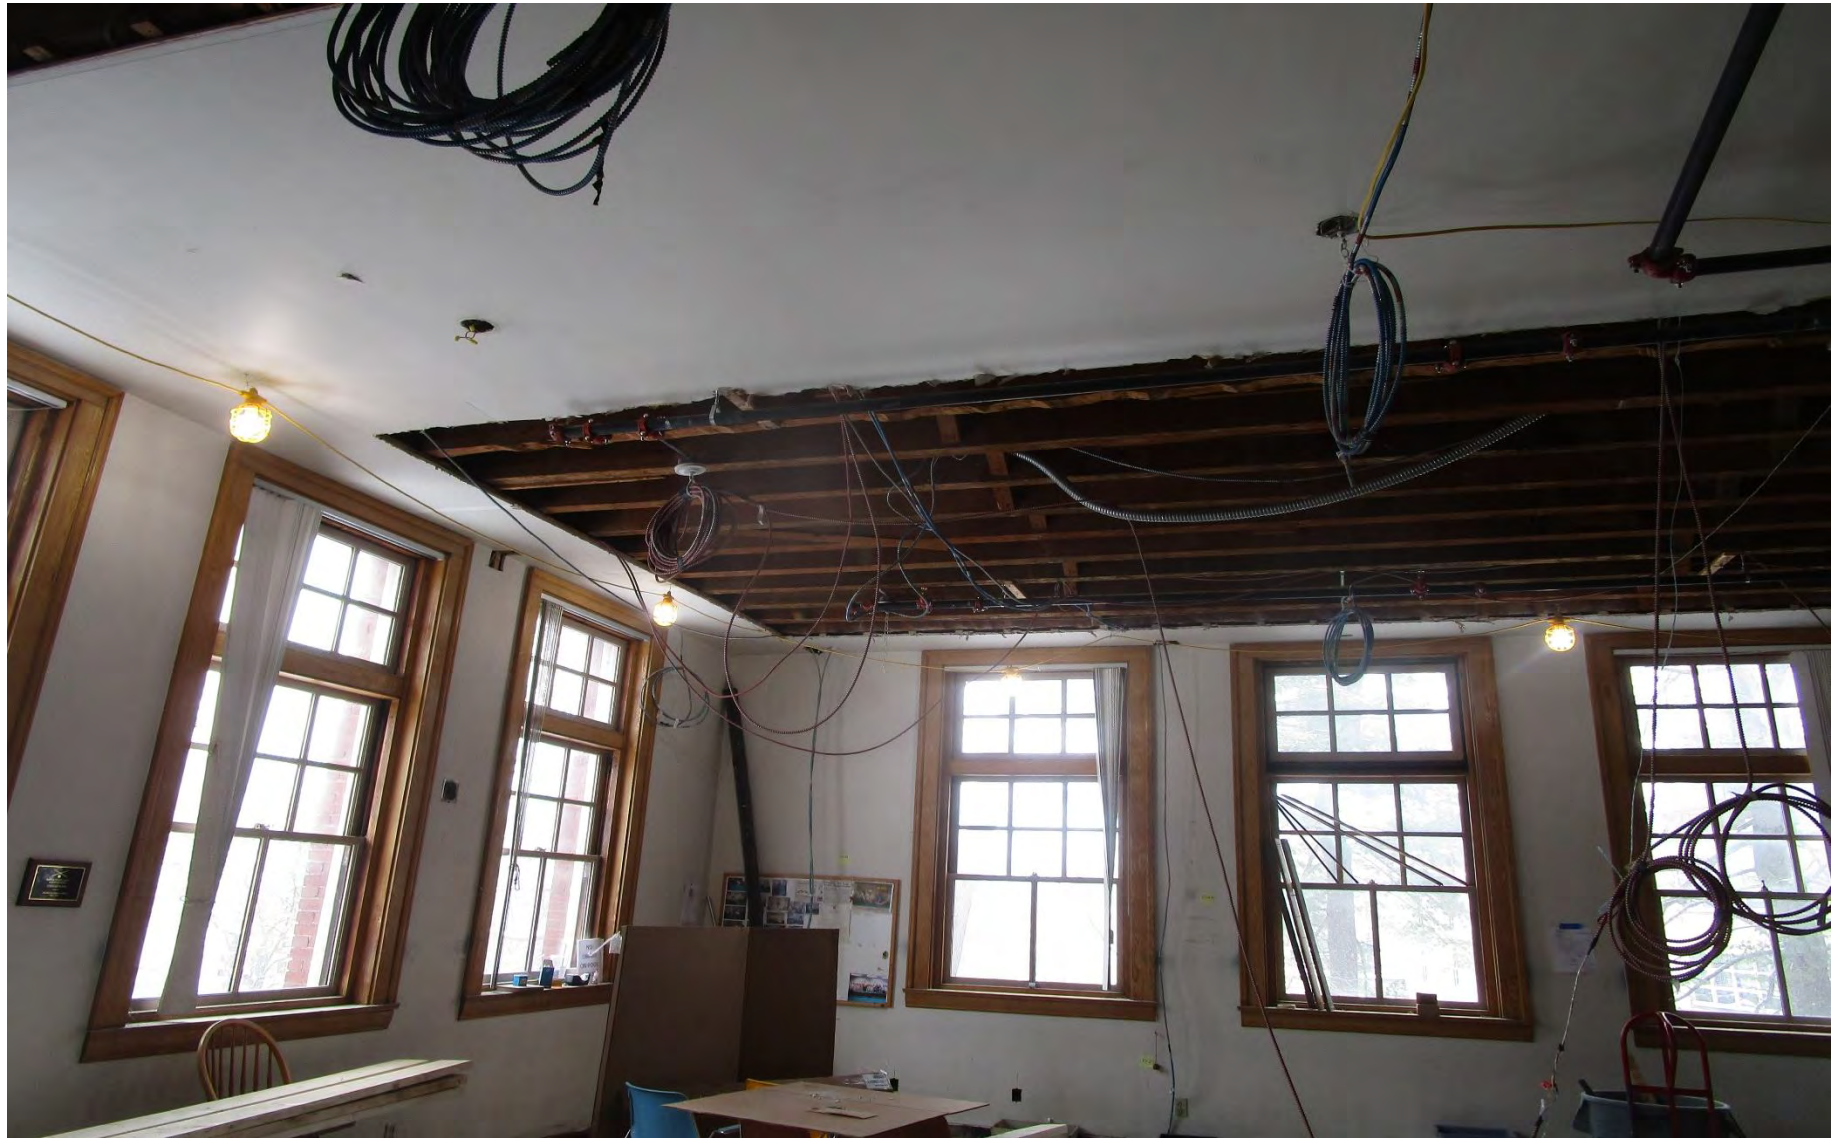
Kitchen ceiling area that requires additional LVL reinforcement framing

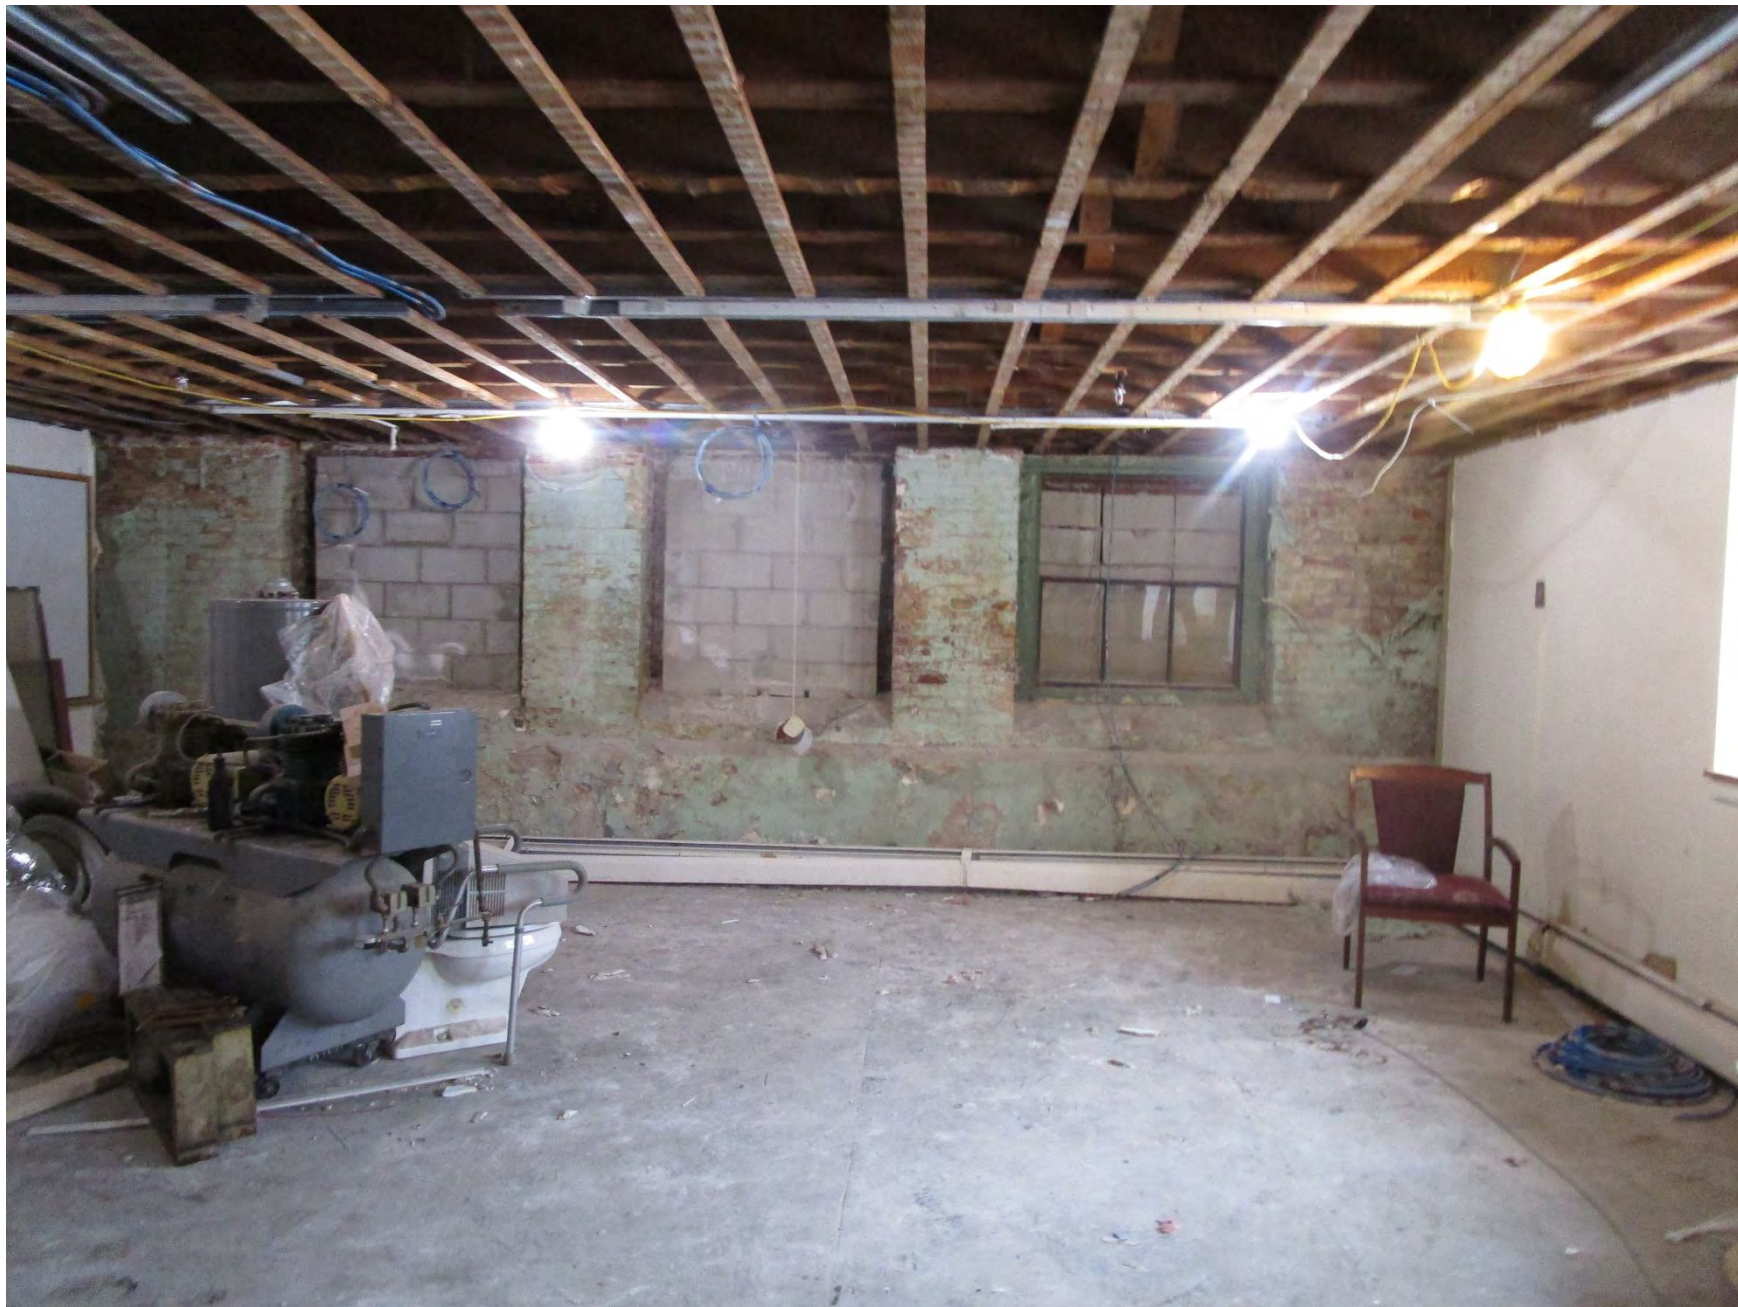
East wall of Yoga room on GF. Old windows previously blocked in due to raising of exterior grade

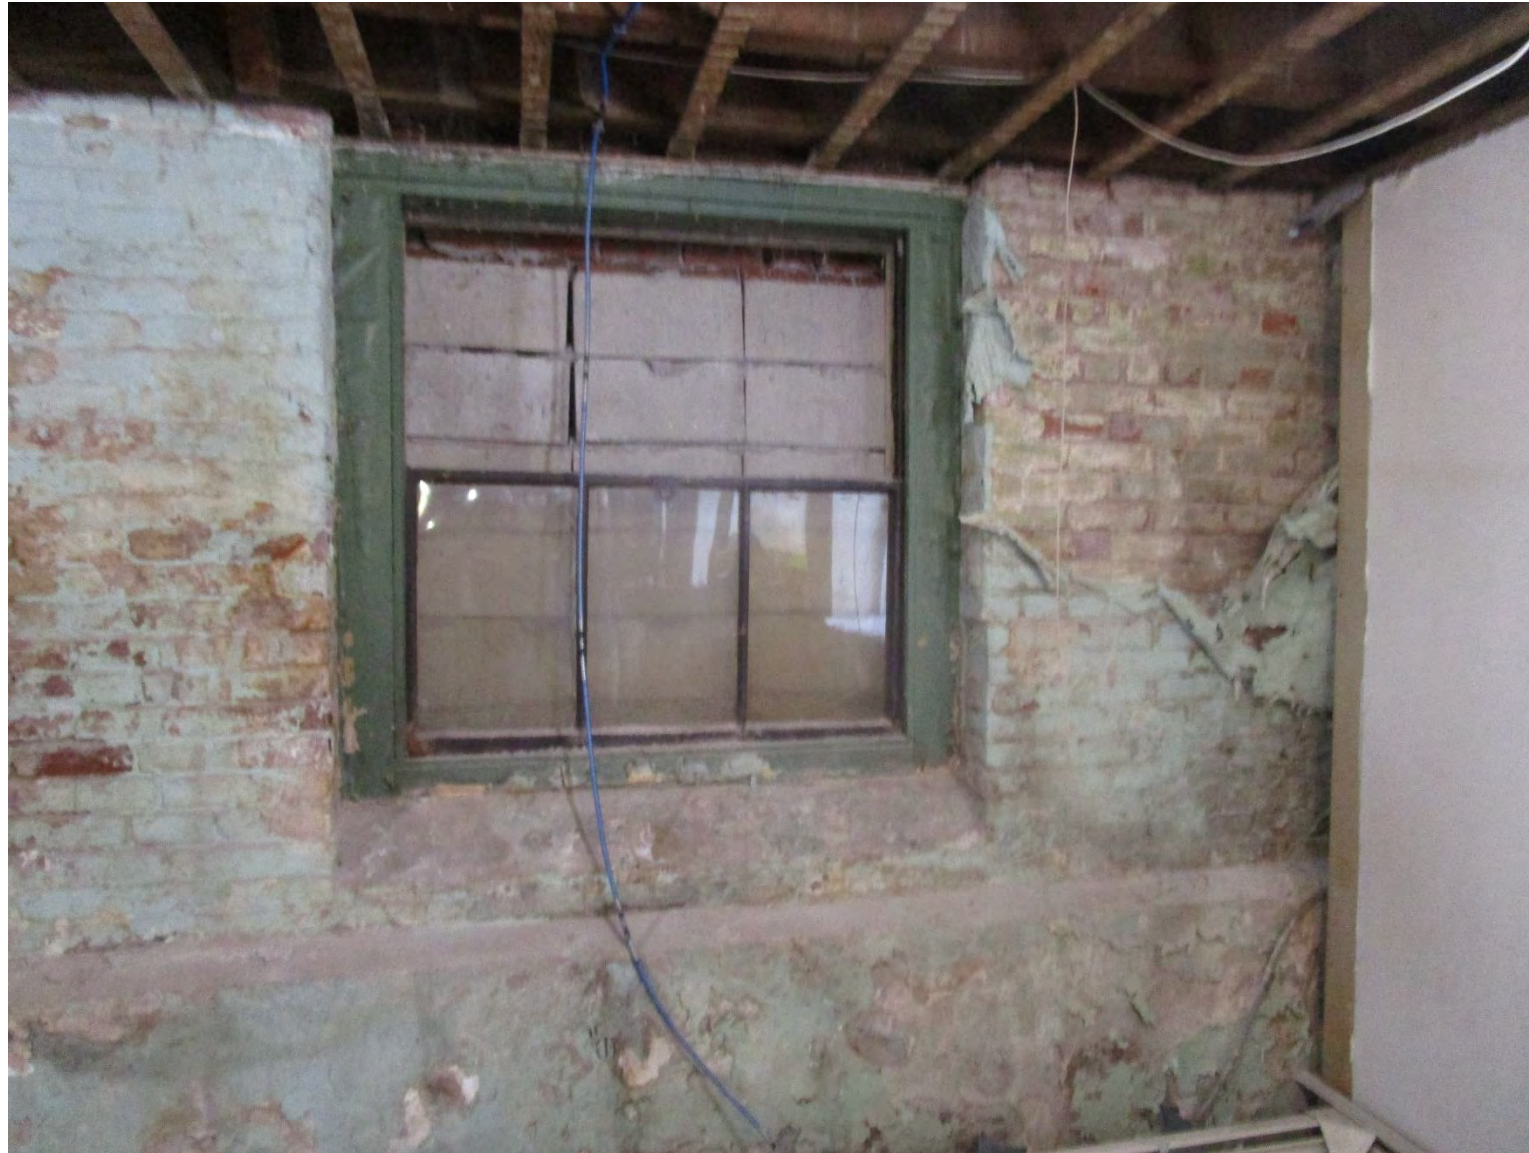
Previous contractor failed to fully remove one window frame and sash before blocking in the opening and installing drywall on interior. Moisture infiltration evident. Mitigated by new work on east side.

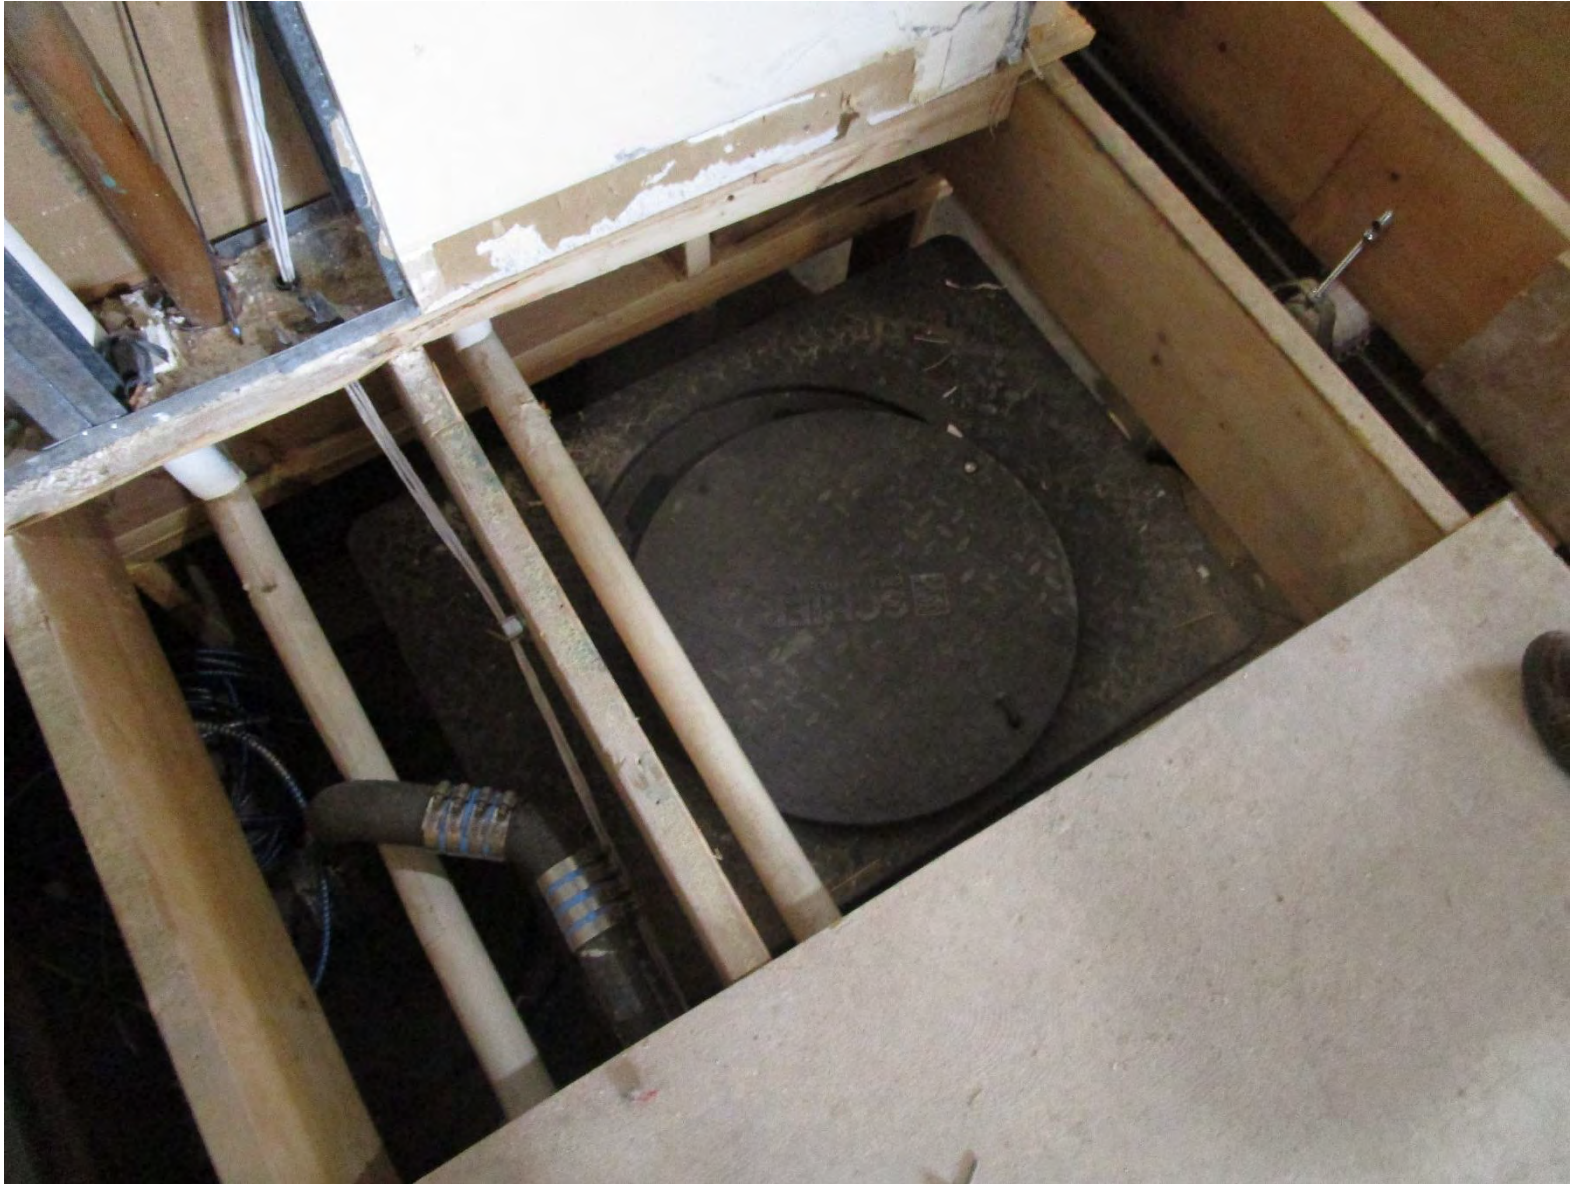
Grease trap for 1st floor kitchen in Ground floor level crawl space

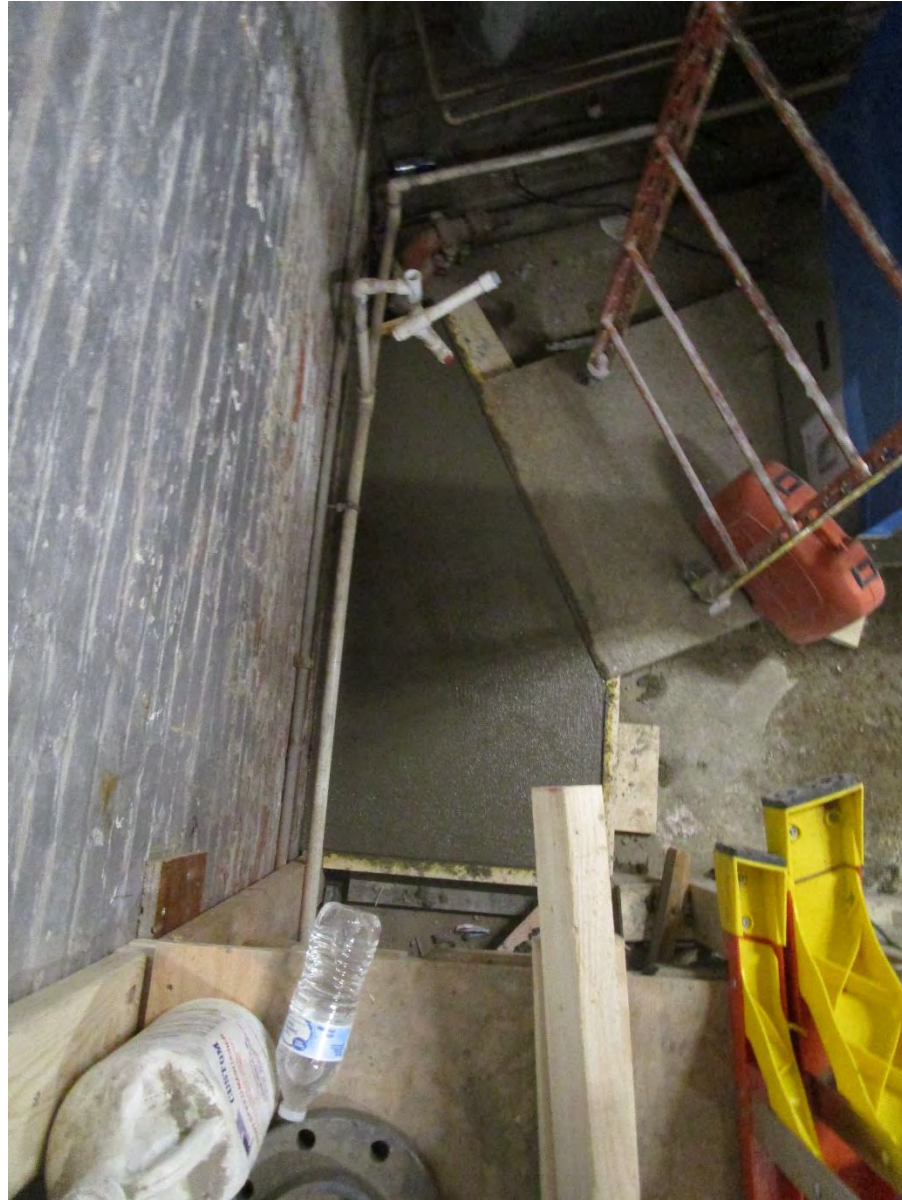
Mechanical room HV unit housekeeping pad extension

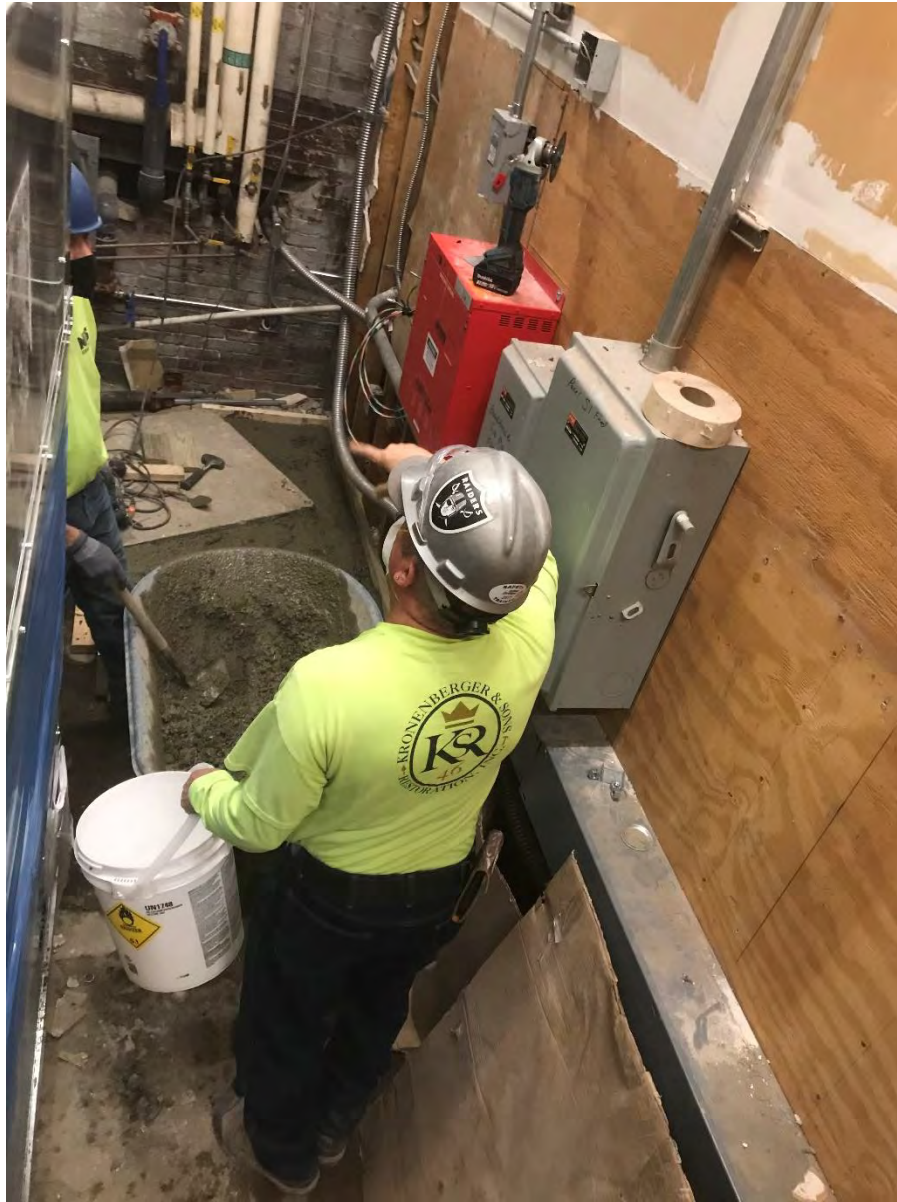
Mechanical room HV unit housekeeping pad extension

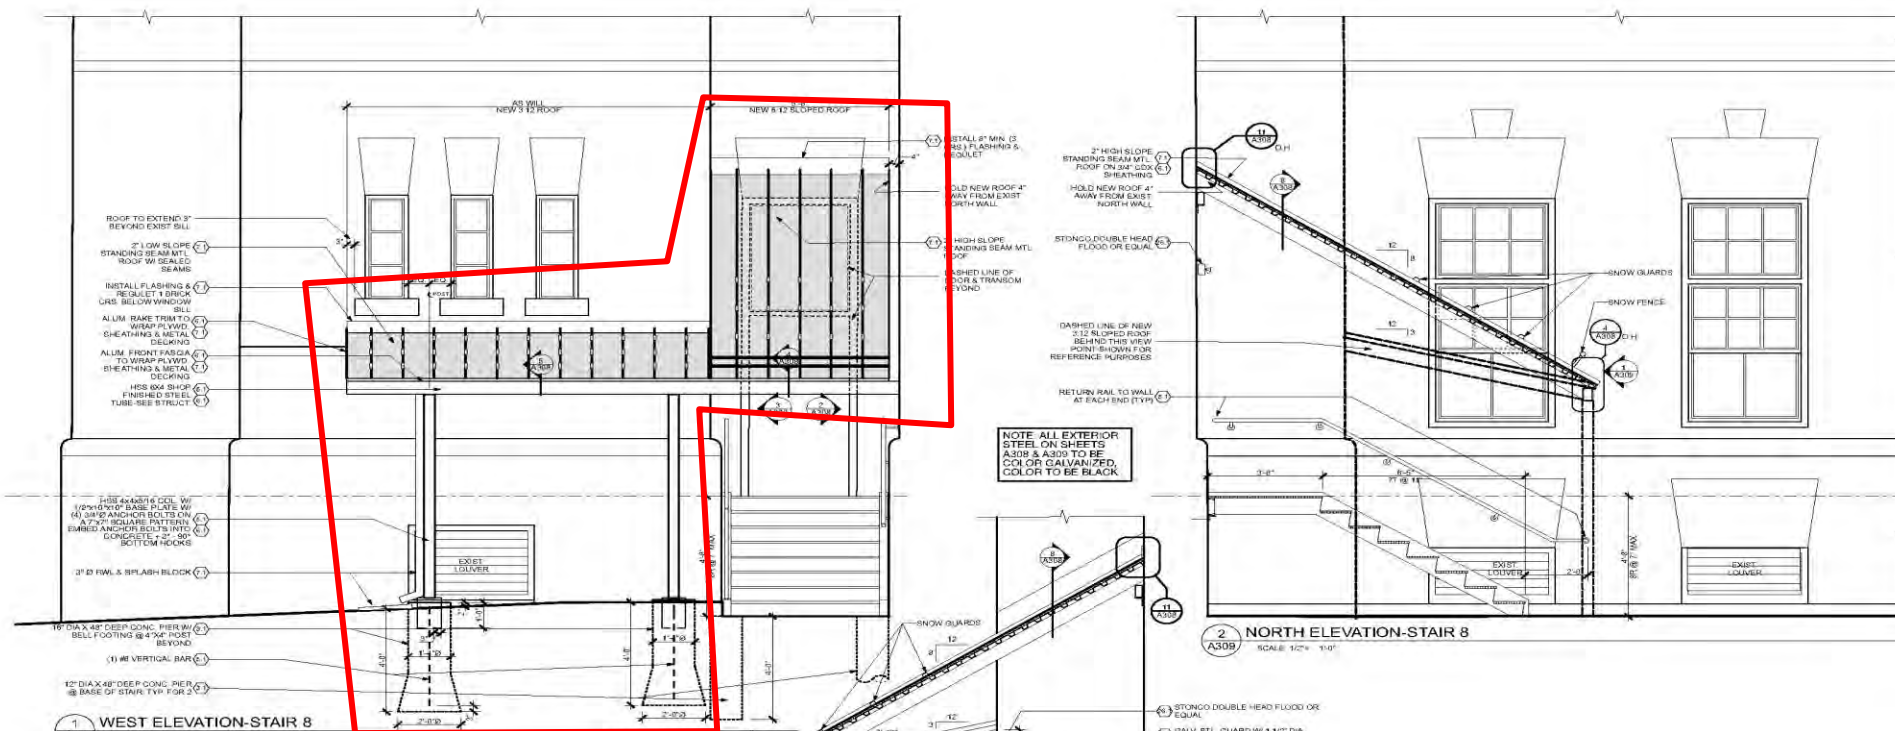
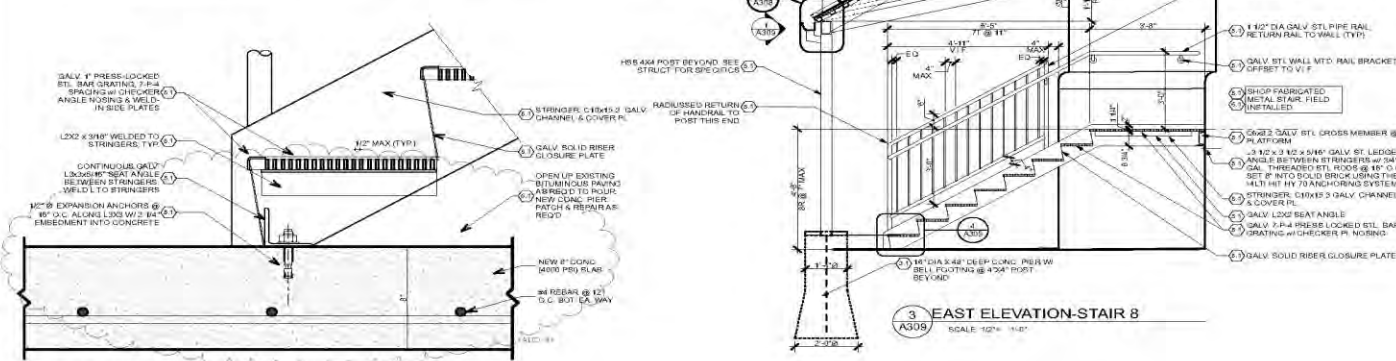
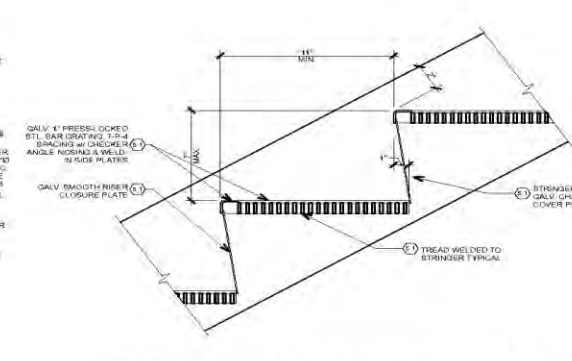
Deletion of north entry roof canopy
