Ref. Asbestos Survey Report
Residence
821 Massachusetts Ave.
Arlington, MA

Job: 821 Massachusetts Ave Arlington MA. – June 3, 2021

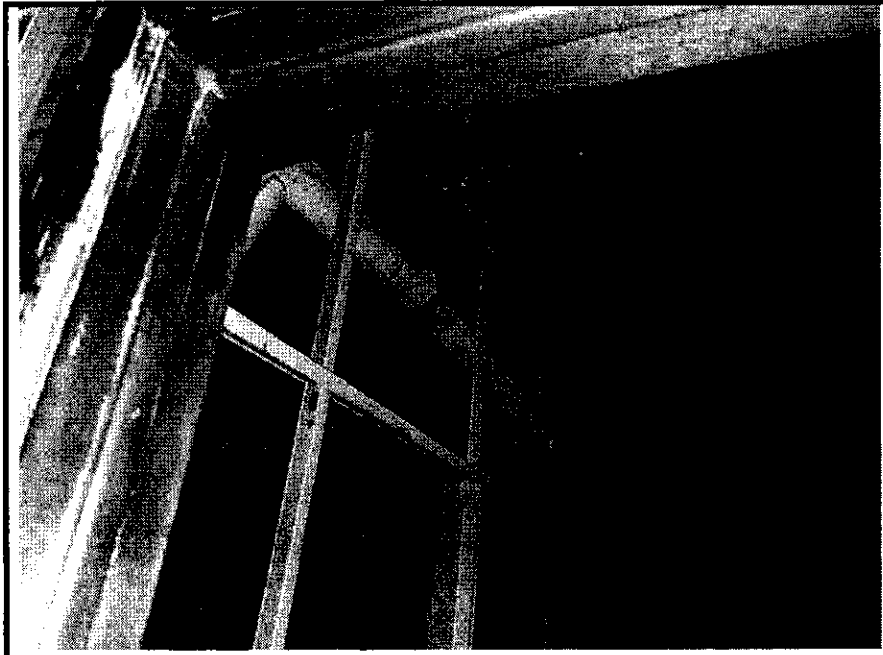
Above Ceiling Basement
Sample #5 A, B, C

Pipe Insulation Chrysotile= 50%

- The US EPA and MassDEP require all ACM be removed from a facility prior to the start of renovation or demolition activities if the materials may be disturbed by these activities. A licensed Asbestos Removal Contractor should remove identified ACM prior to the start of renovation or demolition activities in accordance with federal, state, and local regulations.

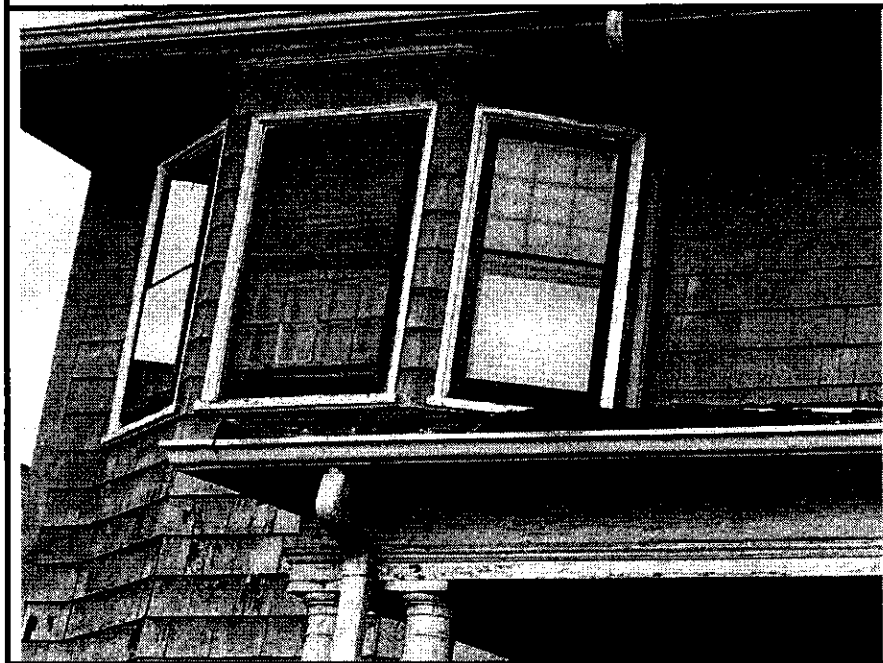
Exterior Windows
Sample #19 A, B, C

Glazing Chrysotile= 2%

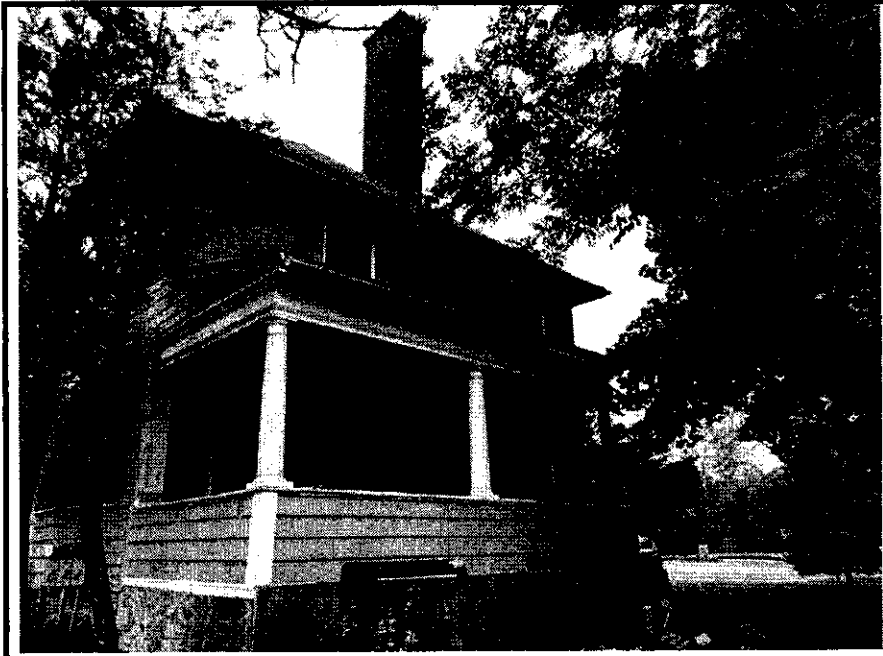
Flat Roof front and
right-side porch
Sample #20 A, B, C

Shingle Roof Chrysotile= 5%
 Tar Paper Chrysotile= <1 %

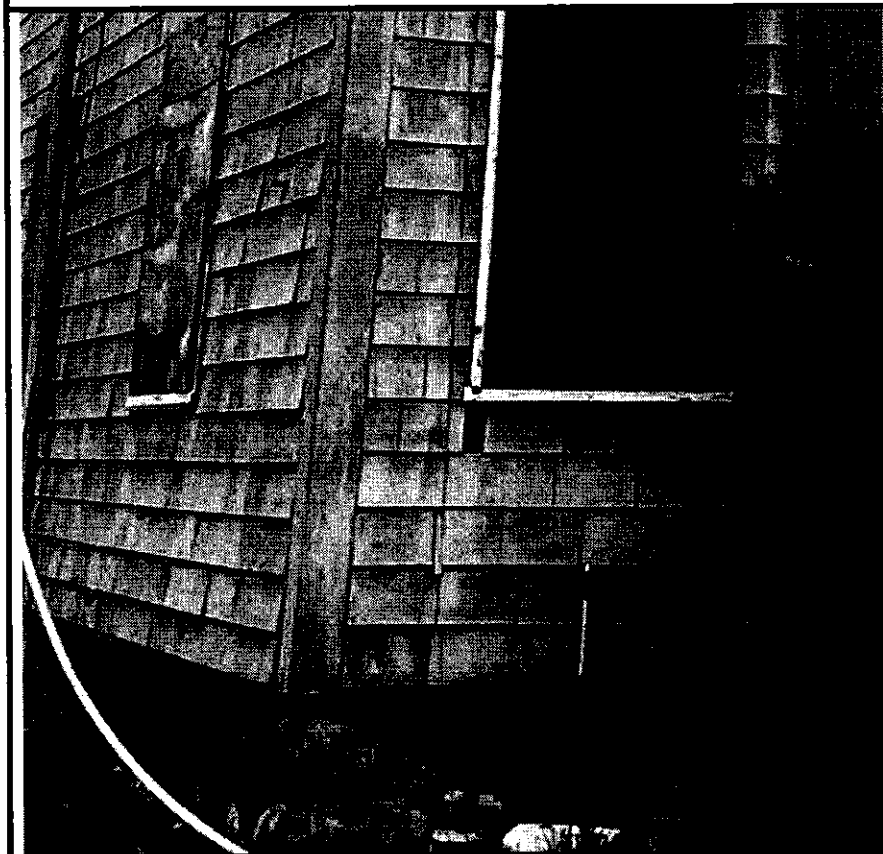
Behind Wood Siding
Exterior House
Samples #21 A, B, C

21B 723136	Tar Paper	Behind Wood Siding Exterior House	black	Cellulose 70 Non-Fibrous 30	Detected Chrysotile < 1
21C 723137	Tar Paper	Behind Wood Siding Exterior House	black	Cellulose 70 Non-Fibrous 30	Detected Chrysotile < 1
