Request for Proposals #23-63

**Landscape Architectural Design Services
Brackett Elementary School Playground**

ADDENDUM NO. 2

PLAYGROUND ASSESSMENT AND RECOMMENDATION REPORT

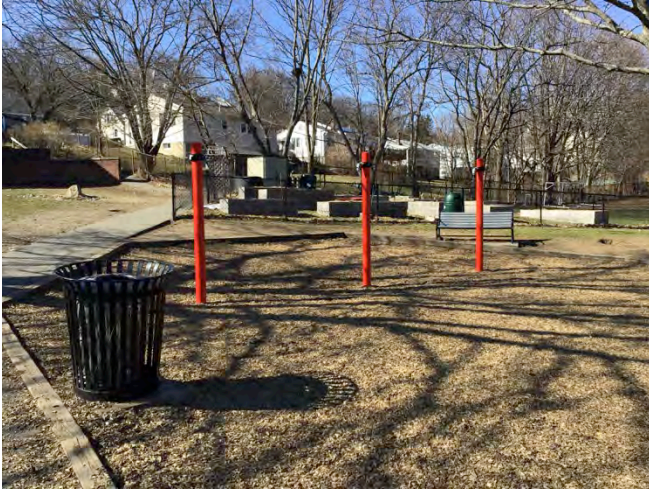
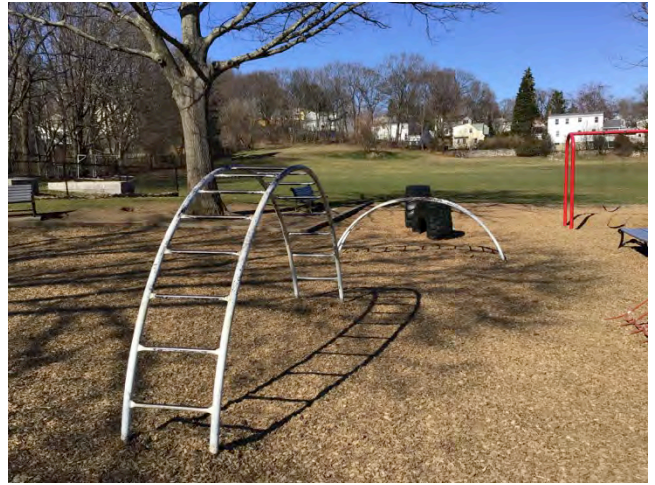
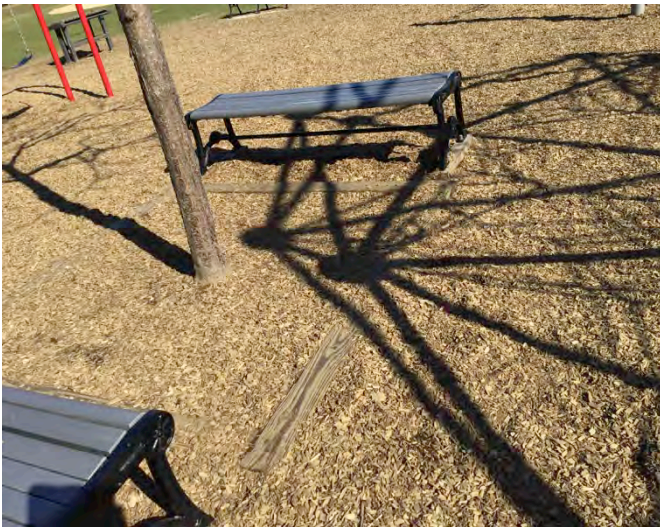
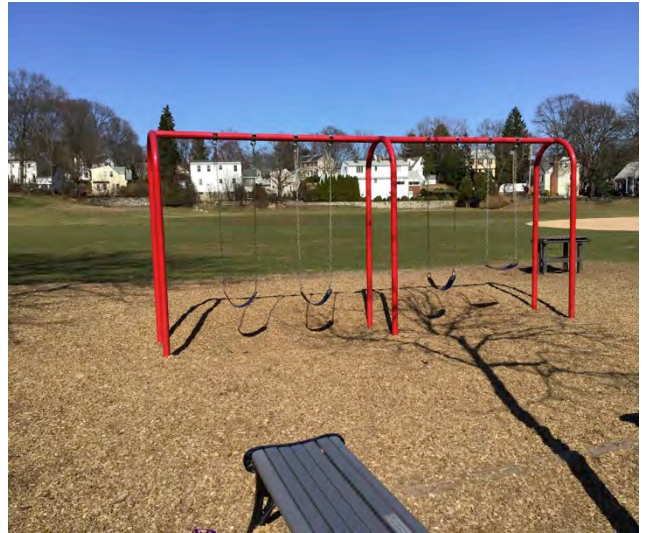
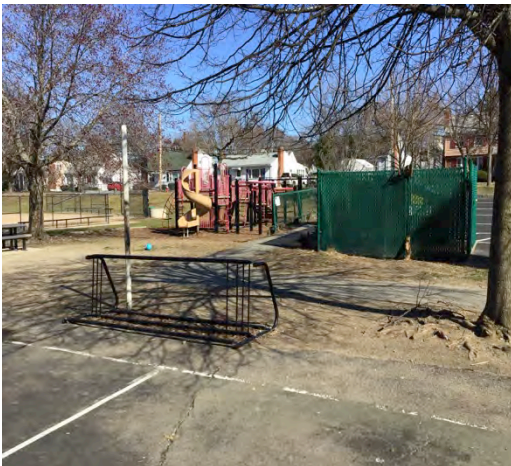
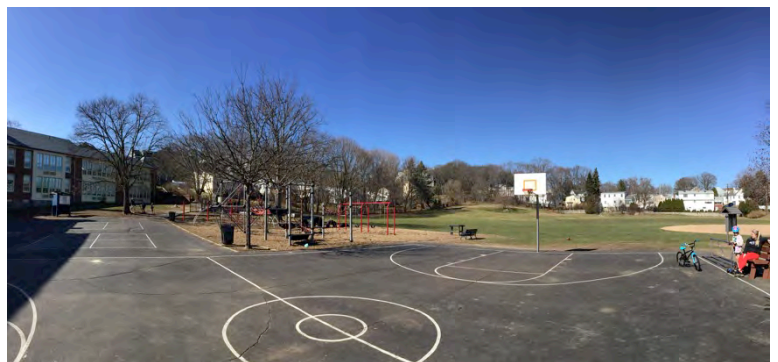
ADDITIONAL PLAYGROUND PHOTOS

The surfacing is loose fill - EWF. Although the playground does meet ADA, it does not meet MAAB. A curb cut is needed for users with disabilities to access the play area. The wood fiber needs to be spread evenly and then additional wood fiber is needed. There is a tree in the middle of the play area, causing a tripping hazard. Using 'wood' as a separator of surface changes is a good idea, however both sides have wood fiber thus this edging is not useful.

The basket type swings [Cloud Nine] have been removed. The belt seats and 2 bay swings are in good condition. The hardware and chain on 2 of the swings need to be replaced. A wood music piece needs to be sanded and sealed. There are no mallets. There are 2 older rainbow climbers that have been painted. They comply with current guidelines. Note the rubber tires: they have latex. Some children are allergic to latex. The filter fabric is revealed inside of the rubber tires. The further indicates the need for additional wood fiber.

- Surfacing is fair – needing special attention at the swings and tree area.
- Sand and paint the rainbow climbers.
- Contact the Manufacturer [Berliner] about the Cloud Nine swings.
- Clean out and /or remove edging around the tree. There is wood fiber on either side.
- Consider adding one more tier of the same profile of the wood perimeter edging. If the first tier is rotted, remove and replace.
- Bishop should consider having [poured in place rubber] PIP installed. The layout and design lends itself nicely to having the appropriate amount of PIP surfacing to meet MAAB. The entire area will not have to be PIP. The second choice is grassmats throughout the playground after the area is defined with edging.
- Safety labels must be affixed [especially to the rope climbers].

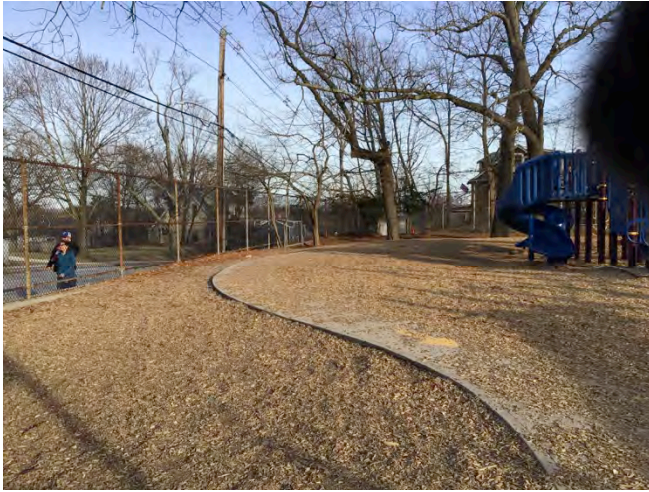
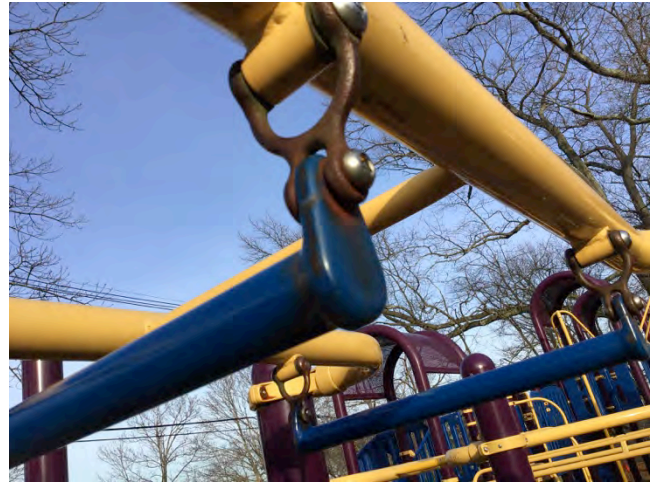
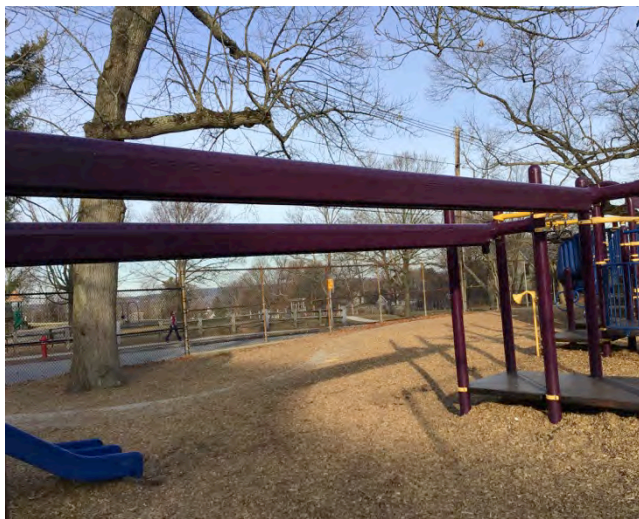
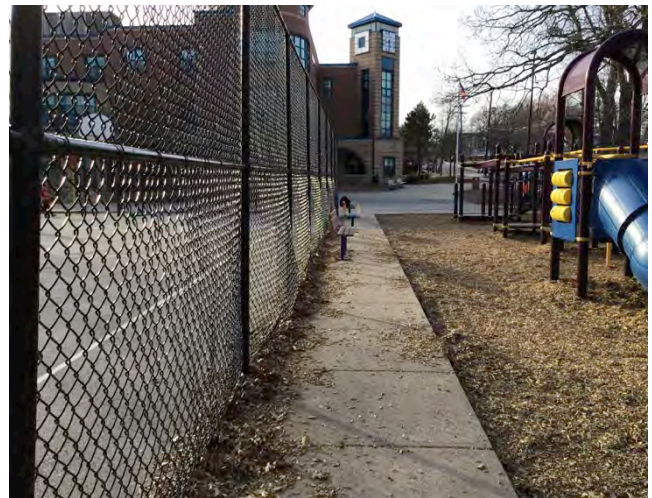
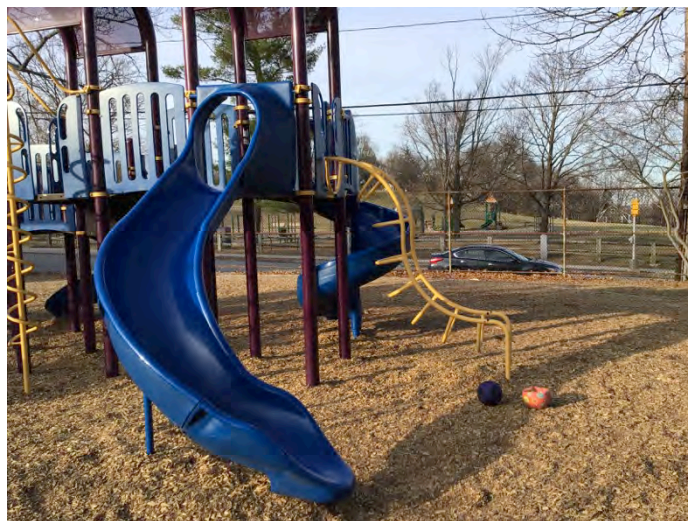
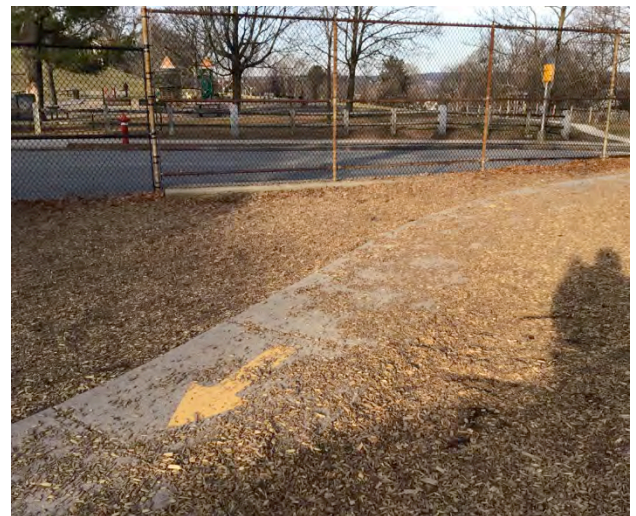
ADDITIONAL PLAYGROUND PHOTOS

The surfacing is loose fill – EWF – is compliant but needs maintenance. It has spread onto the concrete area and is slippery. There is no edging to hold it back. Due to the lack of edging, the wood fiber will continue to travel. The wood fiber on the concrete creates a tripping hazard and the change in surface is hard to see.

The moving components on the large structure need to be replaced. The structure itself is in good condition. However, the decks and stairs all need to be replaced. All are worn and have open steel. It is unusual that all PVC coated deck materials need to be replaced. Had the PVC openings been seen and repaired early, patching could have been done to extend the life of the decks. If you need referrals to contractors to do this specific work I can provide.

There are two spiral slides on the 5 -12 structure and they are non-compliant. The distance between the edge of a slide side and post should be at least 21". Both are under 20" and need to be removed with something else to be put in its place. These are two costly components to lose. If assistance is needed with the rehabilitation of the play area, please let me know. The 2-5 transfer module and PVC coated belt bridge connection needs replacement [see photos].

- Remove and replace all PVC stairs, transfer and decks on 5-12 structure.
- Install a perimeter edge around the 5-12 area.
- Appropriate safety labels needed on both structures.

- Track ride trollies need to be replaced.
- Two spiral slides need to be removed and replaced with a different component.
- Call the Manufacturer Rep to make a site visit and inventory the equipment needs. If you prefer I do this please let me know.

- The step on transfer entry needs to be replaced. Unfortunately it is attached to the entire module, therefore the entire module needs to be replaced.

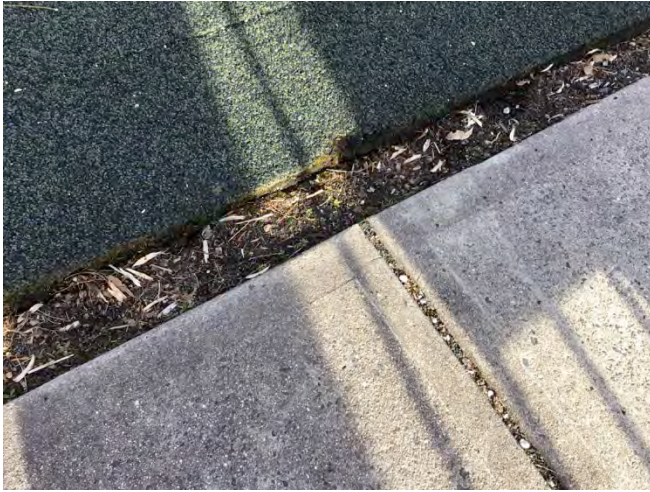
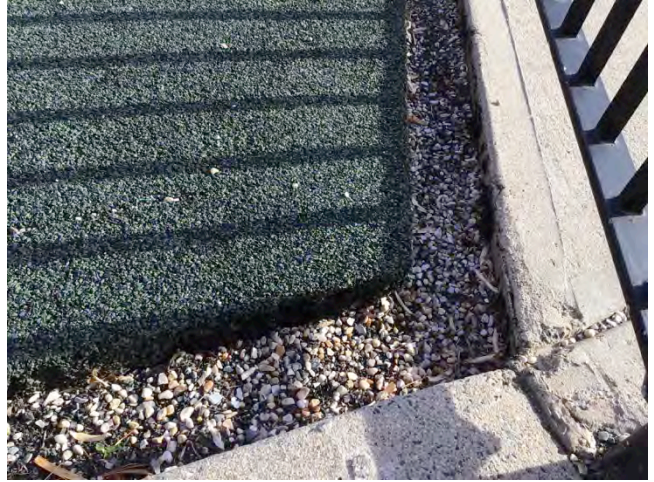
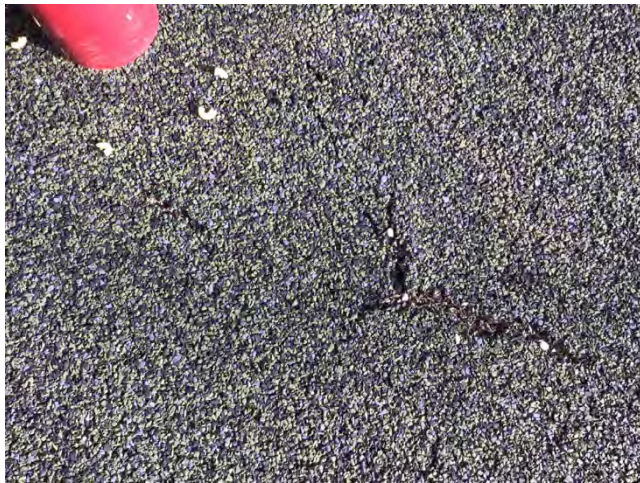
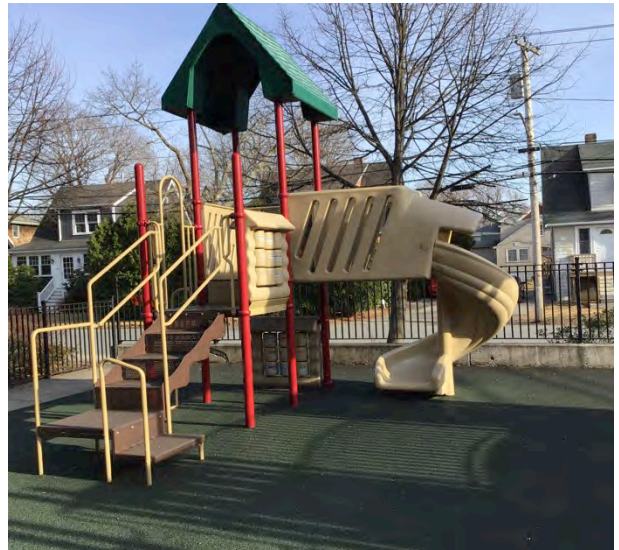
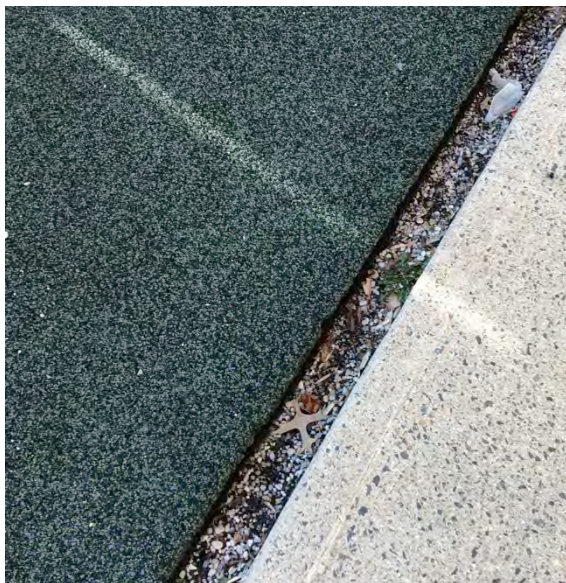
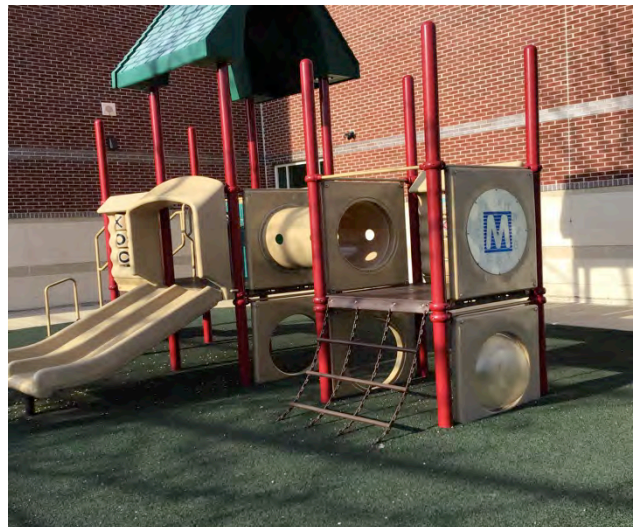
ADDITIONAL PLAYGROUND PHOTOS

The surfacing is PIP and is in fair condition and needs some 'cut outs' and a full overlay. It has pulled away from all sides and cracks are visible. There is mold and mildew in areas. The surface needs to be 'blown out', weeded, power washed and reset.

There are three structures on site. Two structures are age appropriate for 2-5 and one for 5-12. All equipment, except for the moving pieces, is in good condition. The chain ladder needs to be replaced due to wear. Removal of a component that is anchored in PIP can be problematic and should be done by a Professional especially if patching is involved.

- Ask the manufacturer to send appropriate labels for all 3 structures, as 2 age groups [2-5, 5-12] are represented.
- The PIP surface needs repair and overlay.
- The surfacing and all equipment needs power washing.
- The surfacing especially needs power washing, as there are 'ground in' items that may cause health hazards.
- The mold and mildew on the surface is due to its protection from the trees. The surface seems to stay somewhat damp. It has also pulled away on the sides due to poor drainage.

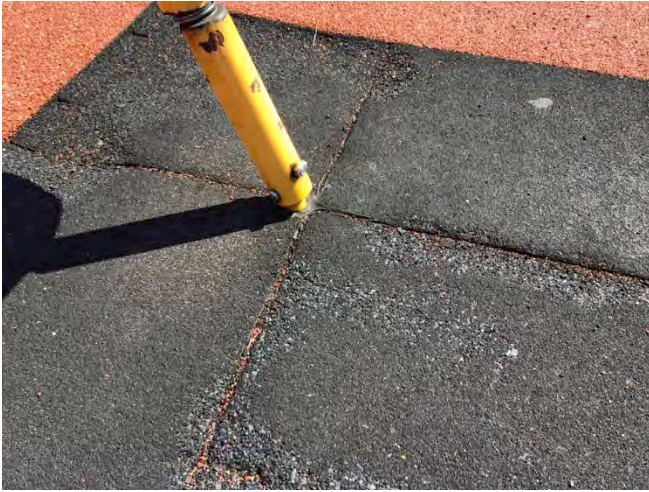
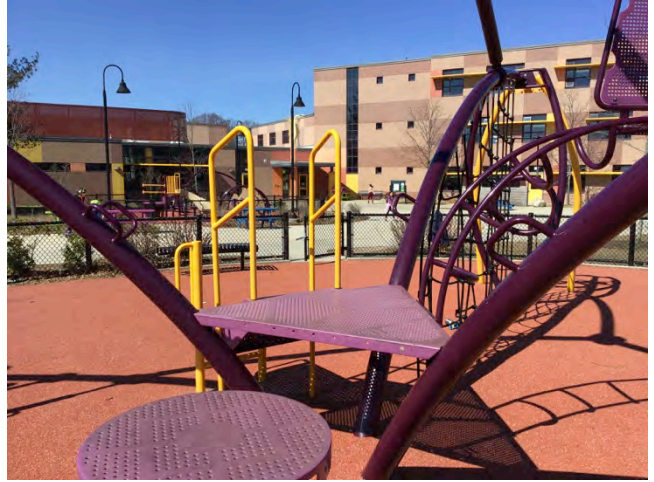
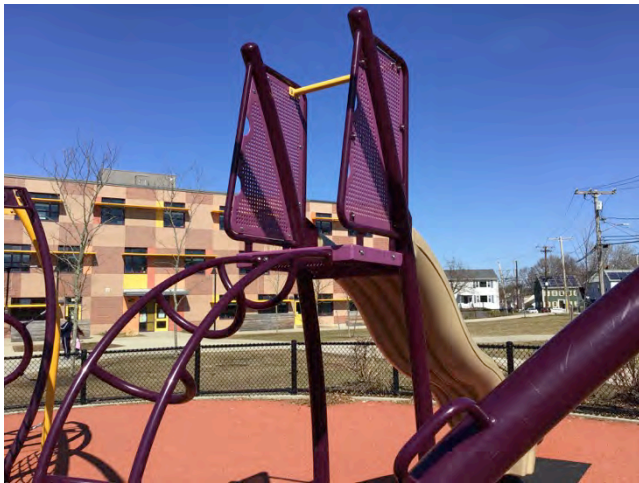
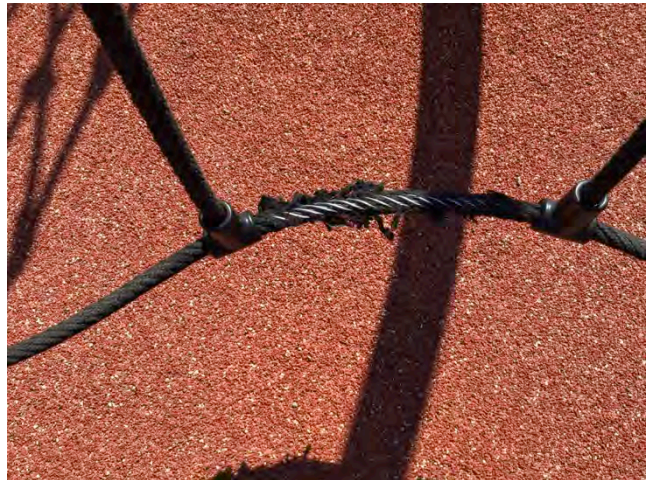
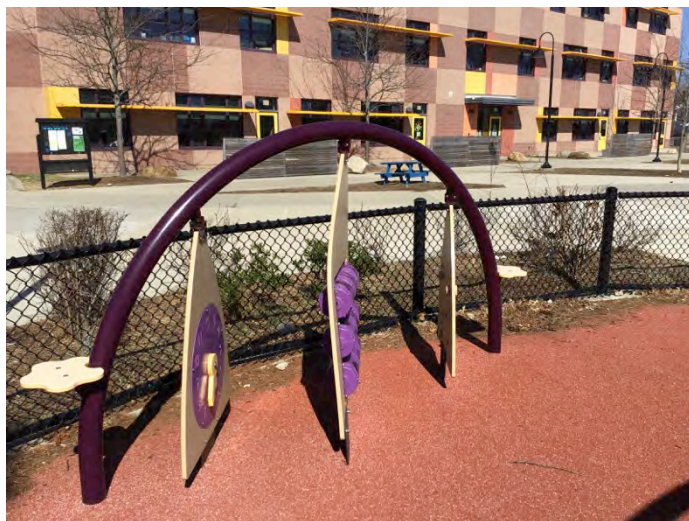
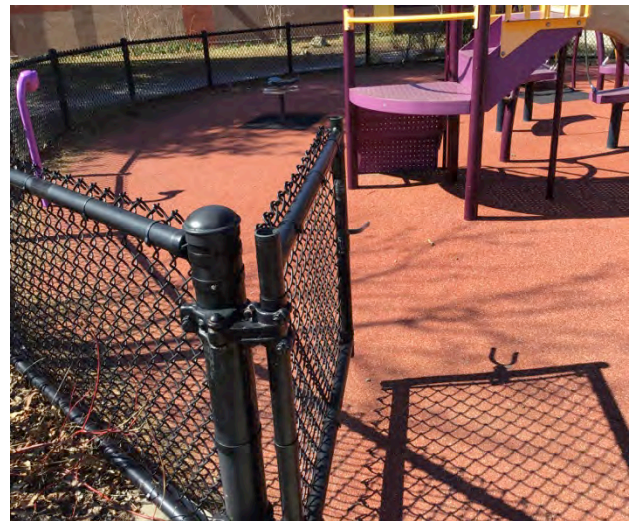
ADDITIONAL PLAYGROUND PHOTOS

The 5-12 surface is PIP and is in fair condition. There are cracks and chunks of PIP that are worn or have been vandalized. Rubber tiles were installed in the high wear area and are failing.

5 -12 structure: The stability of the composite structure is in good condition. However, there are a number of components that are non-compliant. The Transfer modules should be 11 – 18” off grade and they are at 20” off grade. The structure is based on continual or linked play – but it is not – thus giving a false positive

of 'connected equipment'. One rope section has worn to steel and needs replacement. The handhold is also worn. The openings on several components are too wide to enter and exit.

There are talk tubes, a spinner and panels. The spinner should be closed asap – the top portion/seat is cracked and rusted and need to be replaced. The three play panels are not handicap accessible, as they are too close to the fence and there is not enough space between panels for a wheel chair.

- The overall condition of the 5-12 area is good. However, in my professional opinion, I believe the equipment seems very worn for being [what I believe to be] less than 5 years old.
- Review warranties for equipment and surfacing, there could be current warranties for repairs needed.
- Age appropriate labels are not on equipment; all safety labels are missing.
- The gates should open out only for ADA.
- The slope should be reviewed in a few areas to validate the ADA grade requirements.
- Tiles and PIP have sections that need repair.

- The fence is 3' high and if this is a Pre-K playground, it does not meet state regulations. A 4' fence and share are required for a Pre-K playground.
- In my professional opinion, equipment at both playgrounds were either installed too high, or the PIP too low.
- Discuss with a PIP Installer – if these non-compliant hazards that can be rectified.
