**Community Preservation Committee
Request for Funding
Rehabilitation of the Whittemore-Robbins Carriage House**

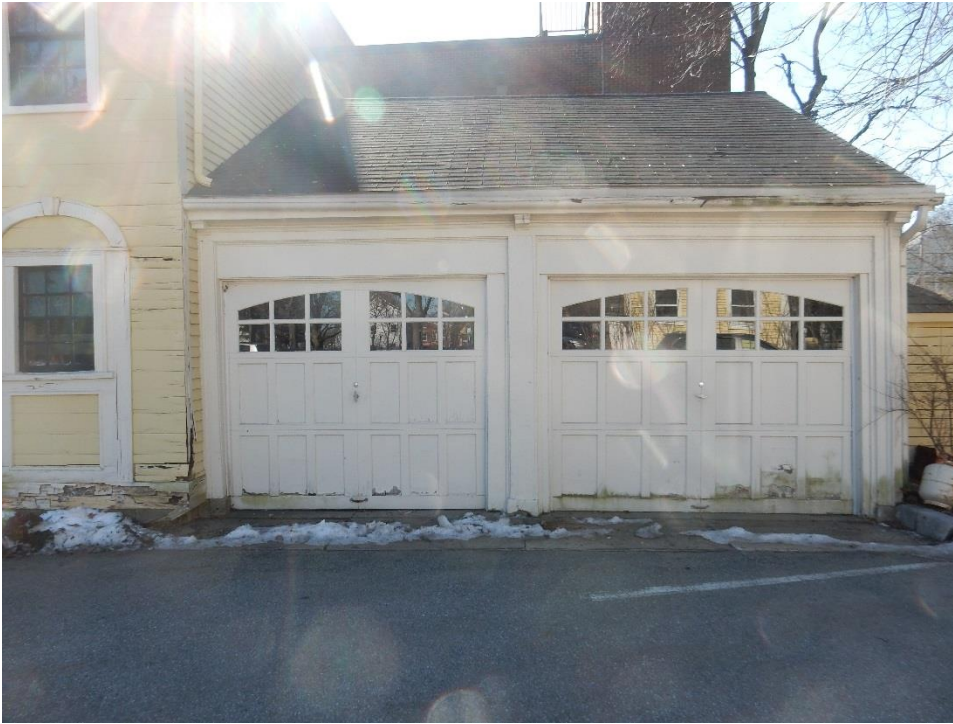
7. At north face of one-story area, rot is present in gutter, corner trim of two-story section, and bottom trim and panels of doors.

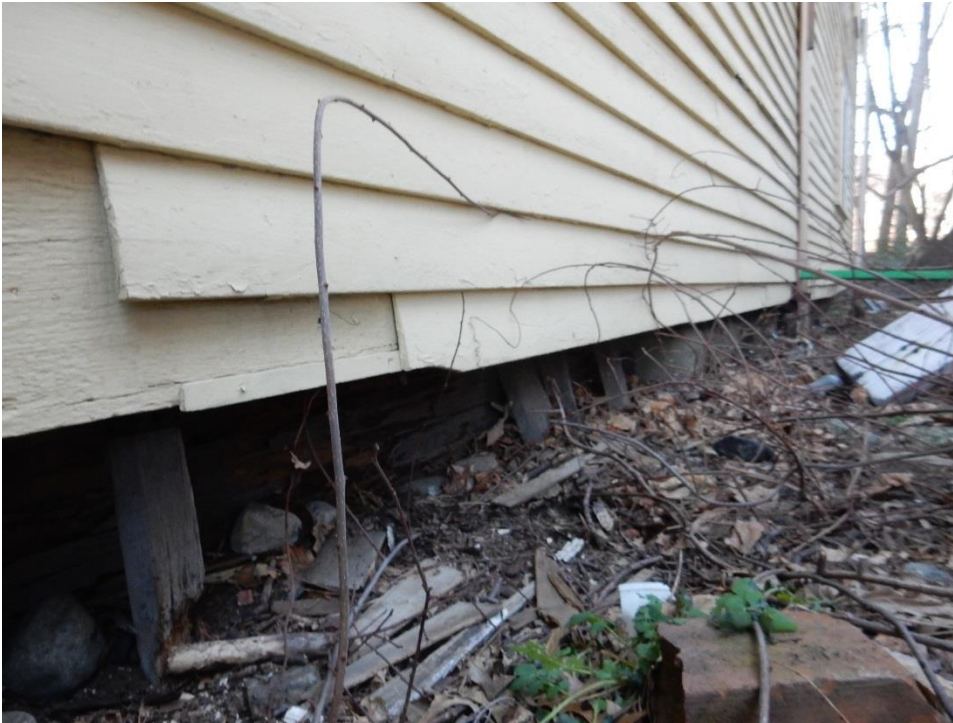
8. Missing sections of clapboard siding and course of cinder block foundation.

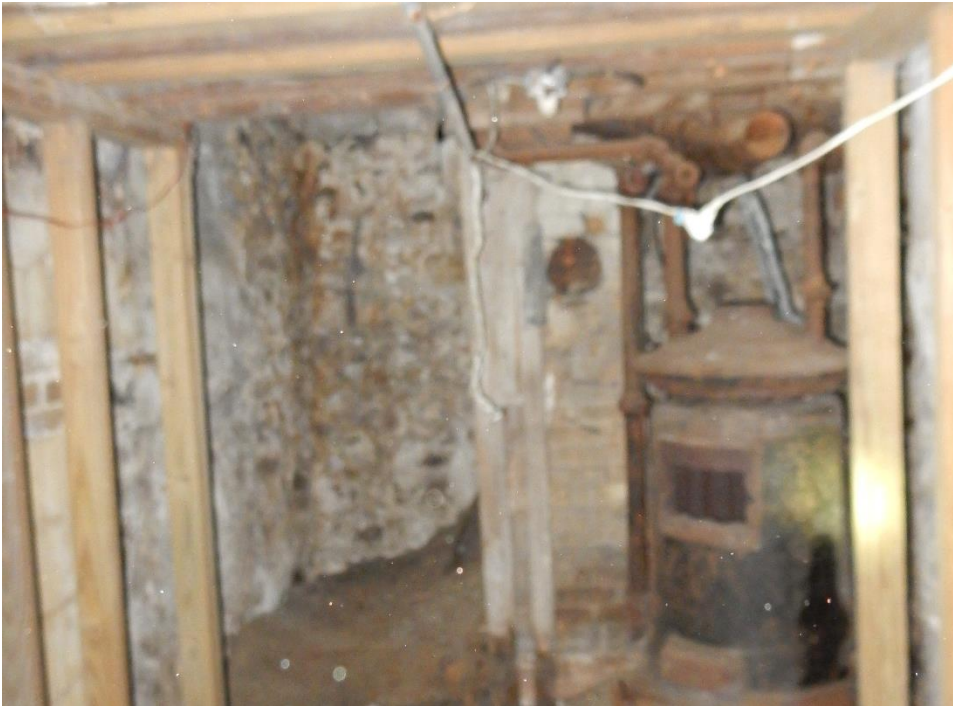
10. View within basement that fits under a small portion of the first floor. Wood studs along two sides support closely spaced planks to shore the concrete slab. Chimney and abandoned boiler in background.

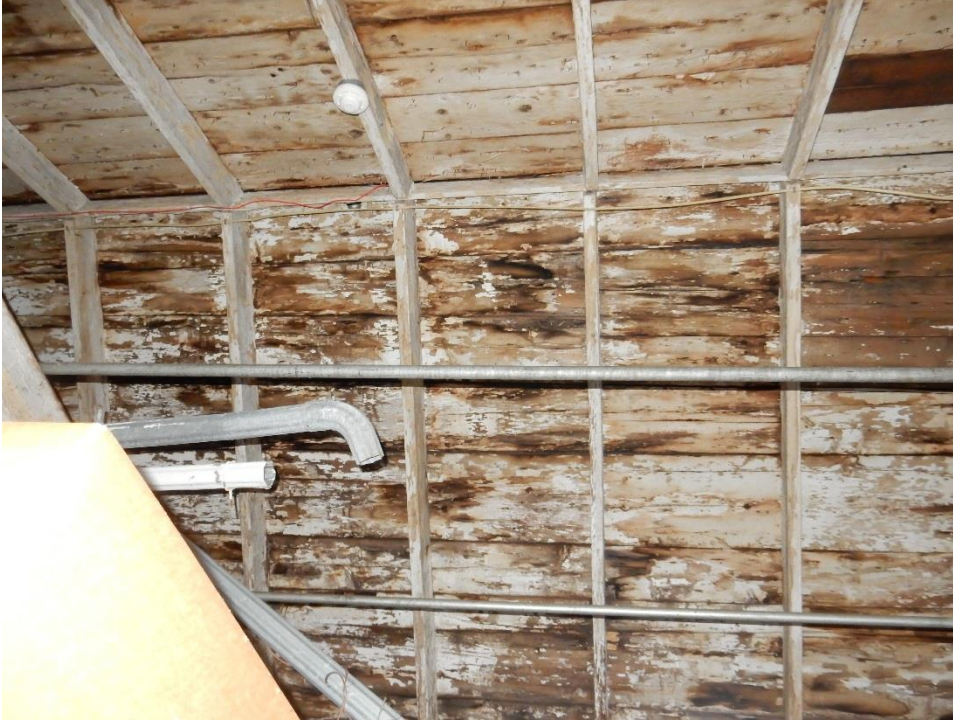
15. Roof framing over aforementioned bay. Rafters appear intact. Board sheathing has dark staining (potential mold/rot) from past moisture.

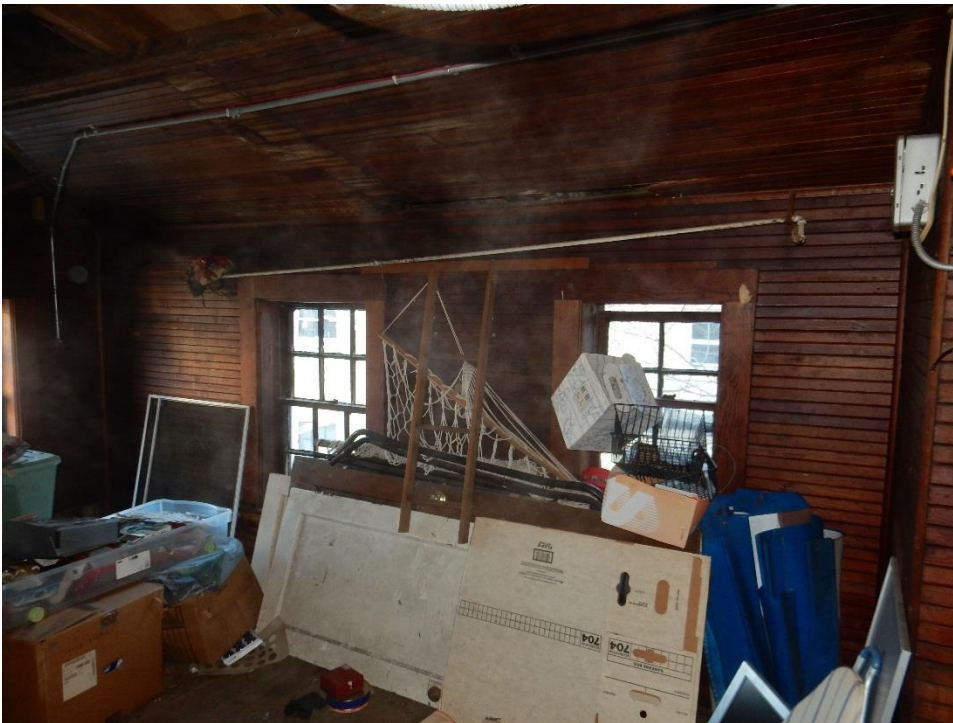
24. Storage on second floor.

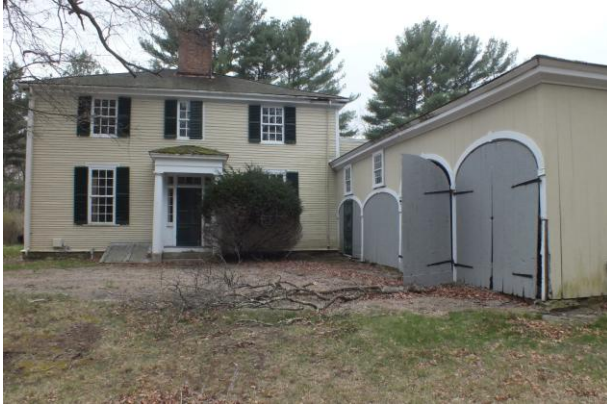
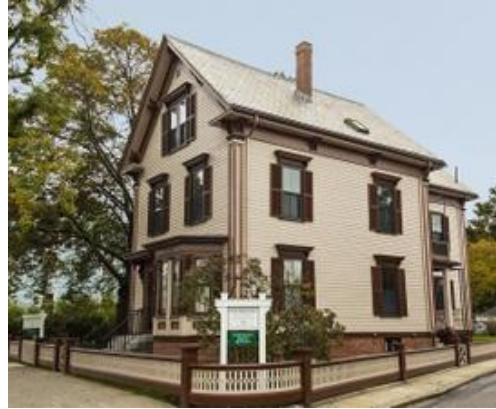
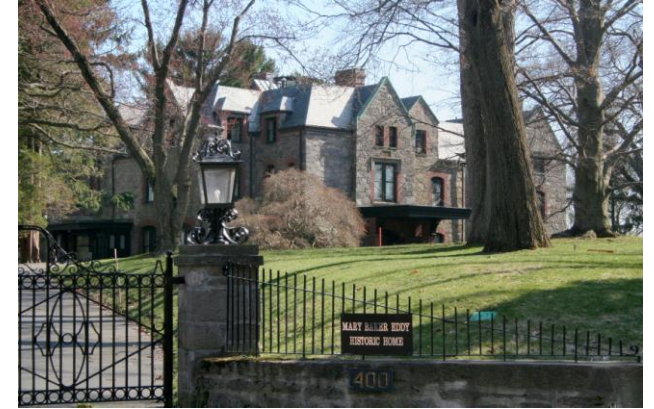
<http://www.b-ase.org/Publications.html>.

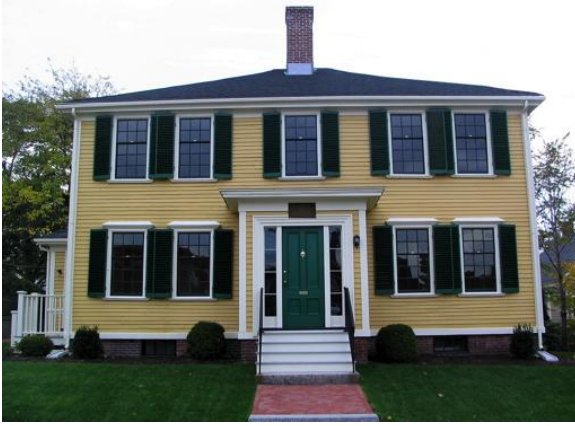
Edmund Fowle House
2006

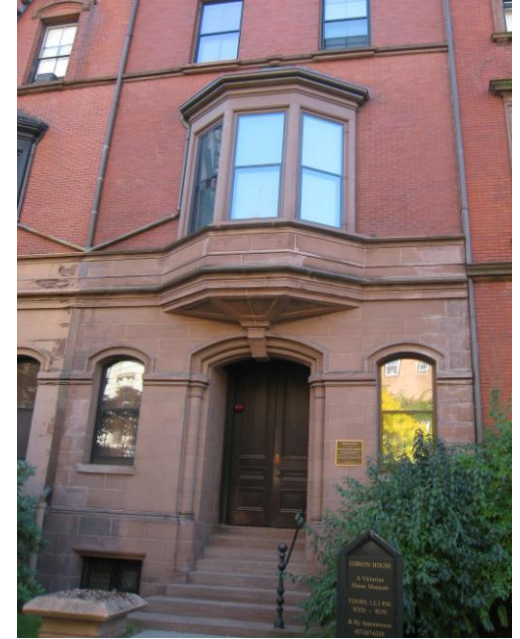
Reference: Gary Wolf. Architect; Gary Wolf Architects, Inc. (617) 742-7557

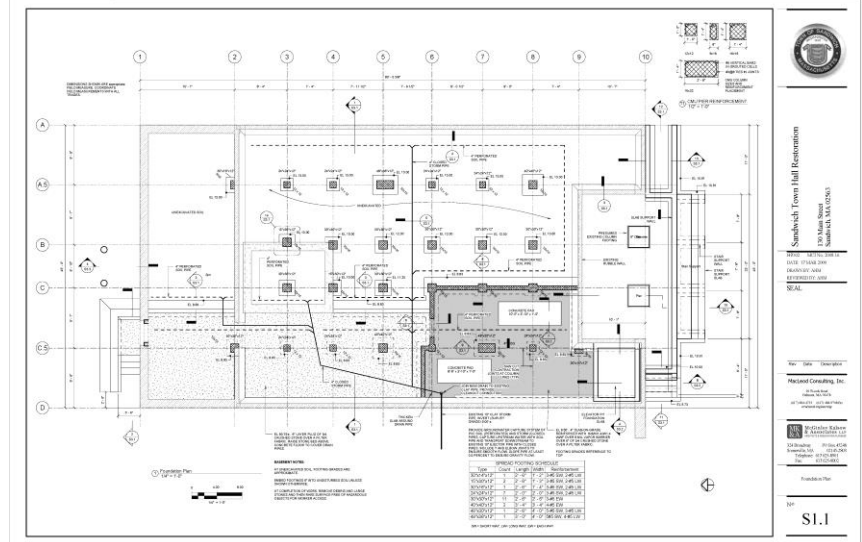
Reference: Wendall Kalsow, Architect, McGinley Kalsow & Associates, Inc. (617) 625-8901
