Town Hall Cupola Demolition

ADDENDUM NO. 4

RE: FLI Project #: 23-2796
Inspection for Asbestos Containing Materials at
Town Hall - 730 Massachusetts Ave.
Arlington, MA

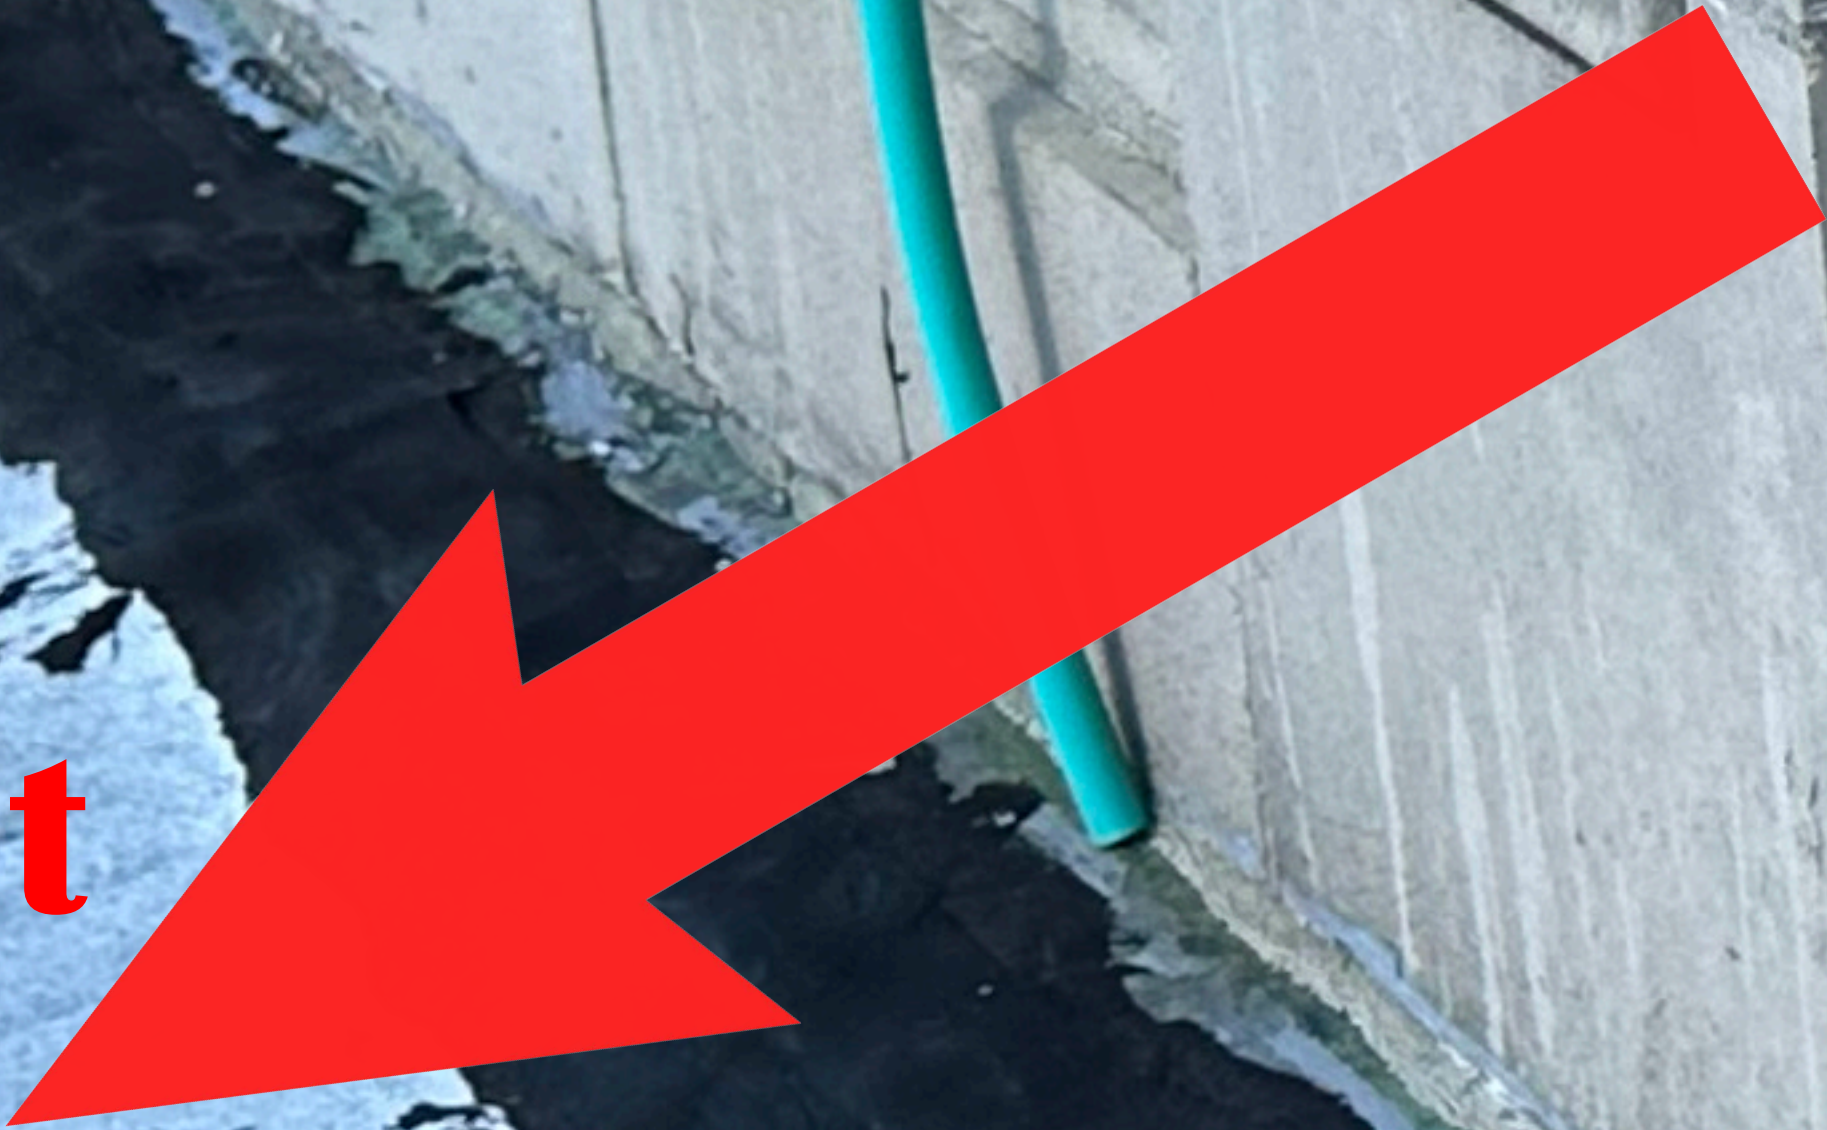
Asbestos Containing Materials Summary Table			
Material	Location	Estimated Quantity	Sample # ('s)
Silver Paint	Base Perimeter of Cupola on Slate Roof and Flat Roof	30 SF	2796-01A,B
Black Flashing Cement	Base Perimeter of Cupola on Slate Roof and Flat Roof	25 LF	2796-03A,B

2. Each identified asbestos containing material must be removed by a licensed asbestos abatement contractor prior to being disturbed by building maintenance, renovation or demolition activities.
3. This report is not meant to be used as an asbestos abatement plan or abatement specification. Material quantities and locations are estimates and approximations and should not be used to obtain pricing from contractors. FLI recommends contracting for abatement after an abatement specification is prepared by a licensed Asbestos Project Designer.
