## **TRANSPORTATION ADVISORY COMMITTEE.**

Date: March 13, 2024

Subject: Highland Avenue and High Haith Road Crosswalk

### **Memorandum**

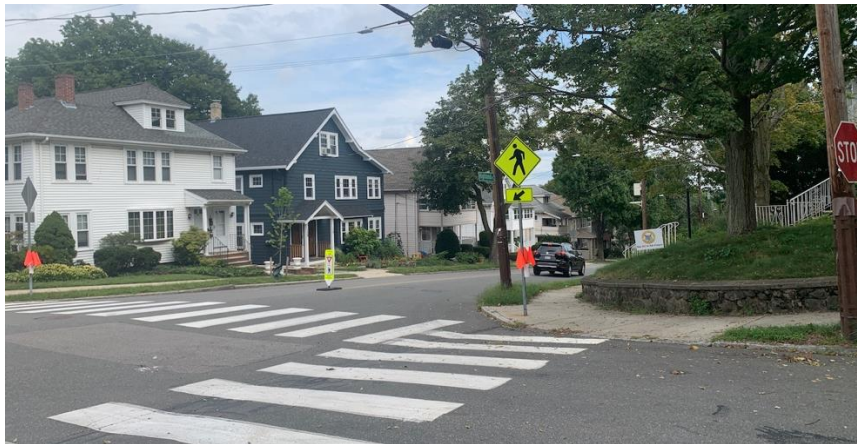
- ADA accessibility
  - The two curb ramps in the west side have tactile pads, but the ones on the east side do not.
- Parking next to crosswalk
  - There is no parking immediately before the crosswalk going northbound because of the intersection.
  - In addition, there is a fire hydrant in the southeast corner preventing parking south of the intersection.
  - Cars parked illegally south of the intersection may block the view of pedestrians waiting to cross.
- Previous improvements from 2015 and before:
  - Pedestrian flags
  - In-Road Yield to Pedestrian bollard
  - New fluorescent yellow crosswalk signs
  - Yield lines before the crosswalk

Figure 2: Existing conditions facing north at High Haith and Highland Ave

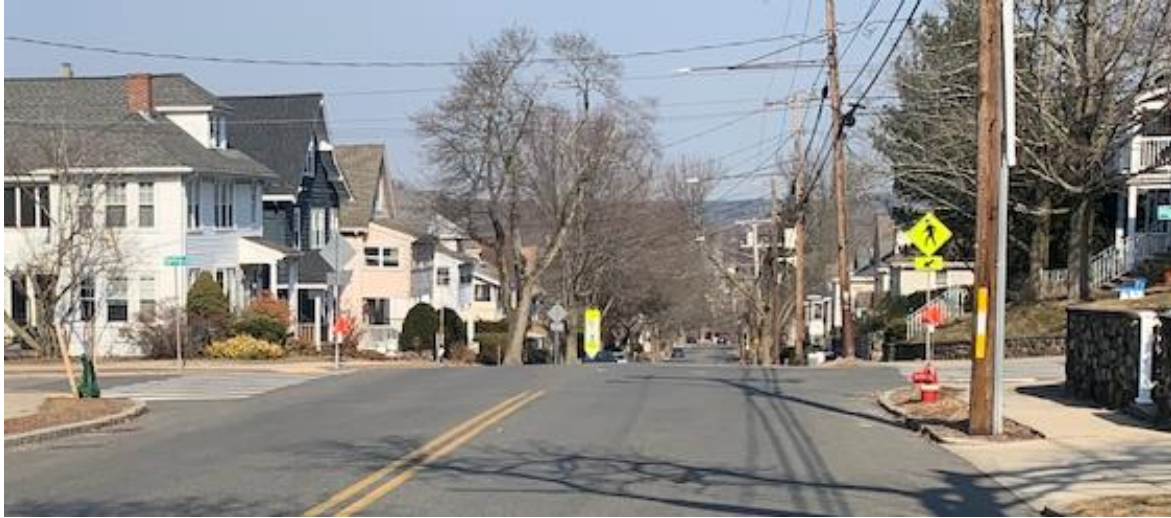
- Because of the downslope, it is difficult to see the painted zebra stripes of the crosswalk itself.
- The yield lines become more important because they help the drivers anticipate where they should come to a stop.
- The crosswalk ahead signs are the older yellow version that is less visible at night.

- The crosswalk ahead sign is partly obscured by a leaning utility pole.
- The in-road bollard is the first fully visible sign that northbound drivers see, but they are sometimes removed for snow plowing operations or moved out of place by vehicle collisions.

Figure 3: An approach angle headed north where the zebra stripes are less visible, and yield lines are faded.

- Repaint the advance yield lines on both approaches to the Highland Avenue to improve crosswalk visibility for drivers.
- Add pedestrian crossing signs to both sides of the street at the crosswalk, and retroreflective surfaces to the poles.
- Replace the crosswalk ahead warning signs with new high visibility signs.
- Move the northbound advance warning sign a few feet south before the utility pole.

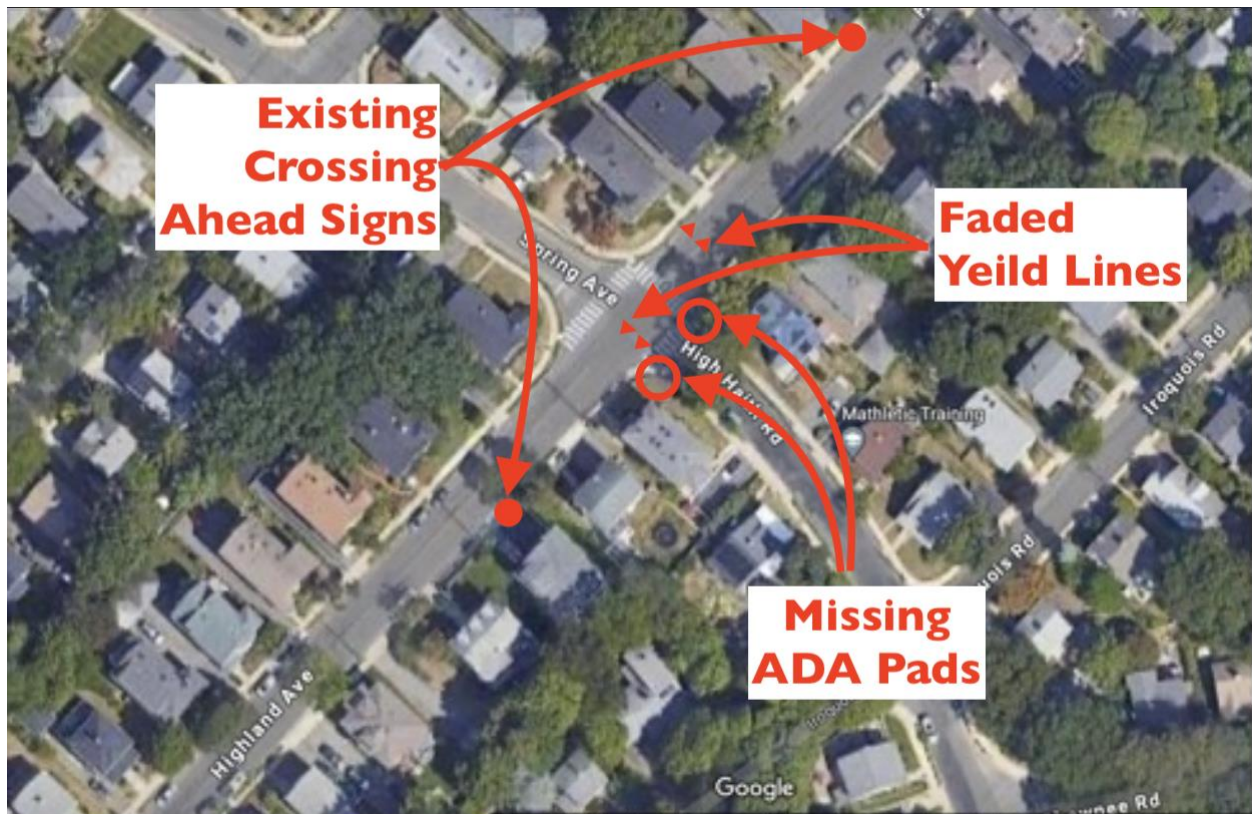
Figure 4: Map of Existing Conditions

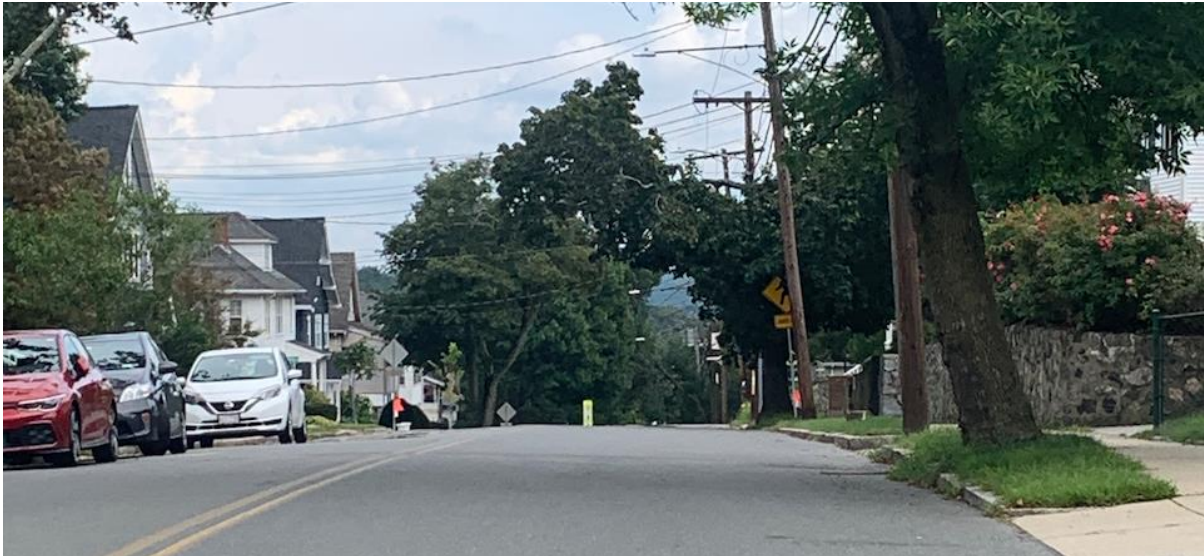
Figure 5: Existing view from 400' away

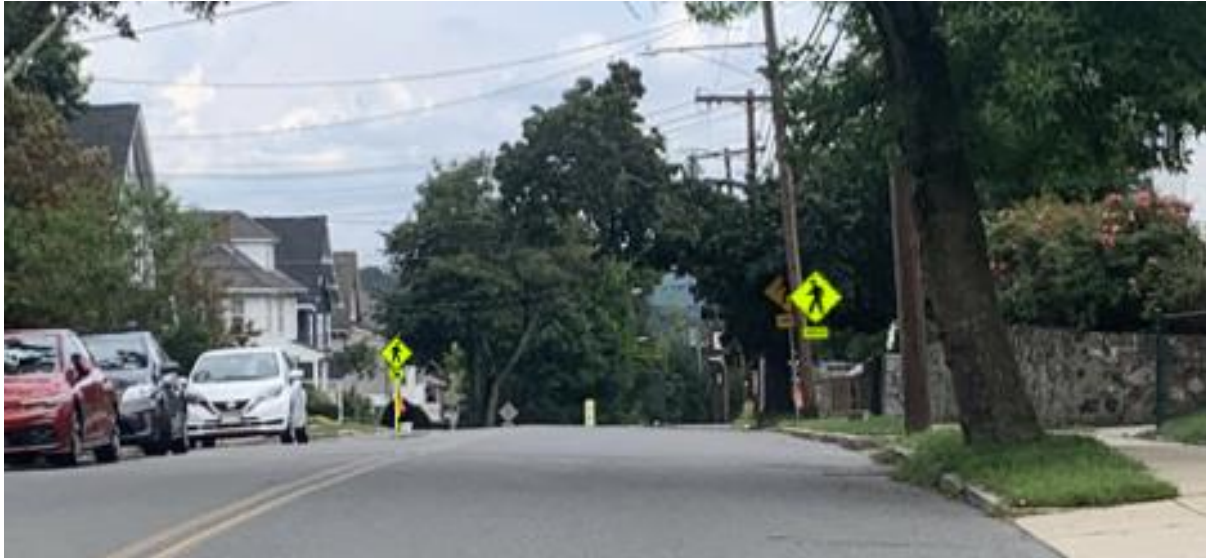
Figure 6: Photoshop rendering of same view with new signs
