Town of Arlington Minuteman Bikeway Planning Project

INTRODUCTION

APPENDIX A: EXISTING CONDITIONS

APPENDIX B: BRIDGE OVER ALEWIFE BROOK ASSESSMENT

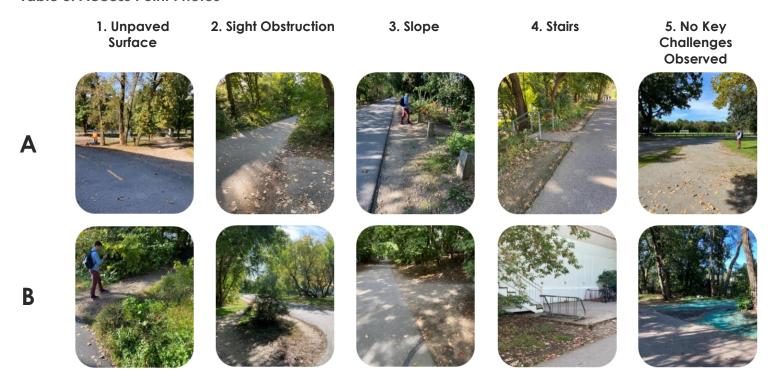
Table 3: Access Point Photos

Slope	Access points with a noticeably steep slope that is likely inaccessible to assistive mobility devices and/or bicycles are assigned to the "slope" category. In most cases (6 of 9), access points under this primary issue category are unpaved as well (3A). Additionally, these unpaved points with slope issues are typically dirt with virtually no vegetation in the path due to wear by path users (3B).	9
Stairs	The "stairs" primary issue is assigned to access points with only stairs and no ramp or level alternative. Stairs are entirely inaccessible to wheelchair users and many other people with mobility impairments. Additionally, stairs are inaccessible to many people with bikes. Any locations with stairs are given this designation regardless of the surface material, slope, or sightlines of the connection between the stairs and Bikeway (4A-4B).	5
No Key Challenges Observed	Any access points to which none of the four primary issue categories above are applicable are assigned to the "not applicable" category. These sites are all paved, level, and absent of stairs and sight obstructions (5A-5B).	11

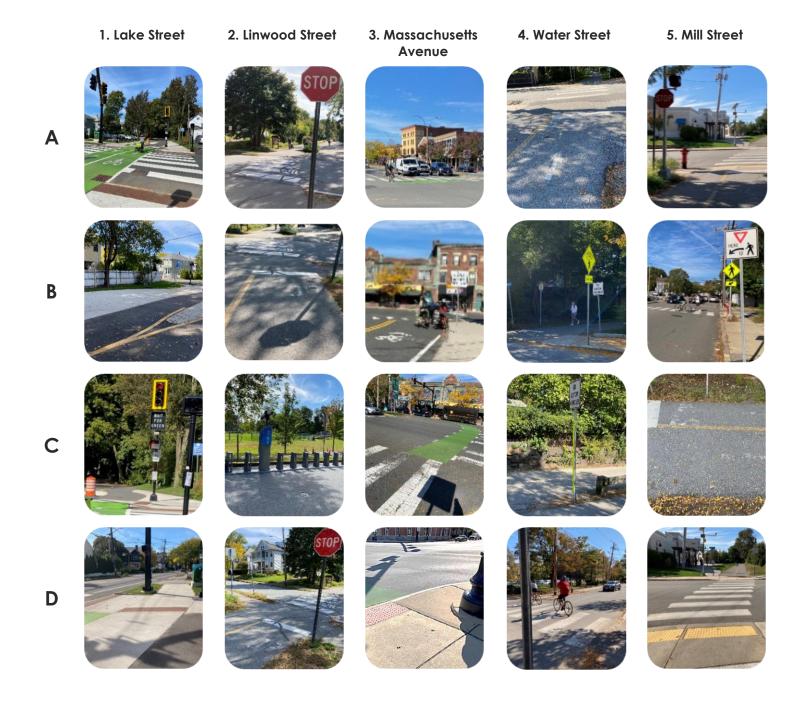
Table 14: Target Intersections

Intersection	Existing Conditions	Observations	Issues
Lake Street	 Pedestrian and bicycle signals control crossing for path users (1A) On each approach, the Bikeway widens to include sidewalks and a splitter island (1B), directing people walking to the outer edge of the path to either turn from the Bikeway onto Lake Street or to cross at the crosswalk. People biking are directed to continue riding straight across Lake Street along a bicycle crossing marked with green pavement When a sensor detects people biking toward the intersection, a sign lights up with the message "WAIT FOR GREEN" (1C) Pedestrian signals direct people walking on Lake Street to stop and wait while people are biking and walking across Lake Street (1D) Lake Street is a minor arterial with a school zone speed limit of 20 mph. Trucks are excluded. 	 Path users generally follow the signal when crossing Lake Street People walking do not always shift to the widened sidewalk area as intended The bicycle detection system is accurate in detecting people waiting to cross Lake Street 	 Drivers are known to mistake the Bikeway for a vehicular roadway and turn onto it This may be due to the large, vehicle-scale infrastructure at this crossing People walking along Lake Street tend to miss or ignore the pedestrian signals for the Bikeway crossing Detectable warnings are installed both at the entrances to the roadway crossing and the Bikeway crossing, which may lead to confusion for visually impaired path users

RRFBs and "YIELD HERE TO [PEDESTRIAN]" regulatory signs alert drivers on Mill Street to crossing path users and direct them to yield (5B) RRFBs and flashing red beacons are passively activated Faded "STOP" pavement markings precede the stop lines on the path (5C) Solid yellow center line is on Bikeway on both path approaches to crossing Detectable warning panels are present for both path ramps (Photo 5C) Mill Street is a minor arterial 	 Passive activation of RRFBs generally detects path users reliably but continued maintenance is needed Southbound vehicles queuing for flashing beacon spill back onto Summer Street 	 Priority and right-of-way is ambiguous at this crossing due to combination of stop control for path users and yield control for drivers on Mill Street Motion sensors detect path users only when they are in close proximity to the crossing and could be added and/or angled to detect path users earlier

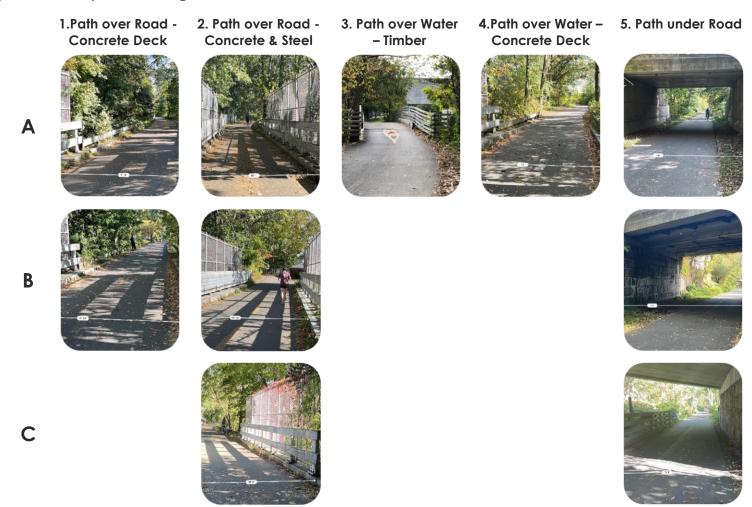
Table 18: Bridge and Underpass Crossings

Location	Clear Width/Type	Issues	Observations
Drake Road (5A)	24'/ Concrete	None Observed	
Park Avenue (5B)	27'/ Concrete	None Observed	Stream passes thru box culvert built into bridge abutment.
Lowell Street (5C)	13'-2"/ Concrete	Undermining of path edge	Path shares underpass with an adjacent stream.

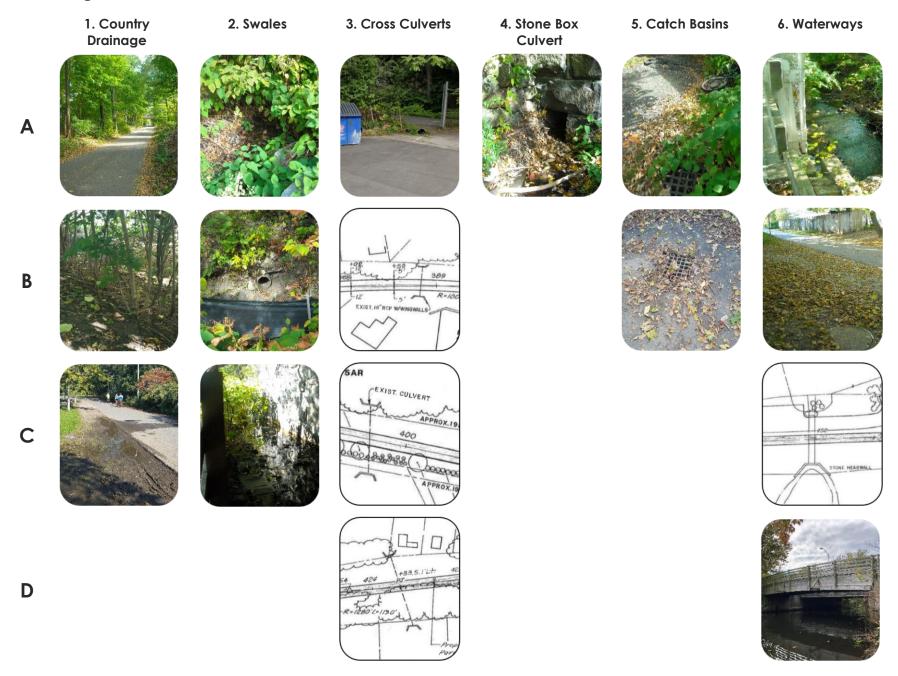
Table 20: Drainage Field Observations

Catch Basins	A handful of catch basins were observed along the trail, including north of Lake Street and at the Park Avenue underpass. (5A) (5B)	
Waterways	The path crosses the Alewife Brook and twice crosses the Mill Brook (6A)(6C)(6D). A small tributary that passes beneath the Lowell Street bridge goes underground at a headwall near Bow Street. (6B)

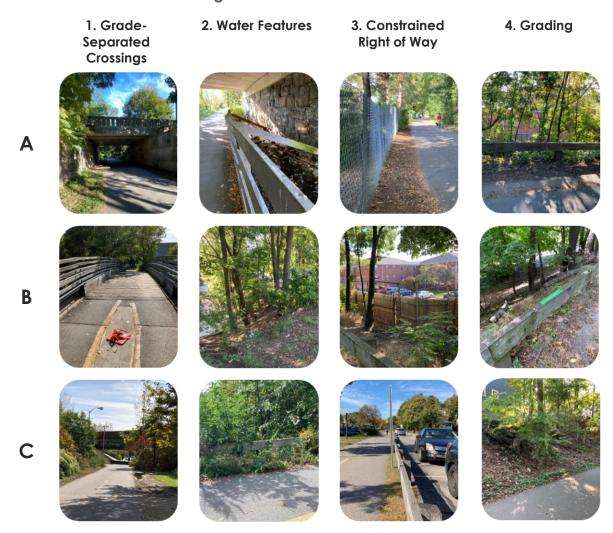
Table 22: Photos of Barriers to Widening

Grading	Natural topography represents a barrier to widening in many locations. Several stretches of the Bikeway are marked by steep downward slopes beyond the edge of the paved width, likely due to the historical use as a railbed (4A-4B). In other locations, the land slopes steeply upward next to the Bikeway (4C).
