Summary

Areas for Intersection Improvement

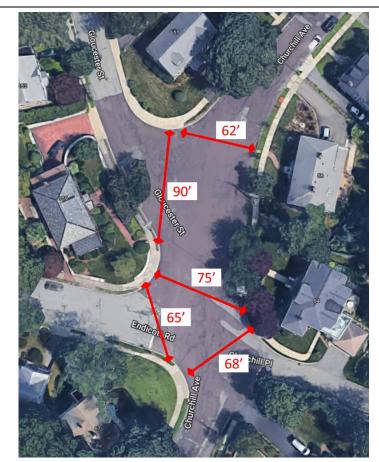
<u>Pedestrian safety</u>: While the roads that feed into the intersection are about 30 feet wide, the primary pedestrian crossing areas range from 62 - 90 feet wide and do not have crosswalk signage. These large distances take extra time to cross on foot and do not have any protections from traffic. Of note, this intersection is heavily trafficked by high school students walking to/from school.

Vehicle safety: Vehicles coming from Gloucester or Endicott and turning onto Churchill have multiple challenges including (1) uncertainty where to stop given the wide road opening and (2) poor visibility looking south along Churchill given a hill and curve in the road. Furthermore, given the obtuse angle of the intersection, it's not always clear what is the main flow of traffic and subsequently vehicles tend to merge or turn at higher speeds than may be safe.

Green space: All the excess pavement area could instead be green space. Our impression is that Arlington recognizes the importance of green space, including water runoff buffering, reduction of urban heat islands, and general citizen enjoyment.

Figure 1: Google image of the intersection. Distances measured in feet and done by hand using a tape measure.

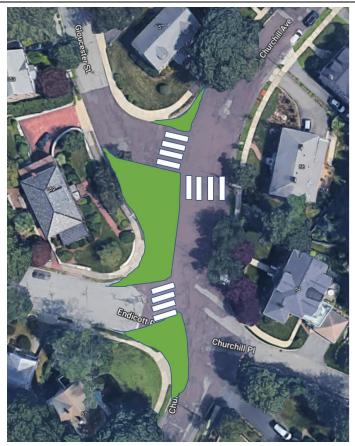
Figure 2: Sketches of alternate intersection design

We believe there are options for extending the curbs and/or adding islands to address some of the issues raised above. Below in Figure 2 is one option we roughly sketched as a potential solution to the problems raised. A similar approach was taken at the intersection of Gray St. And Endicott Rd with success in slowing traffic on Endicott. We ask the town to consider this option, as well as explore additional solutions, to significantly improve this intersection and the lives of people who use it.
