# Alewife 604B BMP Development Project

## Public Meeting at Arlington Stormwater Awareness series

Patrick Herron  
Water Quality Monitoring Director  
Mystic River Watershed Association (MyRWA)  
[patrick@mysticriver.org](mailto:patrick@mysticriver.org)

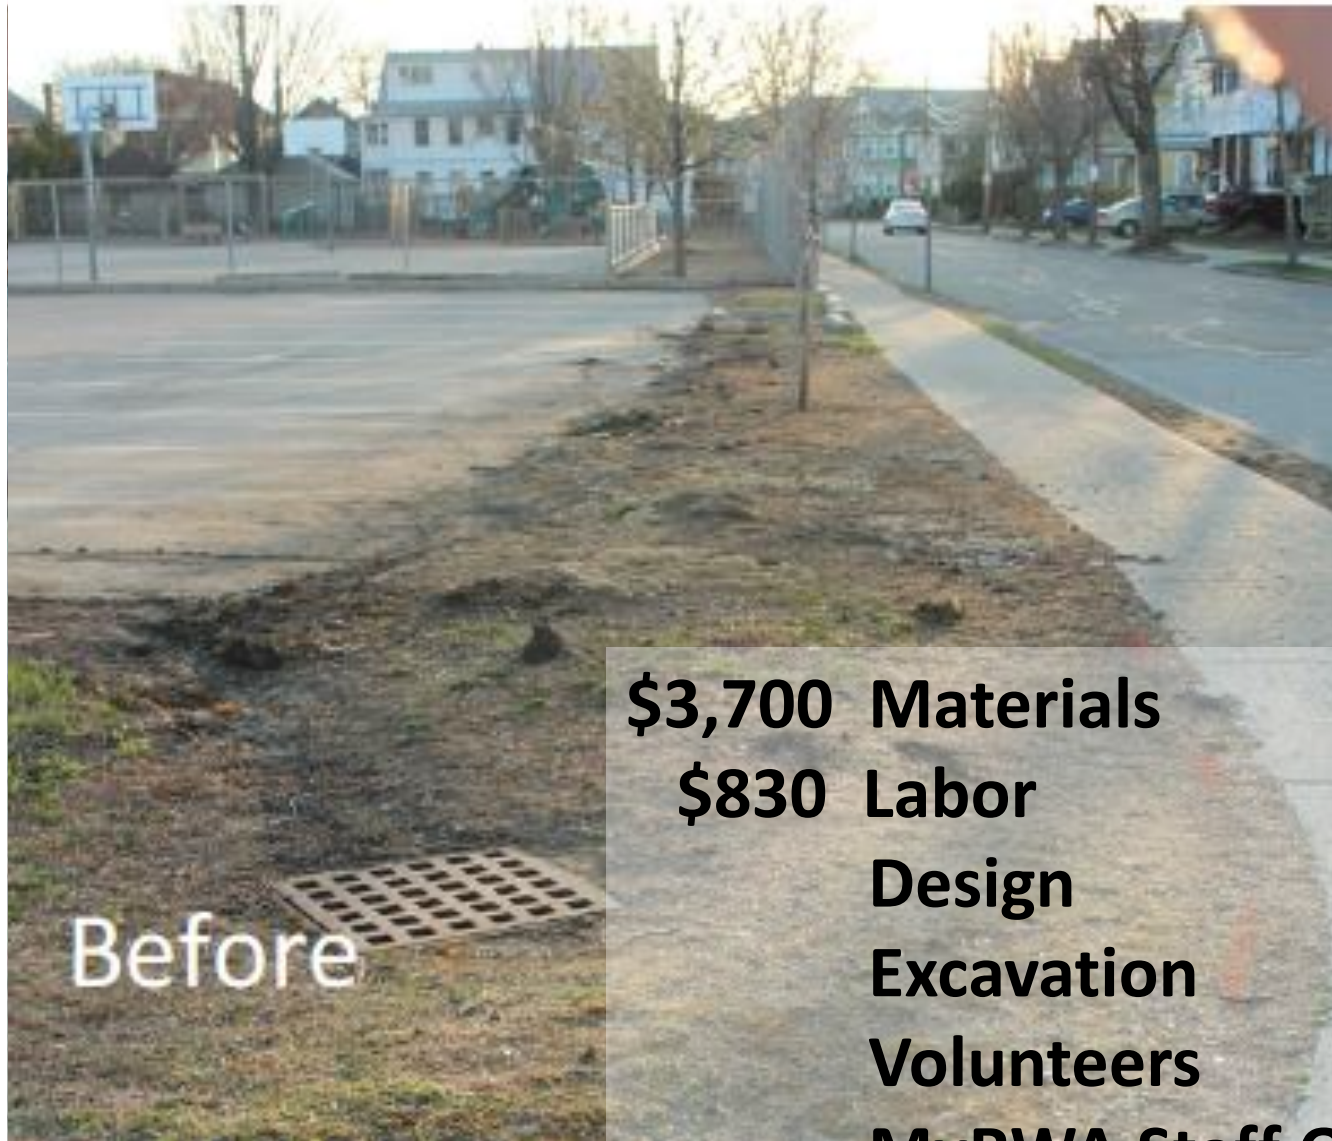
# Raingarden - Hardy School, Arlington

**\$3,700 Materials**

**\$830 Labor**

**Design**

**Excavation**

**Volunteers**
