TOWN HALL GARDEN WATER FEATURES

Town of Arlington, Massachusetts

Pre-Design Report: Garden History & Rehabilitation Recommendations

February 2018

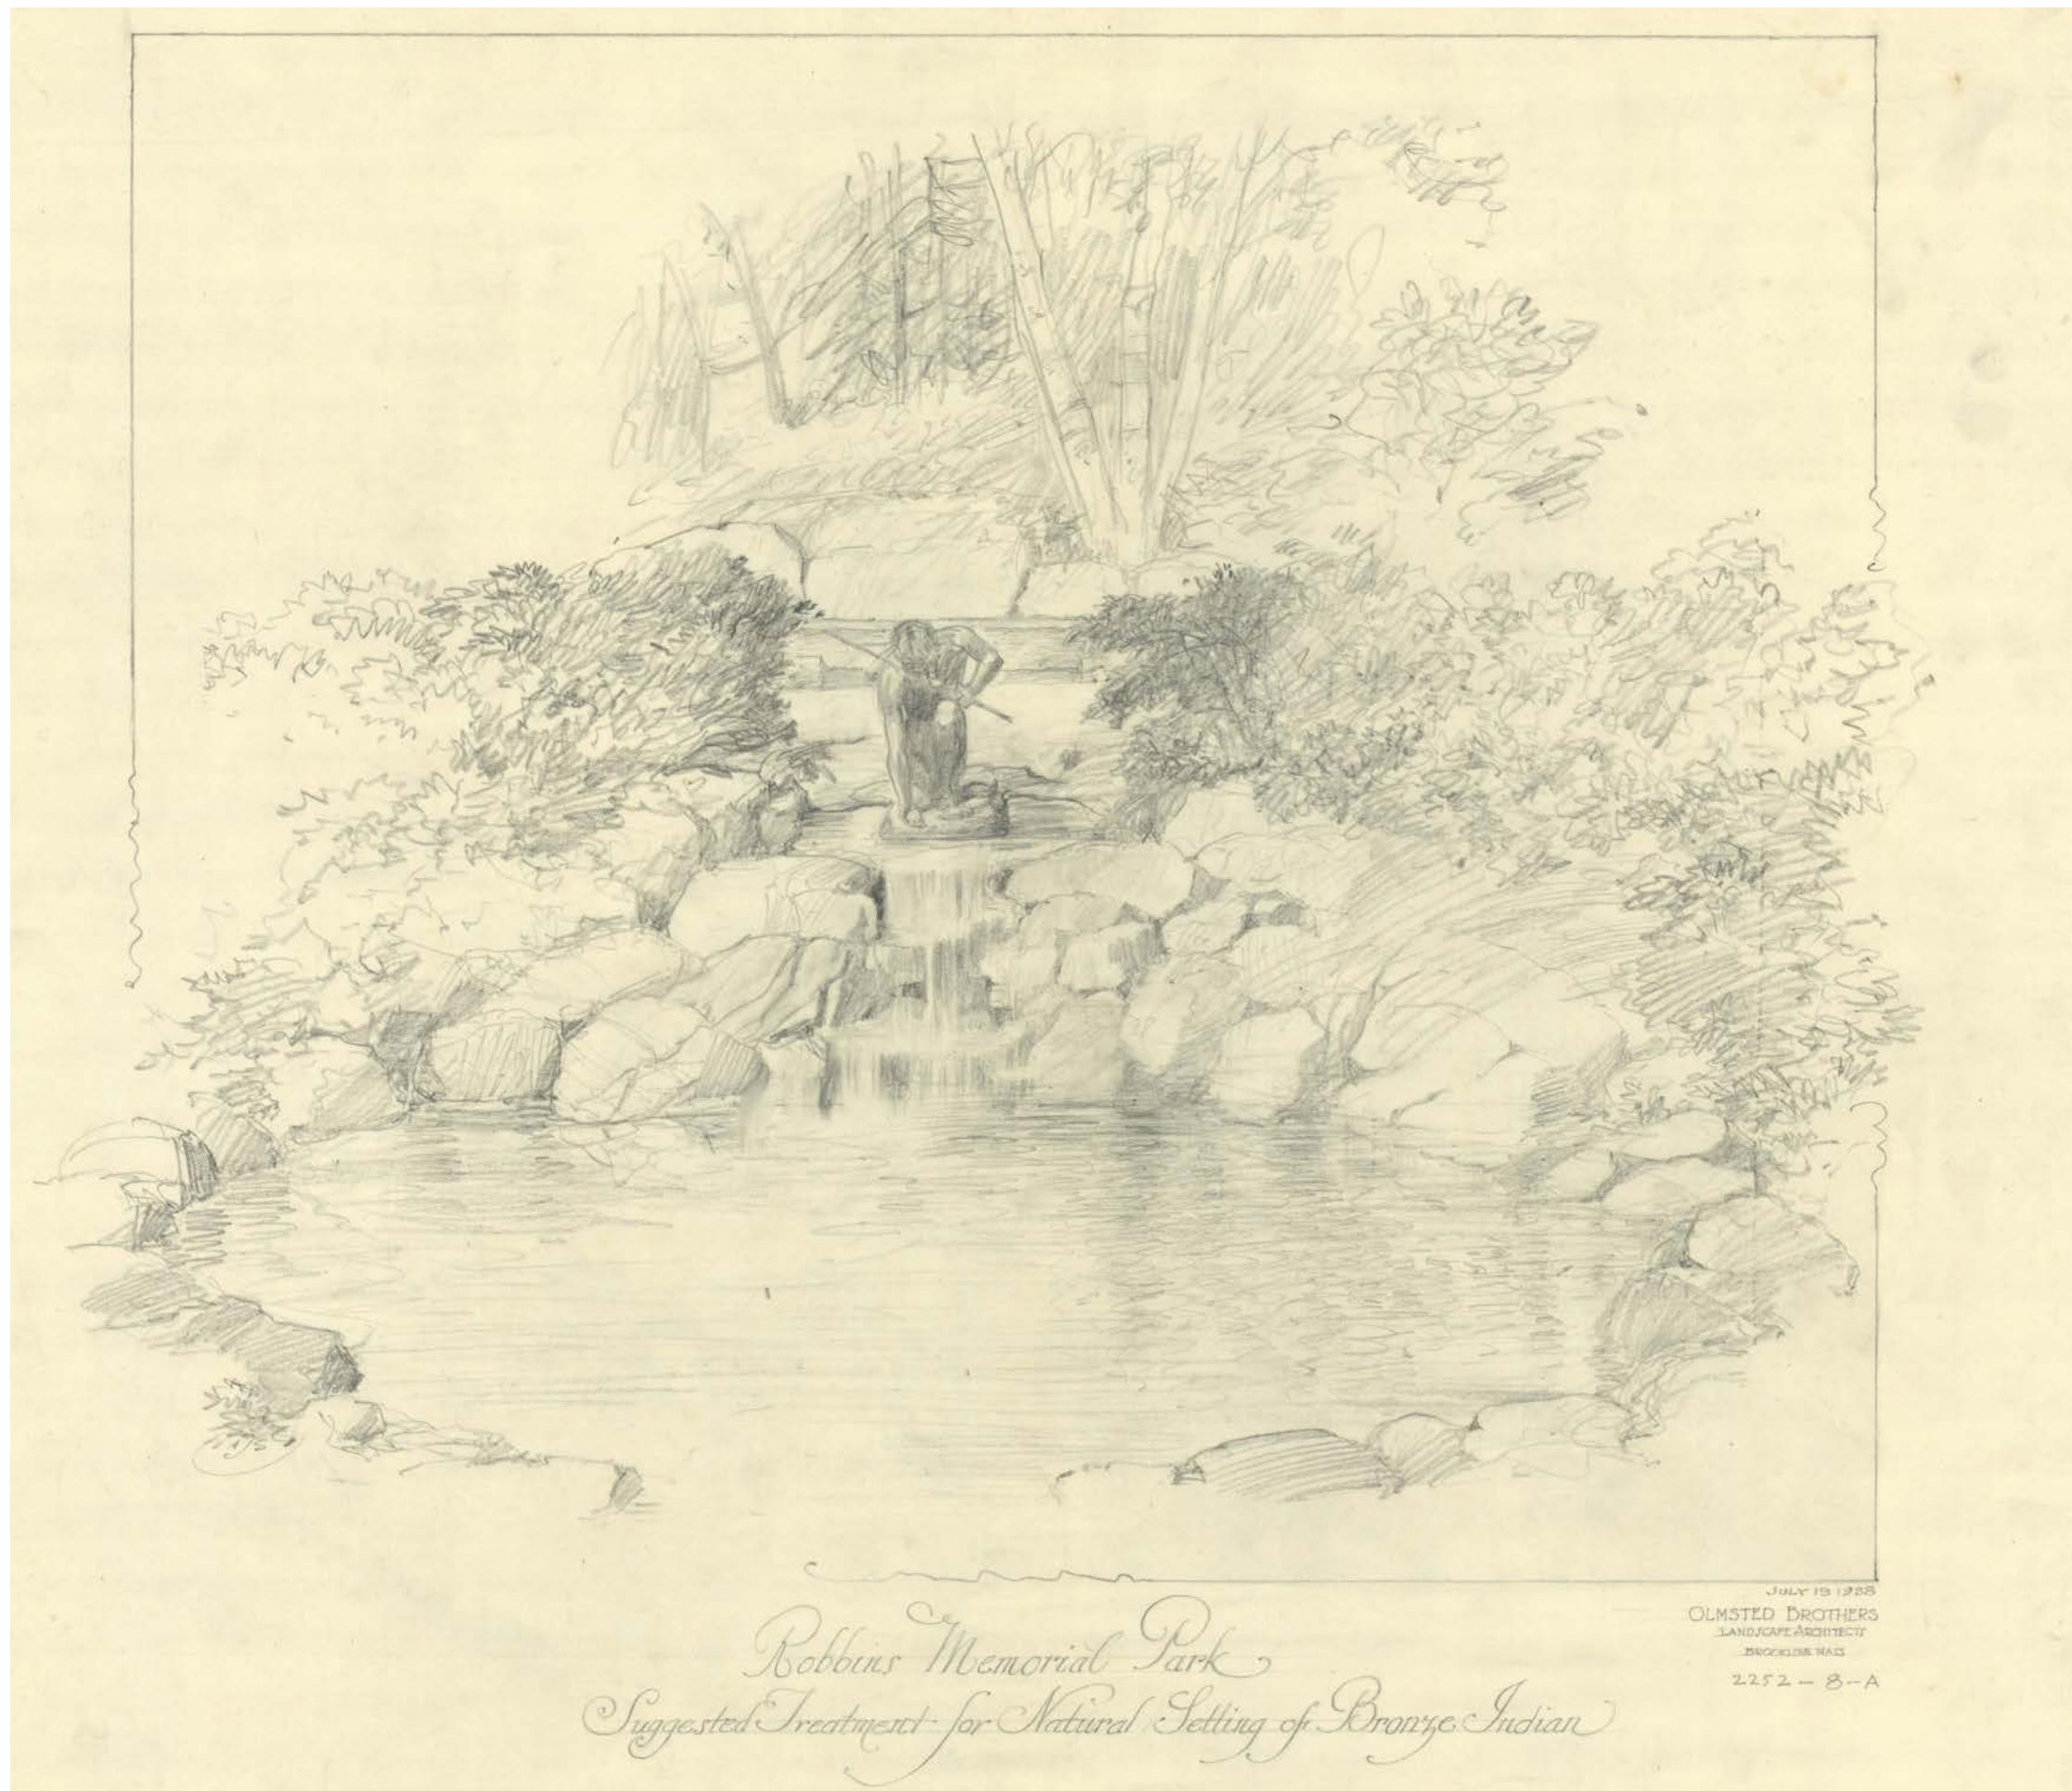
Olmsted Plan No. 8-A, "Suggested Treatment for Natural Setting of Bronze Indian", dated July 19, 1938; Courtesy of Olmsted Archives, Frederick Law Olmsted National Historic Site, NPS

- Plan No. 8-A is entitled “Suggested Treatment for Natural Setting of Bronze Indian”, dated July 19, 1938. The sketch shows the sculpture in the upper pool with the rustication of the concrete pools with boulders, including the stone spillway from upper to lower pool. The vegetation frames the sculpture with mid-level shrubs surrounding the pools. To the rear of the sculpture is the boulder wall, which contains the circular walk where the drawings suggest birch trees and some shrubs.

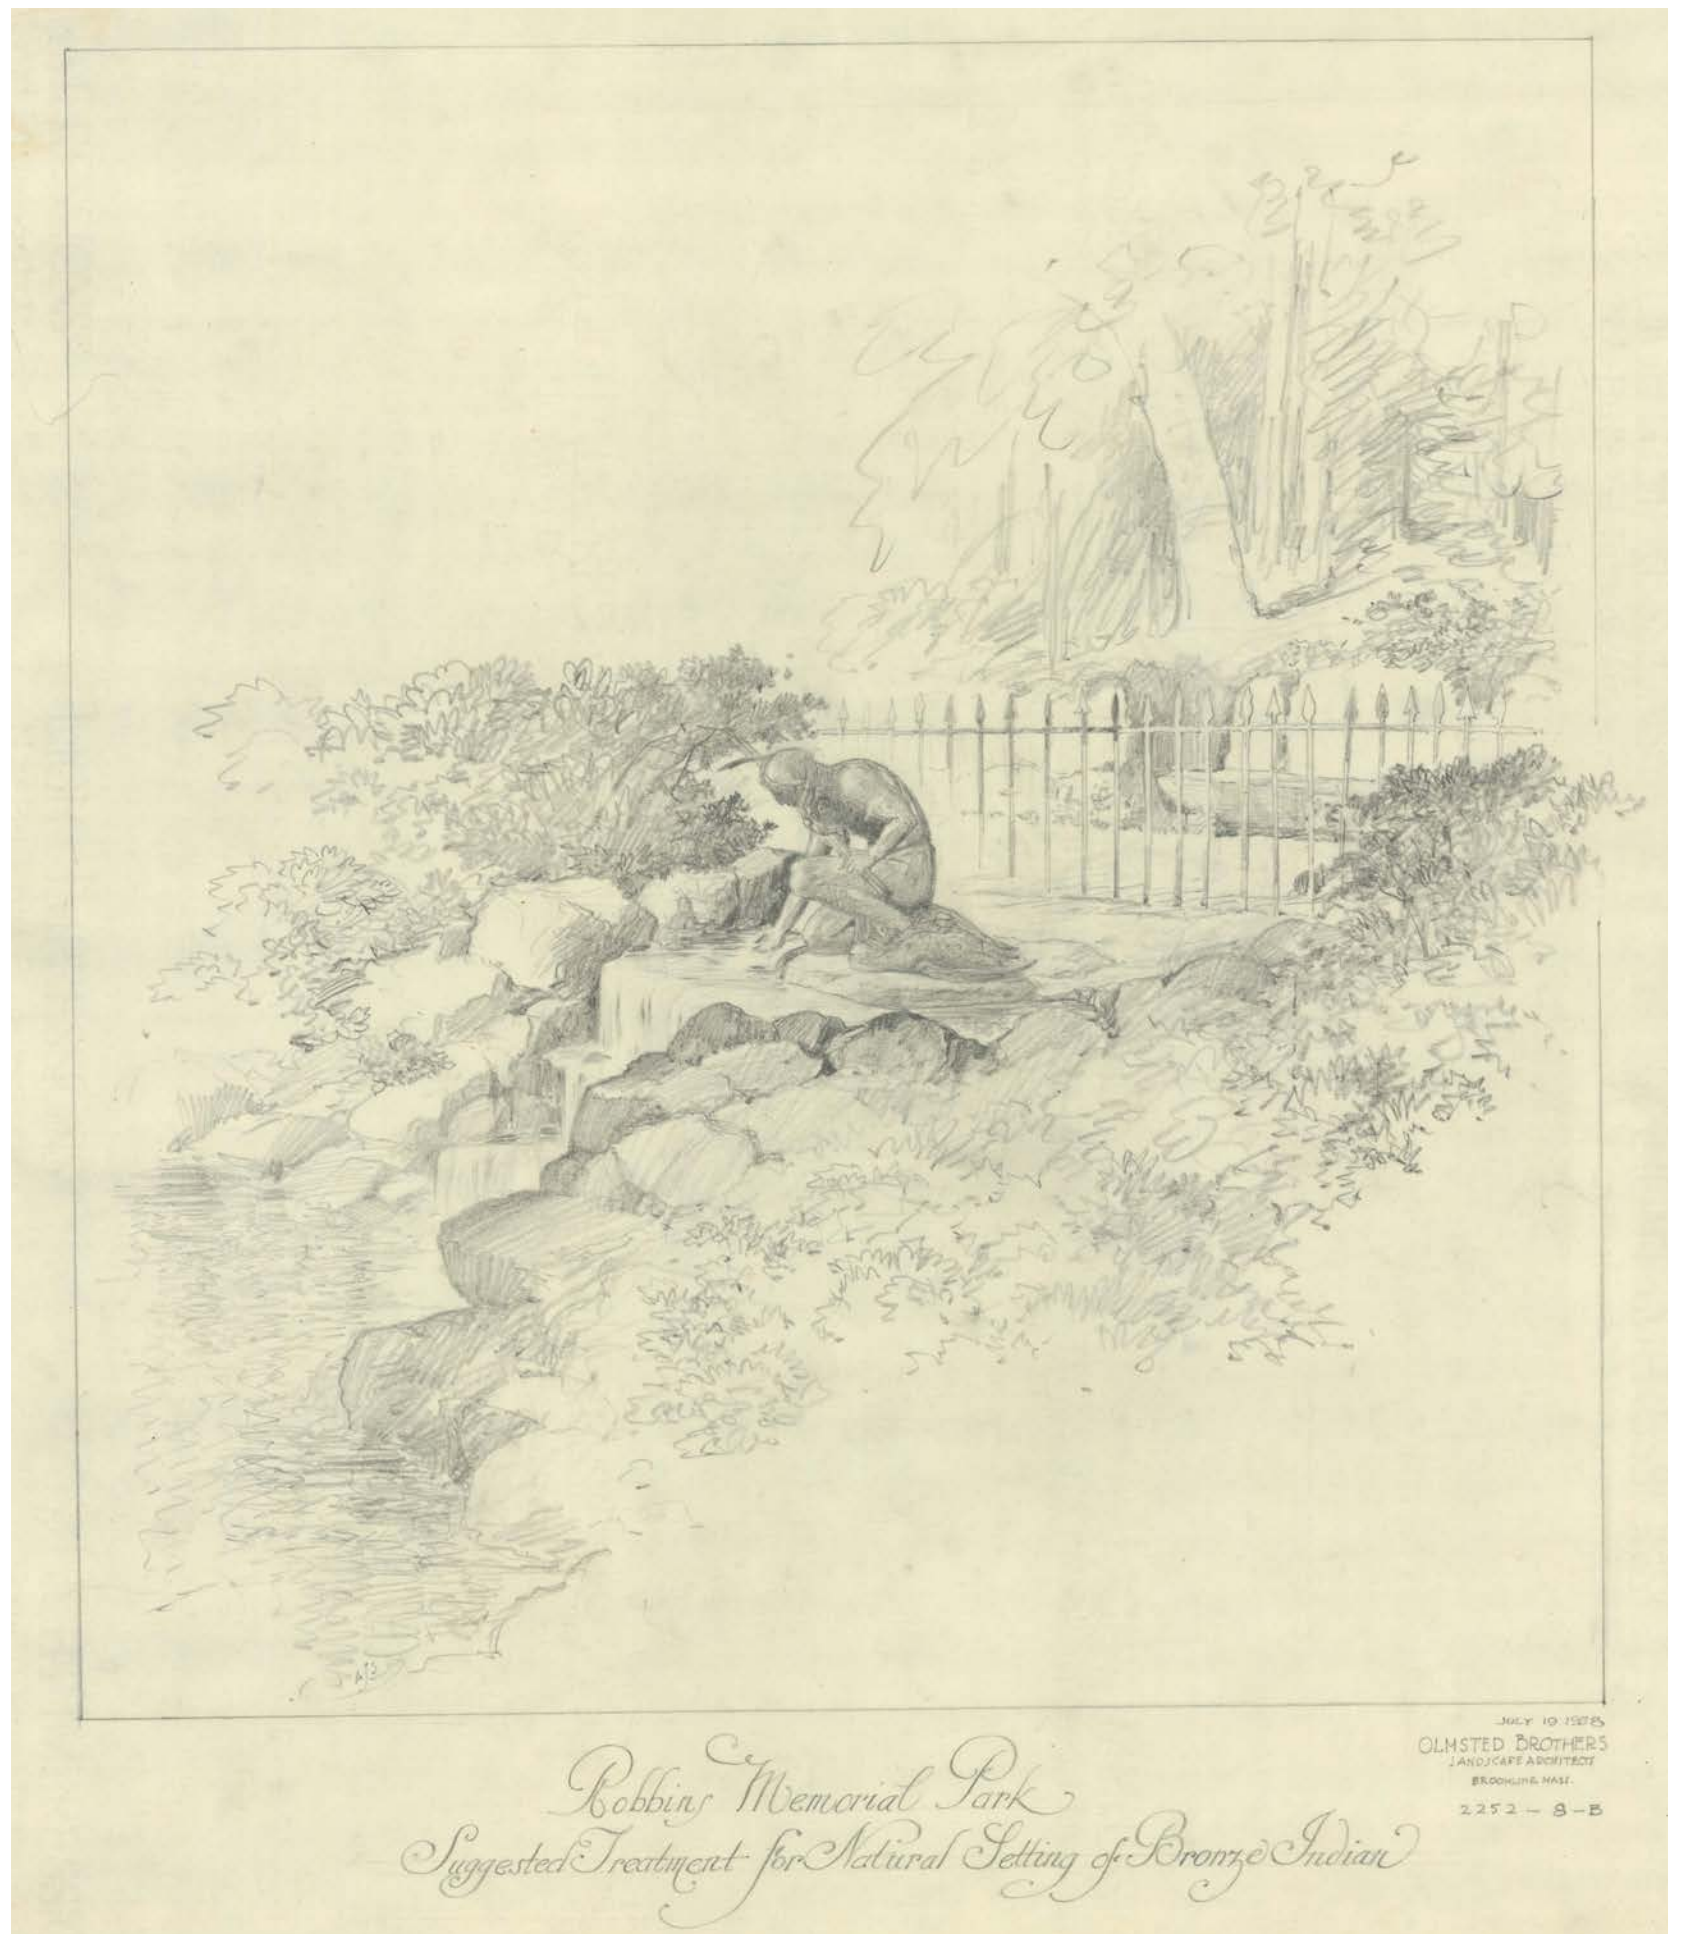
Olmsted Plan No. 8-B, "Suggested Treatment for Natural Setting of Bronze Indian", dated July 19, 1938; Courtesy of Olmsted Archives, Frederick Law Olmsted National Historic Site, NPS

- Plan No. 8-B has the same title and date as Plan No. 8-A but shows a different view, from the northwest of the sculpture. The planting and rustication are the same, with the one significant change being the addition of a (presumably) wrought iron fence behind the sculpture.

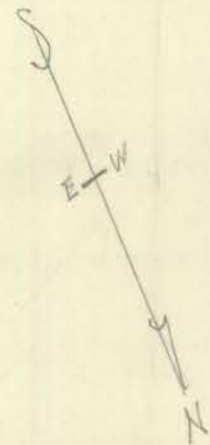
Olmsted Plan No. 21, "Detail of the Boulder Work around Indian", dated November 7, 1938; Courtesy of Olmsted Archives, Frederick Law Olmsted National Historic Site, NPS

- Plan No. 21 is entitled “Detail of the Boulder Work around Indian”, dated November 7, 1938. This shows the rustic intent of the upper and middle pools that is created by overlaying the existing concrete pools with fieldstone. Some of the detail shown on this plan was not implemented. The plan suggests replacing the sculpture’s concrete plinth with a large boulder and shifting the sculpture close to the “spring”; this was not undertaken, nor was a fence installed behind the sculpture.

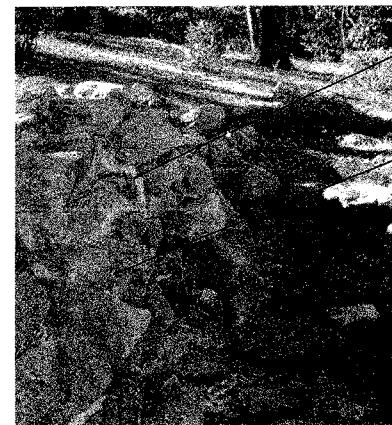
EXISTING FOUNTAIN BASE; CLEAN, REMOUNT VERTICAL STONES AS IN ORIGINAL OLMSTED INSTALLATION

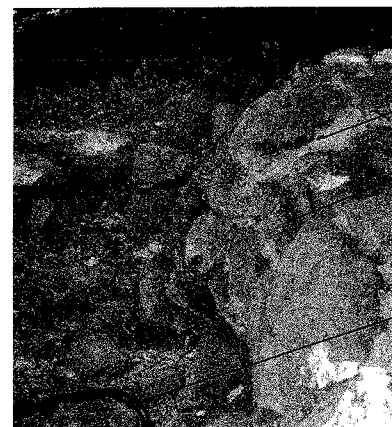
TYPICAL AREAS OF RESTORATION FOR BOTH POOL 1 AND POOL 2 (AREAS OF INAPPROPRIATE MORTAR COLOR OR INSTALLATION TECHNIQUE) REMOVE STONE, NUMBER STOCKPILE, CLEAN, RESET ACCORDING TO PLAN APPROVED BY LANDSCAPE ARCHITECT & PRESERVATION CONSULTANT

REMOVE STONE FACING, CLEAN AND WATERPROOF ENTIRE BASIN OF POOL 1 AND POOL 2 WITH LIQUID MEMBRANE WATERPROOFING, NOTE CURING TIME FOR CONCRETE PATCHING PRIOR TO WATERPROOFING AS NOTED IN MANUF. INSTRUCTIONS.

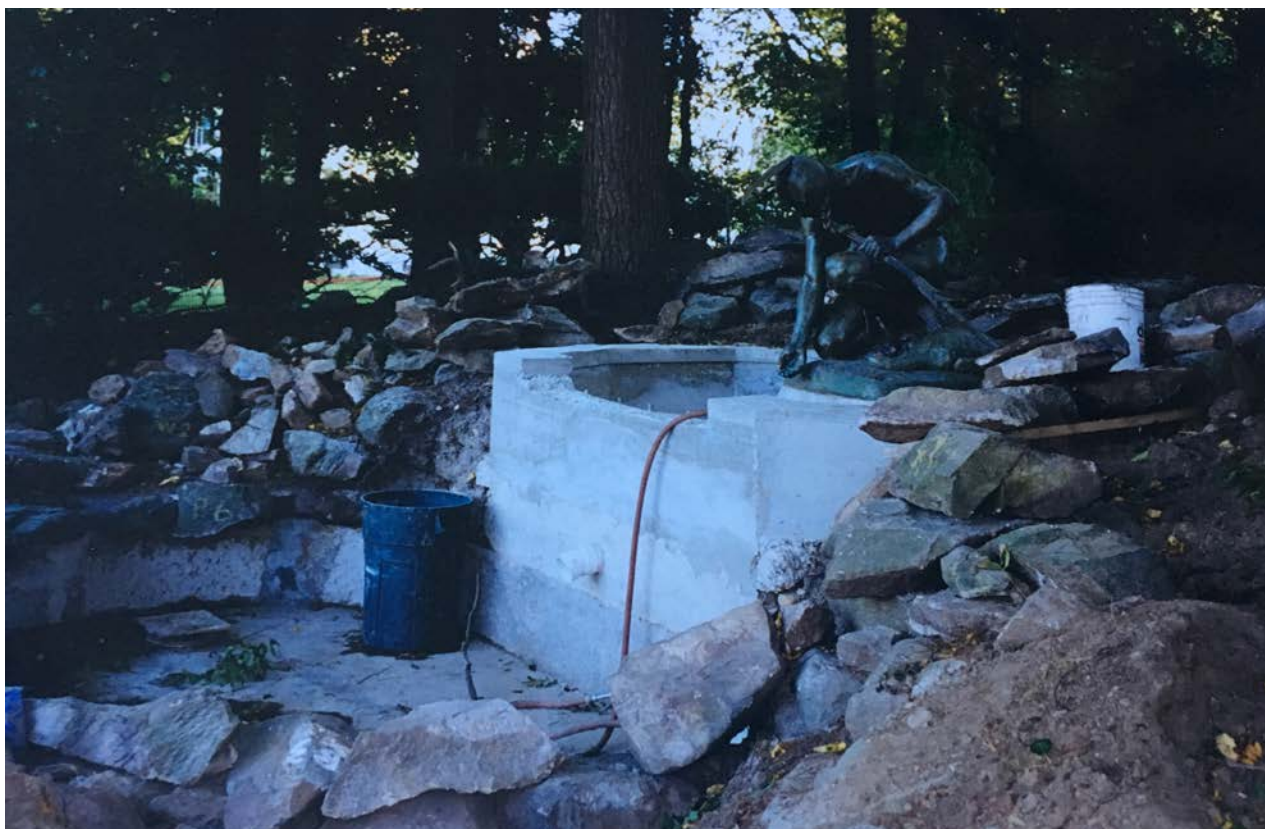
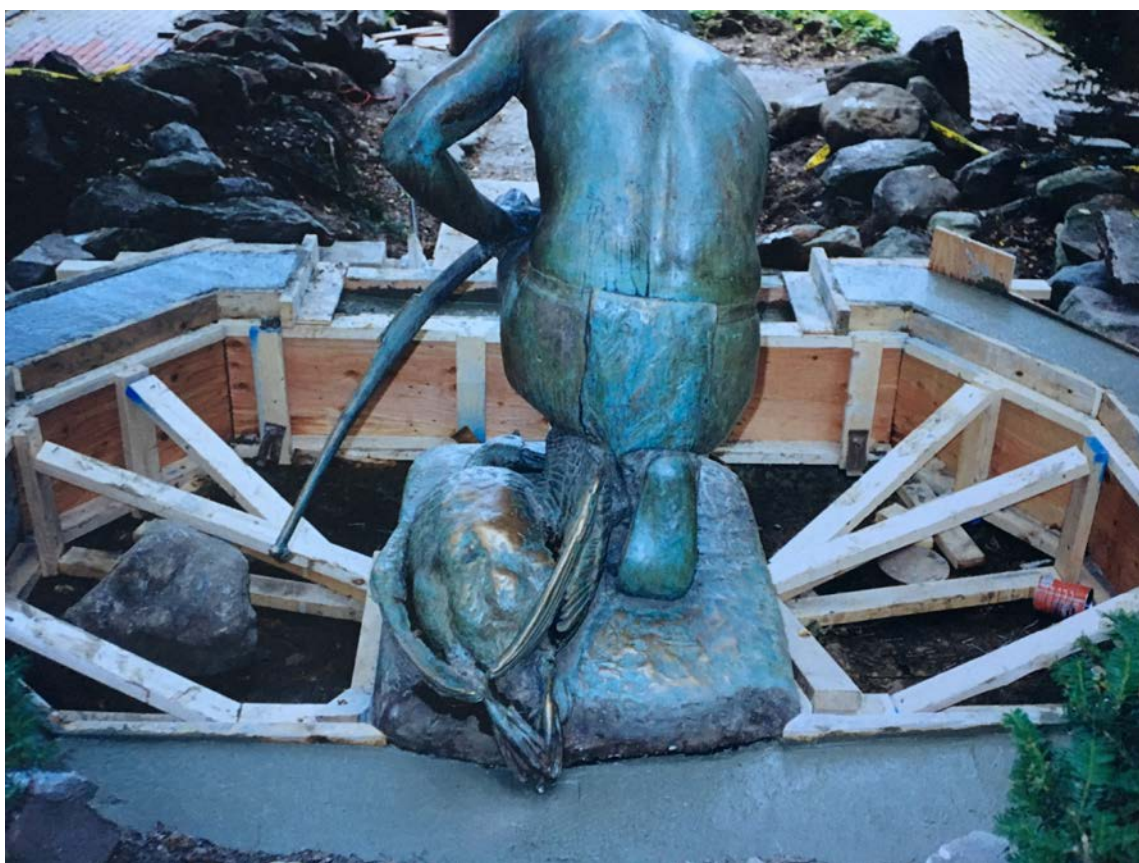
1999 image of reconstruction of the “spring”; Courtesy of the Town of Arlington

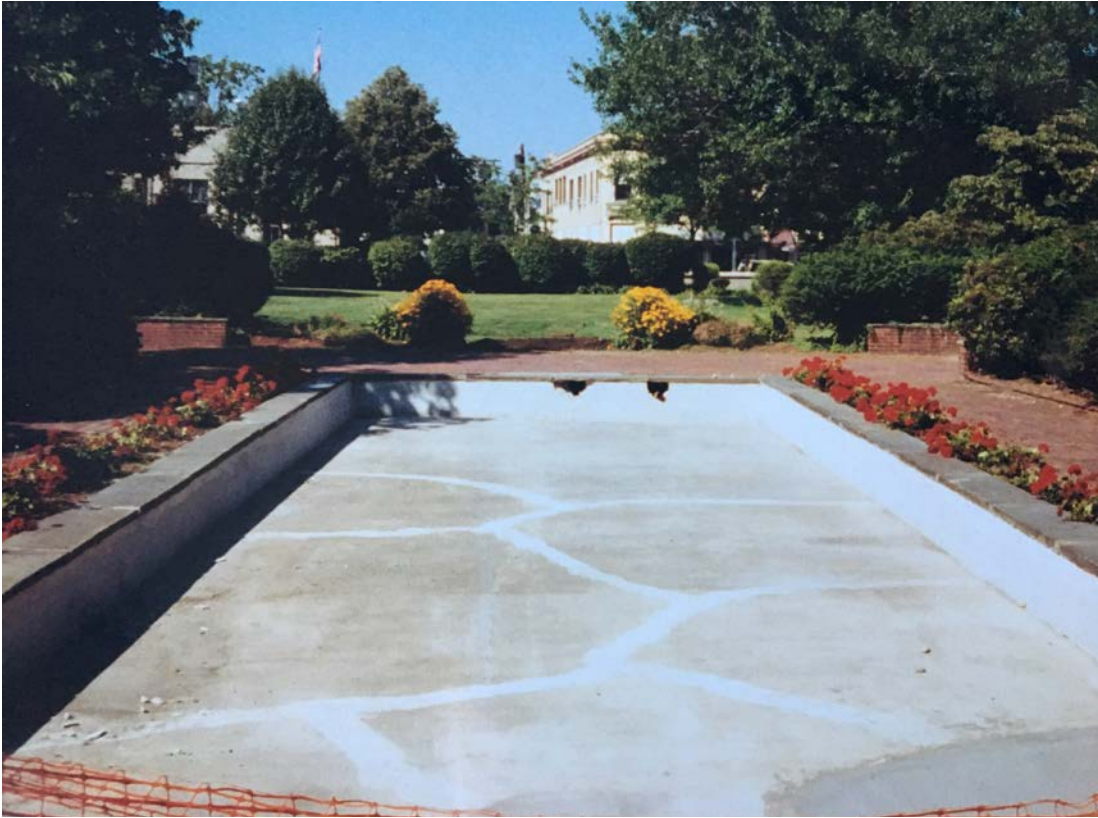
1999 image of repairs to the lower basin; Courtesy of the Town of Arlington

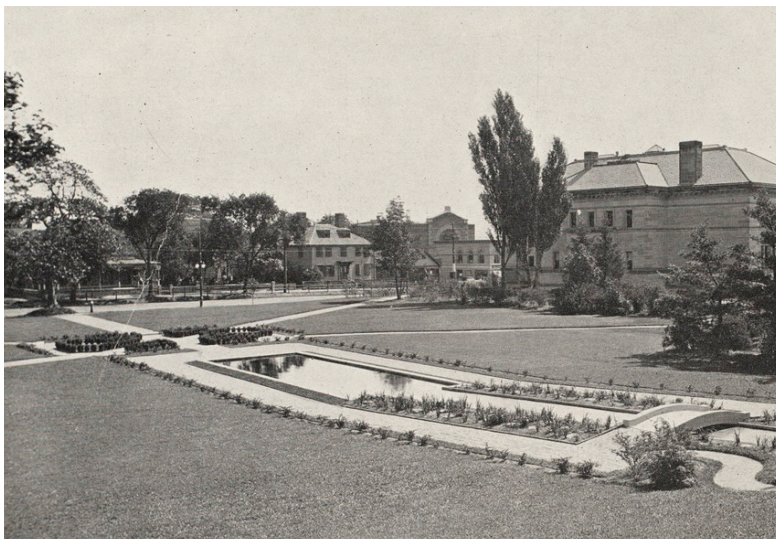
The lower pool is in poor condition. The skim coating that was applied in the 1998-1999 restoration has failed. The original concrete wall reinforcing and infill material is exposed. The depth of the pool varies (from 15 1/4 inches to 16 inches at the northern end) due to the thickness of the skim coating. The overhang of the bluestone coping varies greatly all the way around the pool from 1/4 of an inch to 1-1/2 inches. The pool is shallower than the originally designed depth of 2 feet 3 inches which leads to the assumption that there may have been a later pour over the original concrete pour in 1913. The drain, installed in the 1998-1999 restoration is bright yellow and is in sharp contrast to the concrete and is distracting.

1911 image of lower pool; Courtesy of Digital Commonwealth: Massachusetts Collections Online

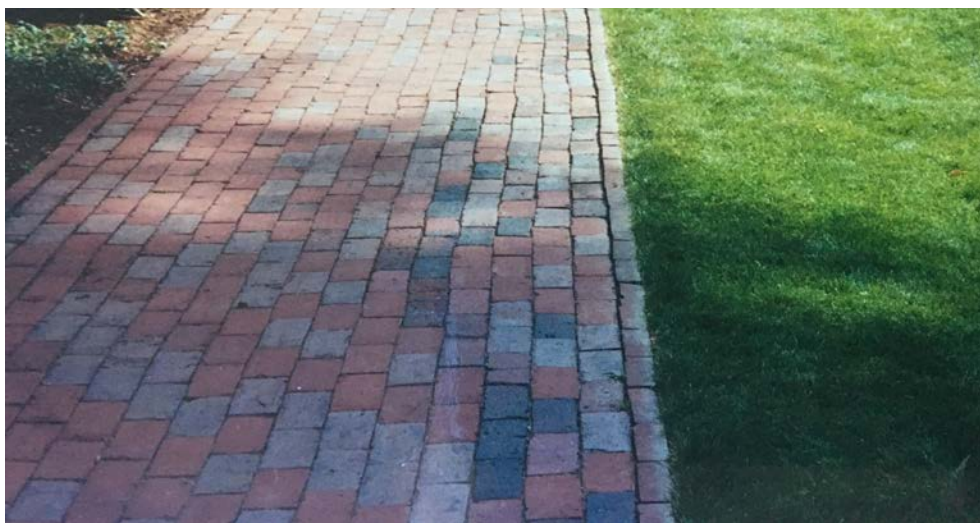
1999 image of brick walkway adjacent to the Whittemore-Robbins House with flush brick edging

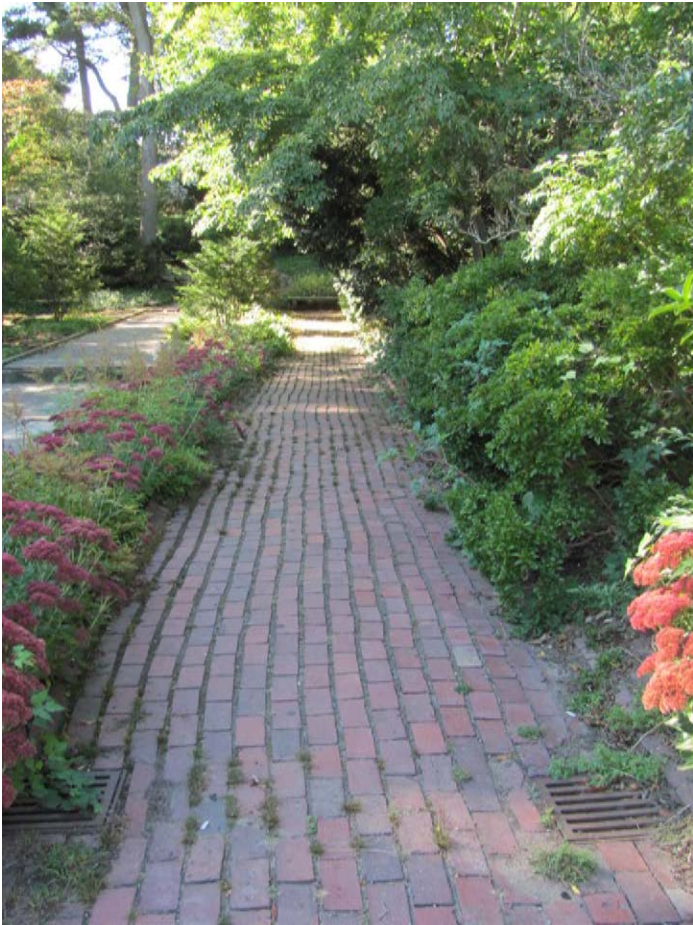
View from brick walkway with dogwood limbs blocking view of sculpture
