Annual Report
2017 Aquatic Management Program
Spy Pond
Arlington, MA

Prepared by: SÖLitude Lake Management
590 Lake Street
Shrewsbury, MA 01545

Prepared for: Town of Arlington
c/o Teresa DeBenedictis
51 Grove Street
Arlington, MA 02476

Submitted on: December 20, 2017

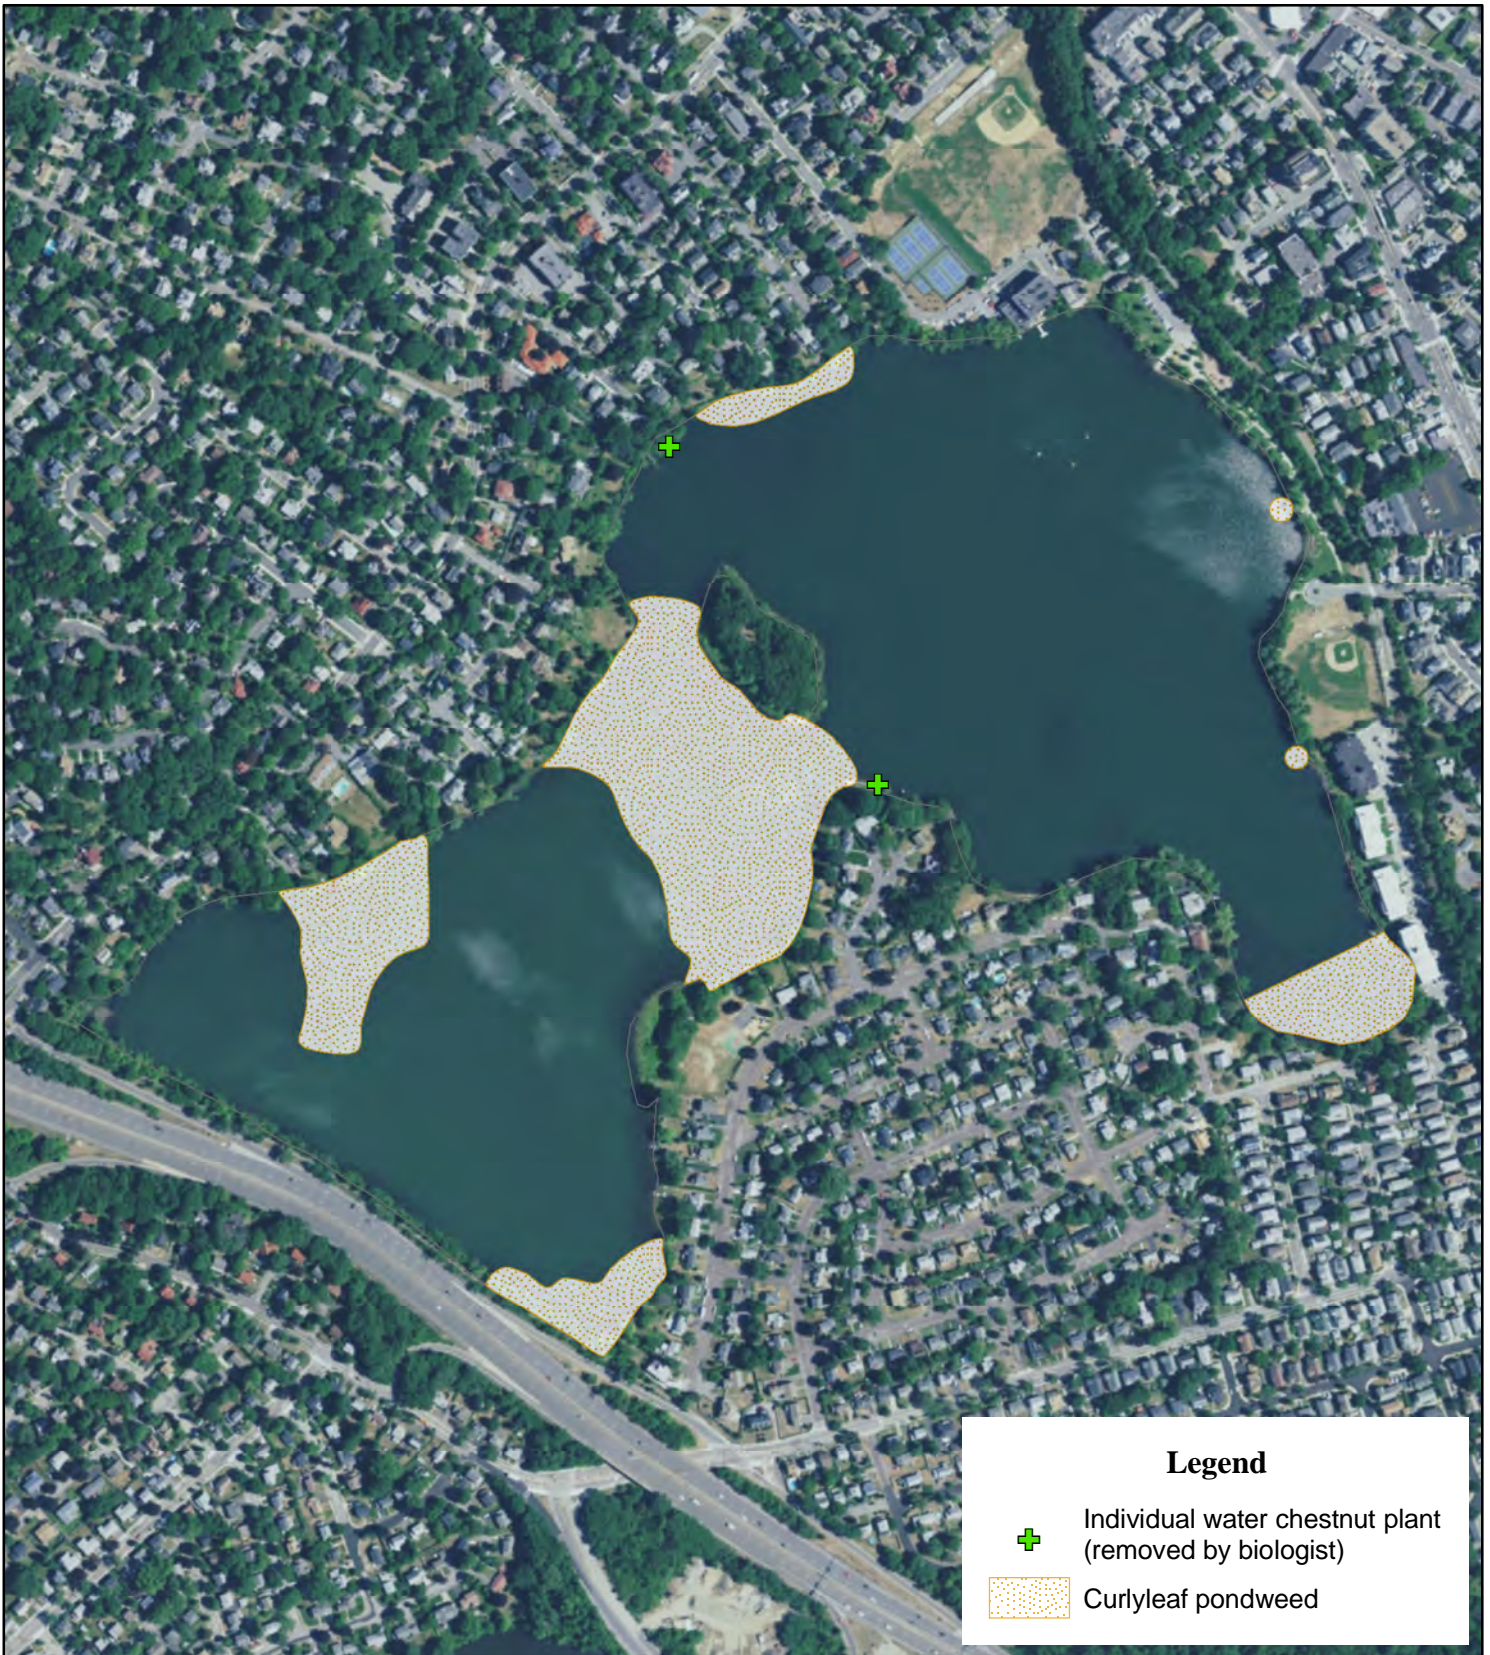
FIGURE 1: June 2017 Distribution of Invasive Aquatic Vegetation

Individual water chestnut plant
(removed by biologist)

Curlyleaf pondweed

On June 13, a SÖLitude biologist conducted a pre-management inspection of Spy Pond to assess the relative abundance and distribution of non-native aquatic vegetation, specifically Eurasian watermilfoil (*Myriophyllum spicatum*). During the survey, the entire waterbody was systematically toured and a GPS was utilized to record any locations of milfoil encountered. As a result of the 2016 Sonar treatment program, no Eurasian milfoil was observed. Shoreline areas of varying density curlyleaf pondweed (*Potamogeton crispus*) were observed, as well as one individual water chestnut (*Trapa natans*) plant, which was immediately removed by the SÖLitude biologist. Based on the results of the survey, no treatment was scheduled to be conducted at this time.

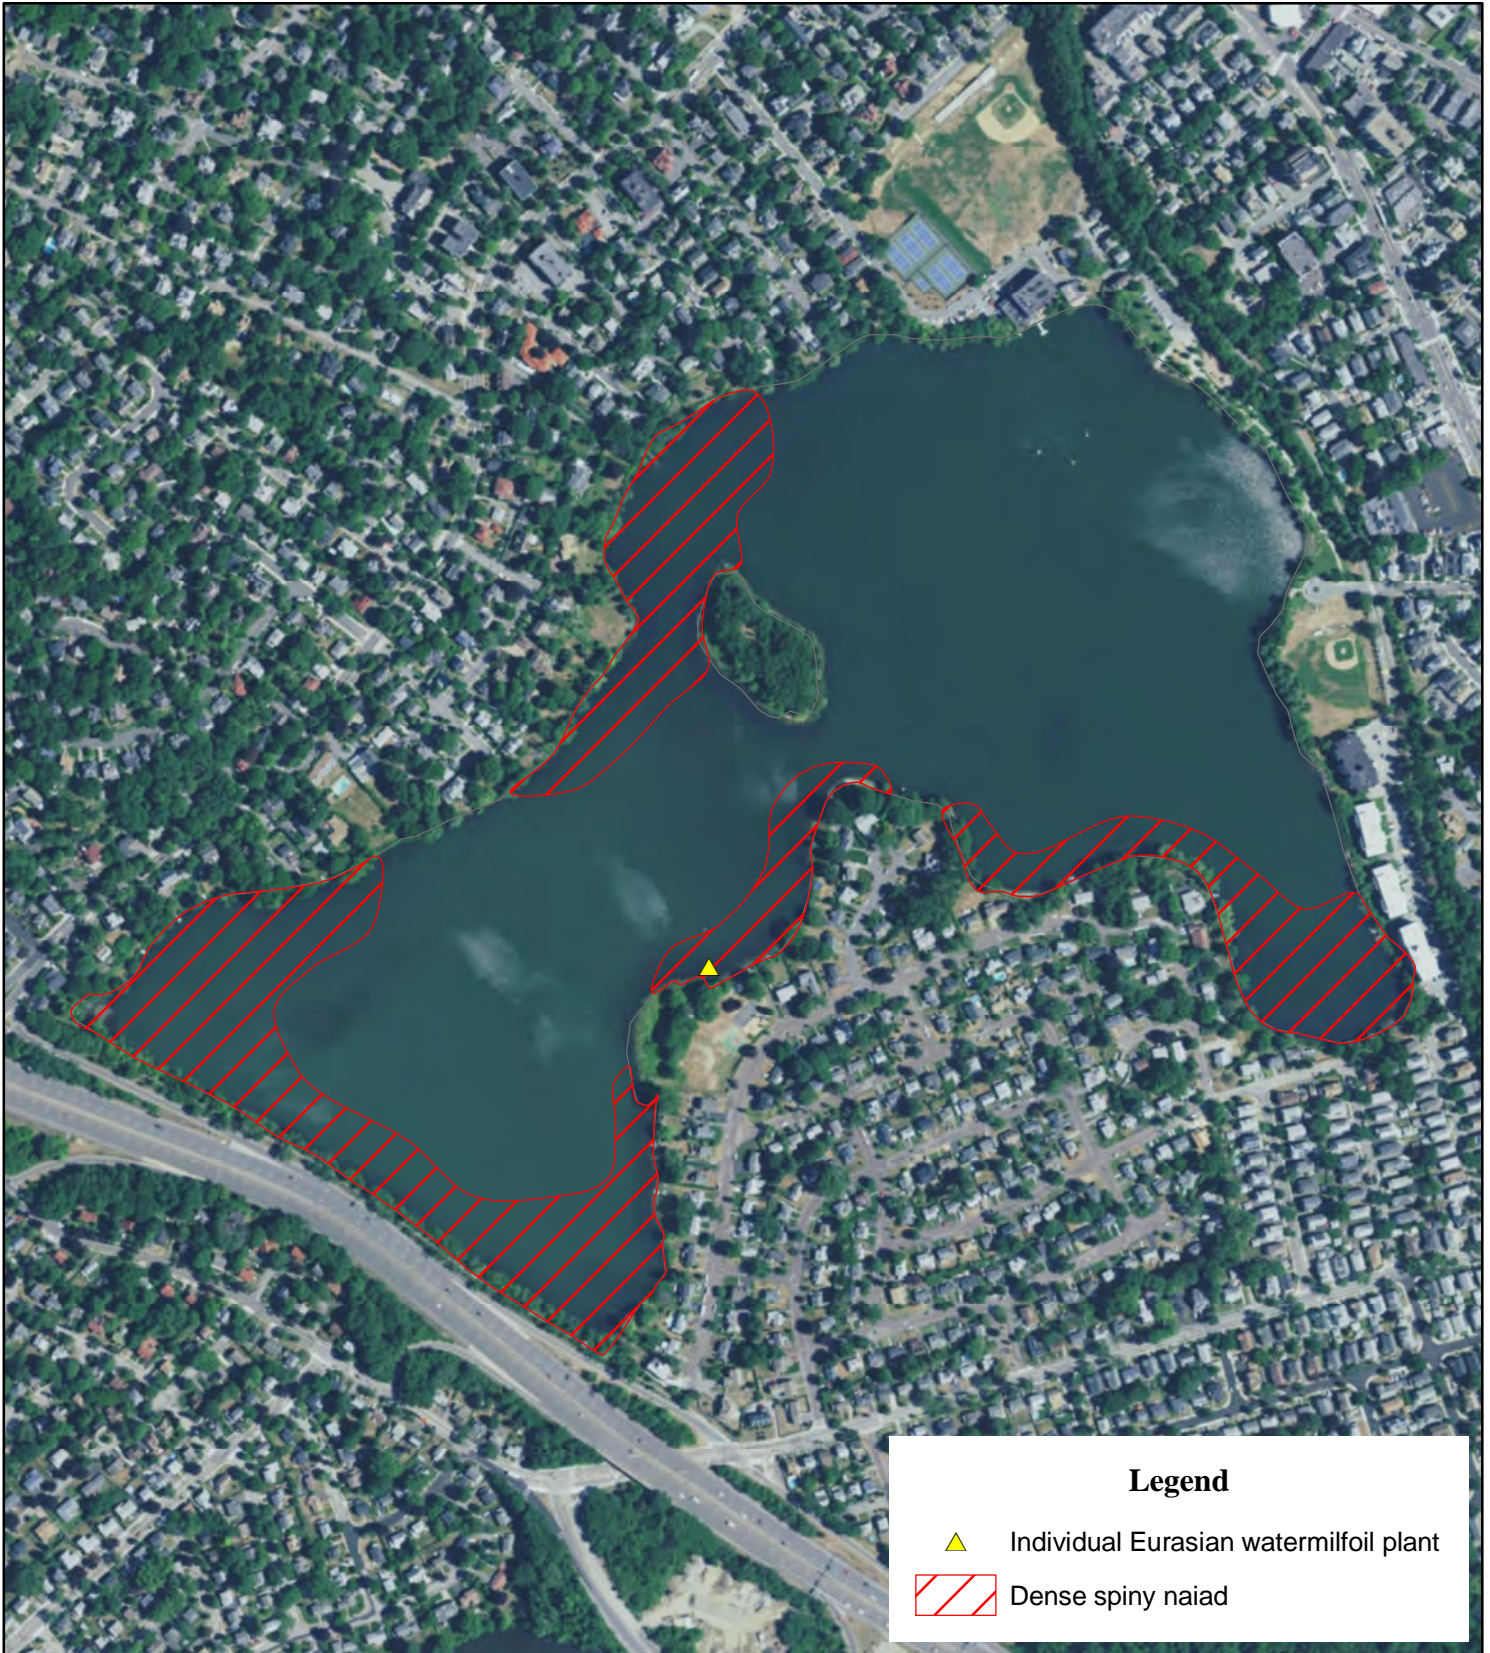
FIGURE 2: August 2017 Distribution of Invasive Aquatic Vegetation

Individual Eurasian watermilfoil plant
-

Dense spiny naiad

At the request of a resident of Spy Pond, an interim survey of the pond was conducted on August 4 to assess the nuisance aquatic plant growth of concern. Upon inspection, the growth was found to be spiny naiad (*Najas minor*), which is an invasive species capable of creating dense, nuisance mats of vegetation. One individual Eurasian milfoil plant was observed near the Kelwyn Manor Park boat launch at this time as well. As a result, treatment was scheduled shortly thereafter.

On August 28, an herbicide treatment to control the nuisance spiny naiad growth was scheduled and performed. Treatment of 30 acres of growth was completed using an airboat

equipped with an on-board low-pressure pump system, in which the liquid diquat herbicide was diluted with pond water and applied subsurface via trailing hoses. Although the treatment was targeting the spiny naiad growth, Eurasian milfoil is also impacted by diquat herbicide and any viable plants would have been impacted by the treatment. At no time during or following the treatment were non-target or aquatic organisms adversely impacted.
