**Annual Report**  
2018 Aquatic Management Program  
Spy Pond  
Arlington, MA

*Prepared by:* SÖLitude Lake Management  
590 Lake Street  
Shrewsbury, MA 01545

*Prepared for:* Town of Arlington  
c/o Teresa DeBenedictis  
51 Grove Street  
Arlington, MA 02476

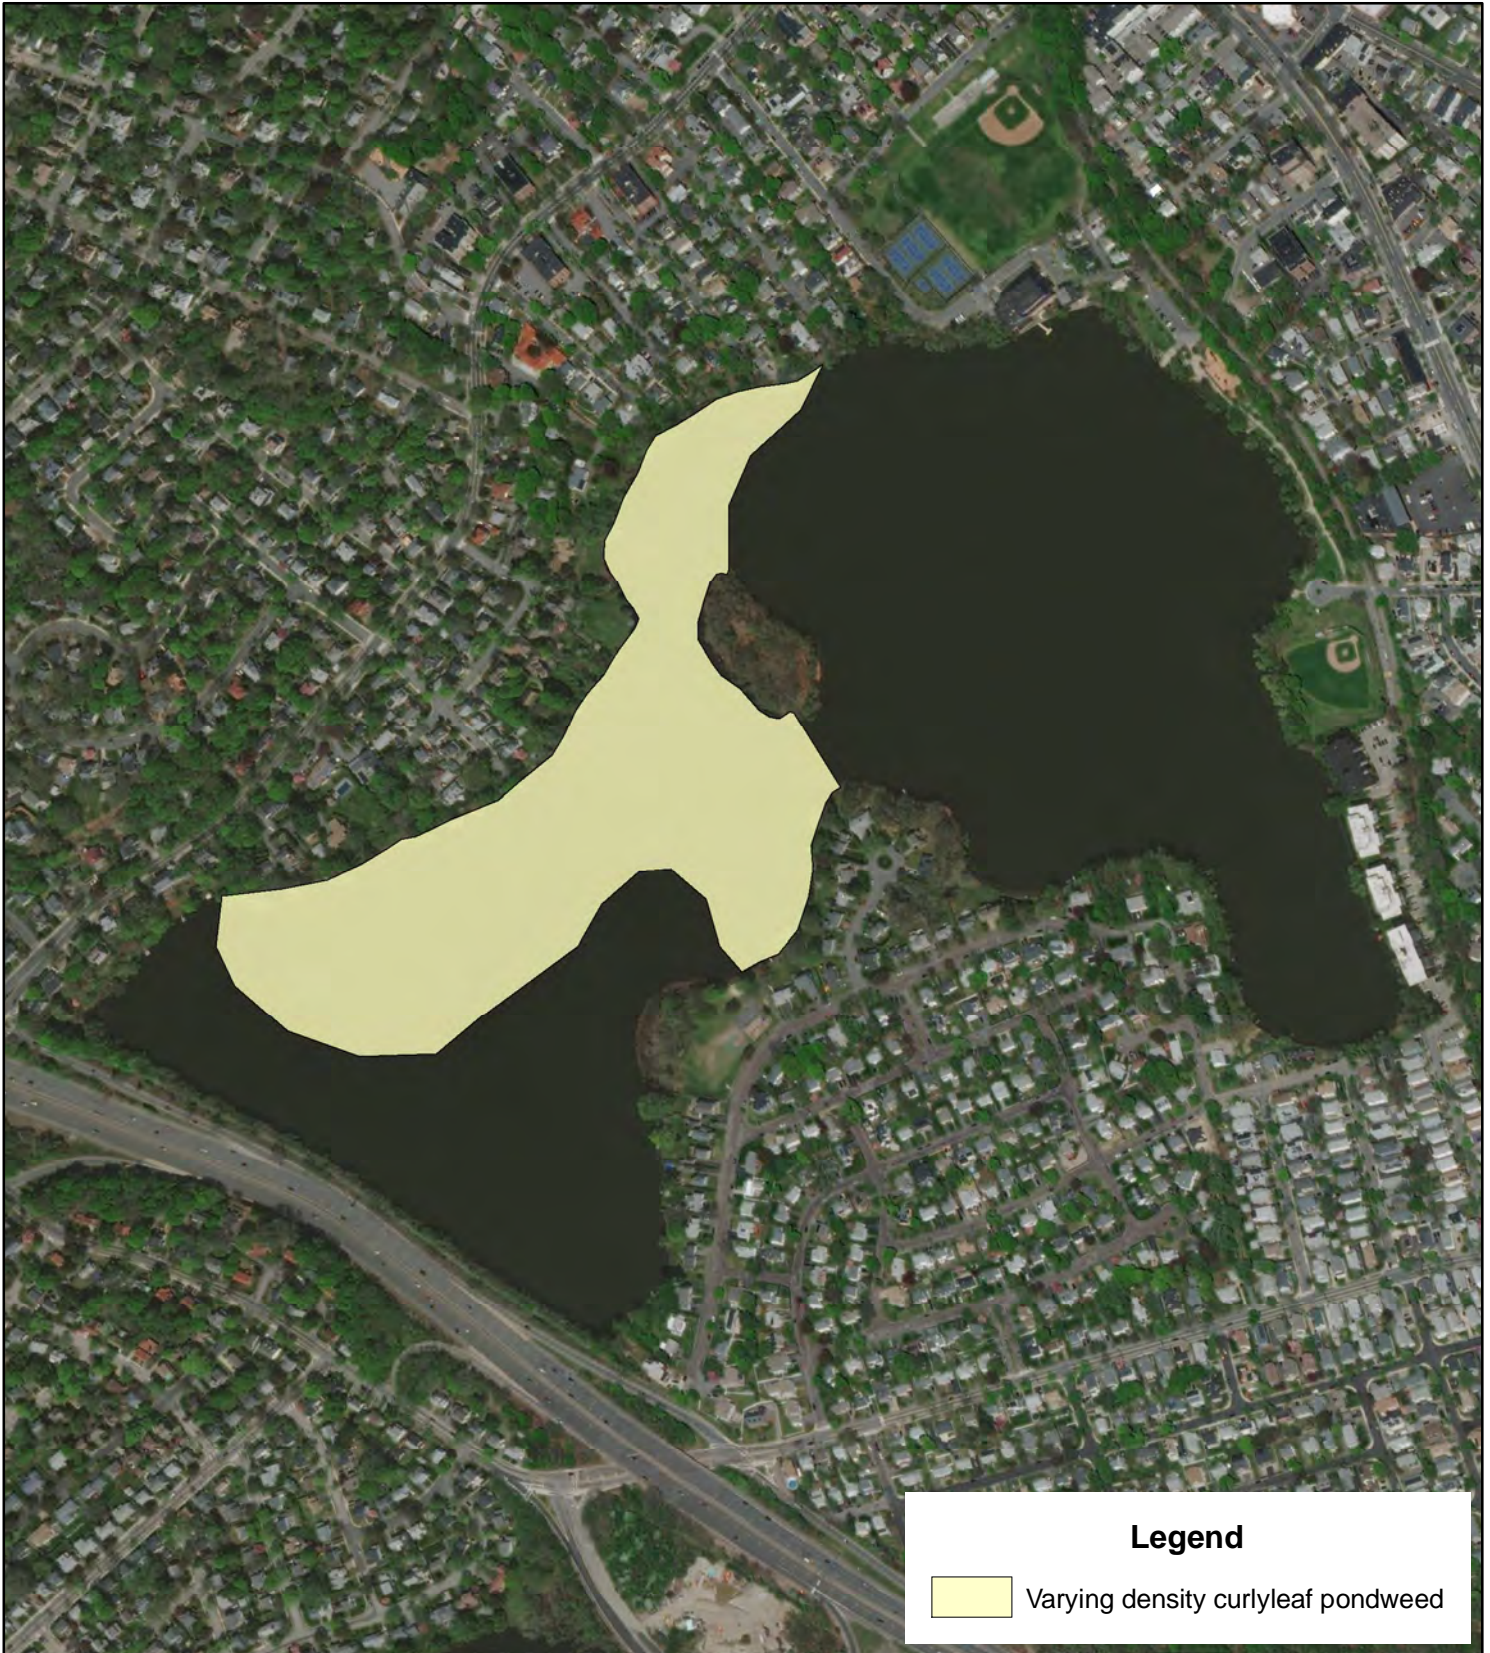
**FIGURE 1: May 2018 Distribution of Invasive Aquatic Vegetation**

On May 16, a SÖLitude biologist conducted a pre-management inspection of Spy Pond to assess the relative abundance and distribution of non-native aquatic vegetation, specifically Eurasian watermilfoil (*Myriophyllum spicatum*) and curlyleaf pondweed (*Potamogeton crispus*). During the survey, the entire waterbody was systematically toured and a GPS was utilized to record any locations of milfoil encountered. As a result of the 2016 Sonar treatment program, no Eurasian milfoil was observed. Shoreline areas of varying density curlyleaf pondweed (*Potamogeton crispus*) were observed. Based on the results of the survey, no treatment was scheduled to be conducted at this time.

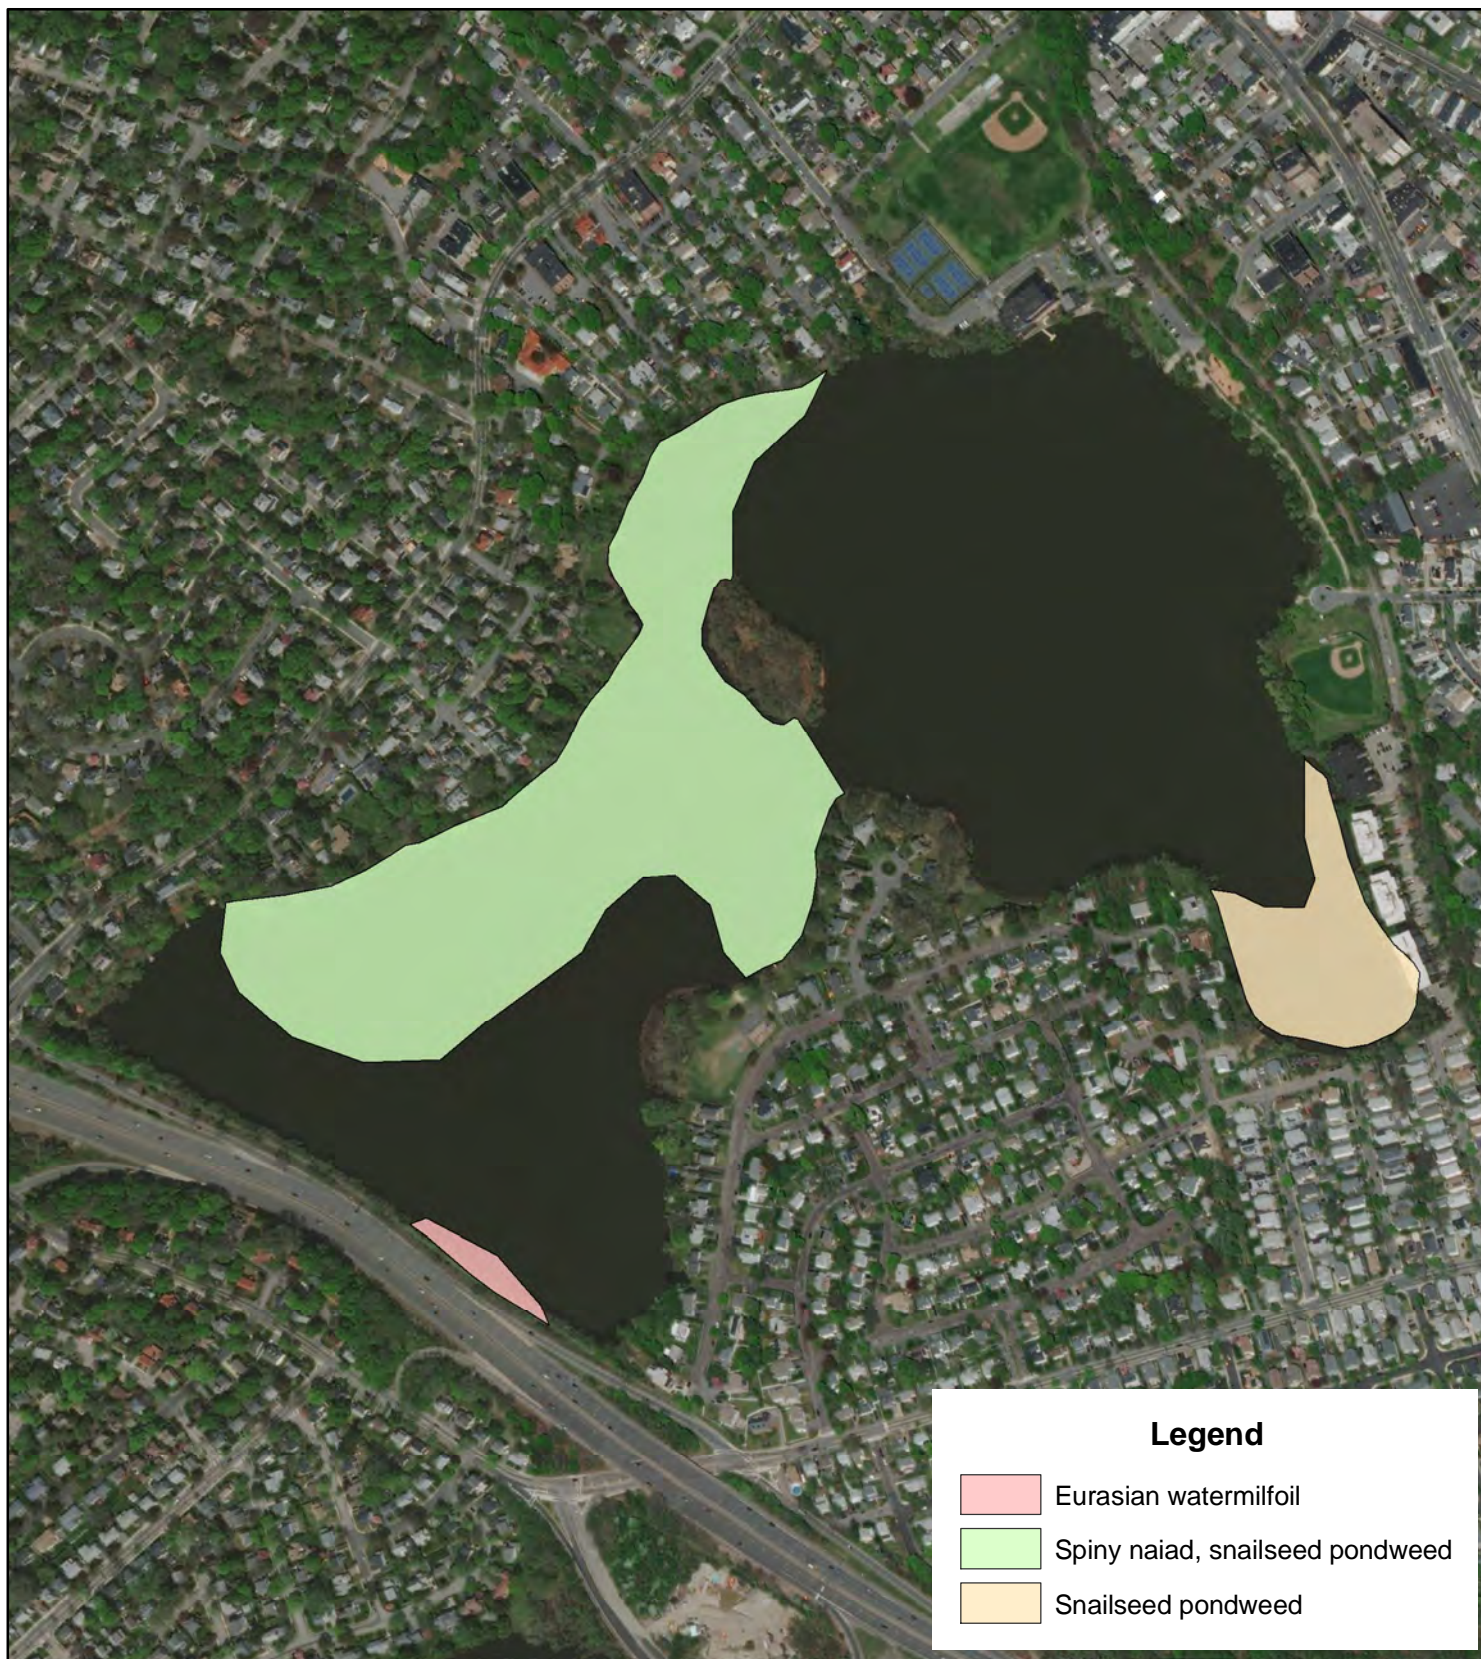
**FIGURE 2: July 2018 Distribution of Invasive Aquatic Vegetation**

In anticipation of later season spiny naiad (*Najas minor*) growth, a survey was conducted on July 19 to assess it's growth and determine a management approach. Spiny naiad growth at this time was moderate and low-growing still along the western shoreline. Some individual Eurasian milfoil plants were observed along the shoreline opposite Kelwyn Manor Park boat launch at this time as well. Dense snailseed ponweed (*Potamogeton bicupulatus*) was observed in all shallower water depths south of Elizabeth Island and in the eastern most cove. As a result, treatment was scheduled shortly thereafter.

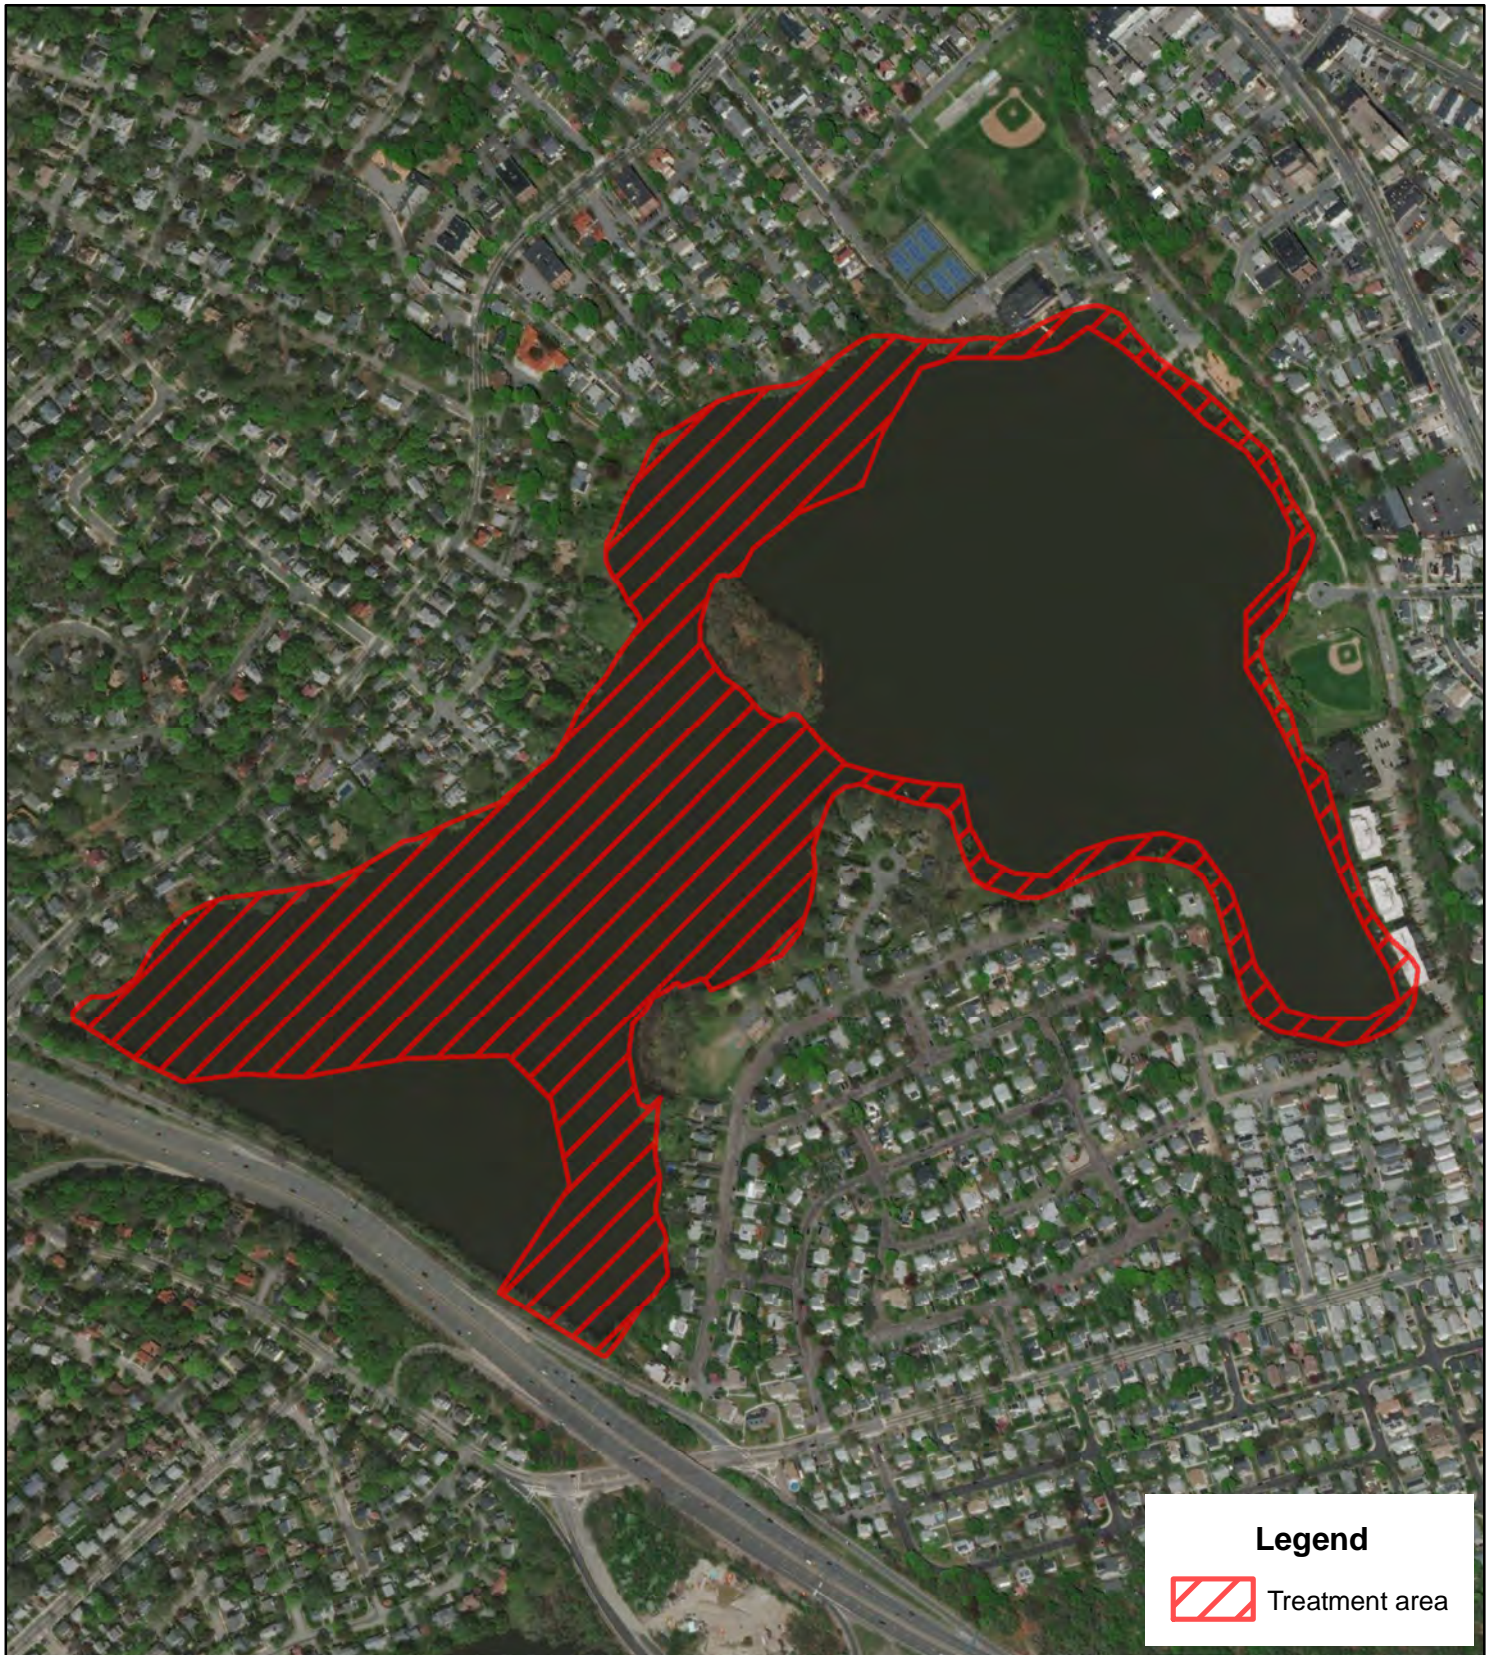
**FIGURE 3: August 2018 Herbicide Treatment Areas**

On August 13, an herbicide treatment to control the nuisance spiny naiad growth was scheduled and performed. Treatment of 40 acres of growth was completed using an airboat

equipped with an on-board low-pressure pump system, in which the liquid diquat herbicide was diluted with pond water and applied subsurface via trailing hoses. Although the treatment was targeting the spiny naiad growth, Eurasian milfoil is also impacted by diquat herbicide and any viable plants within the treatment areas would have been impacted by the treatment. At no time during or following the treatment were non-target or aquatic organisms adversely impacted.
