CPA Funding – FY2020 Final Application

**Community Preservation Committee
Request for Funding
Rehabilitation of the Whittemore-Robbins Cottage Exterior**

Re: Whittemore Robbins Cottage
Structural Engineering Services

PROJECT
**Whittemore Robbins Cottage
Structural Study**

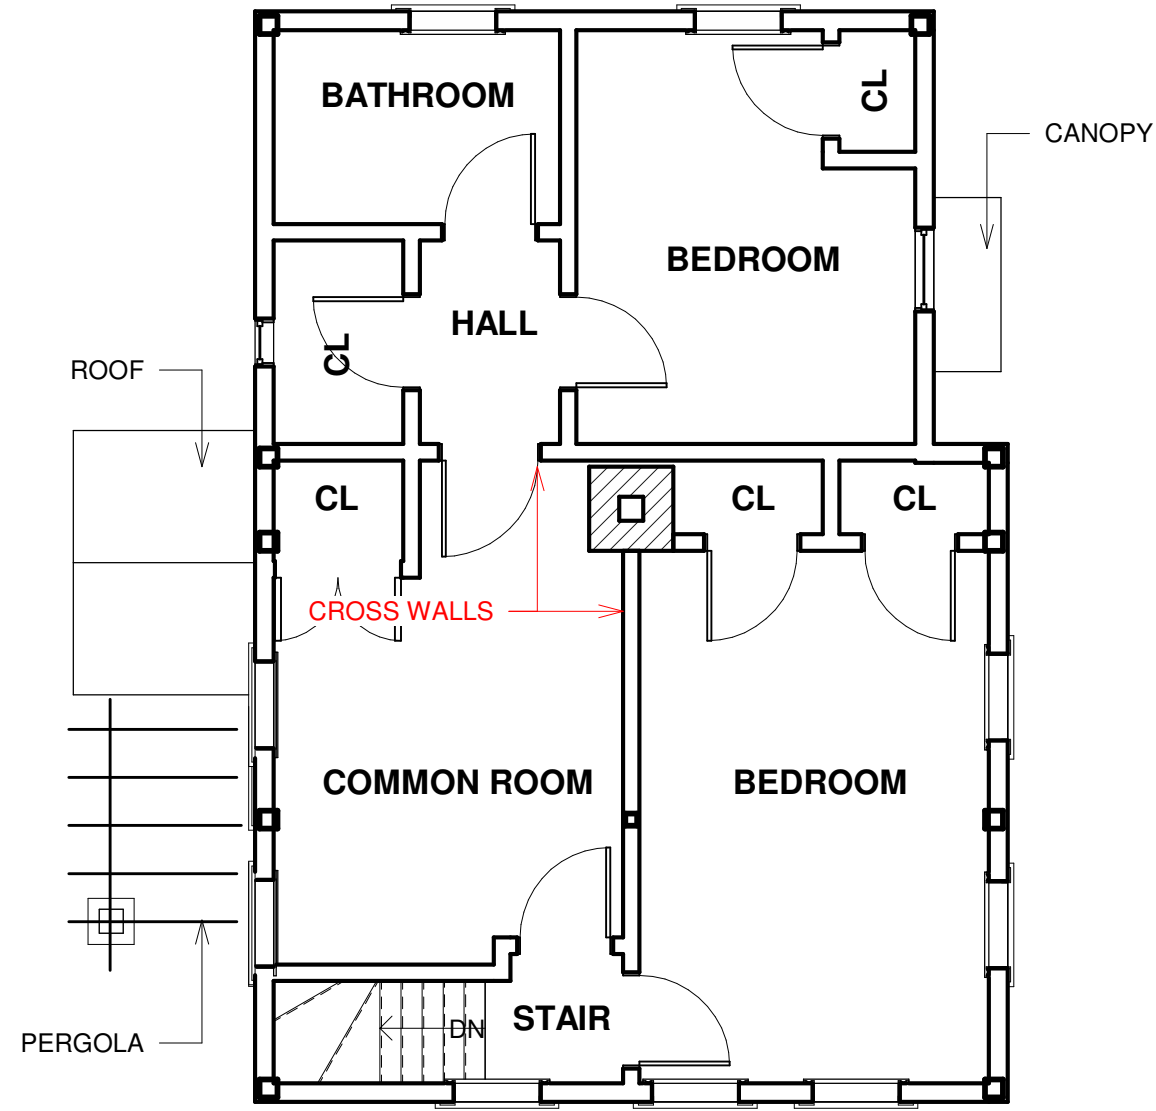
9. Cross walls (See Sheets A1 & A2). Cross walls are usually interior non-bearing walls that serve to separate spaces into rooms. They provide an additional structural benefit in stiffening a building against lateral forces from wind or earthquakes. I've identified two walls, one north-south and the other east-west that should be kept in any proposed renovation. The modern tendency is to remove walls to open up interior spaces. The lengths of cross walls to remain can be reduced following a structural analysis to determine effective lengths. These walls should generally stack from the first level floor to the second level ceiling.

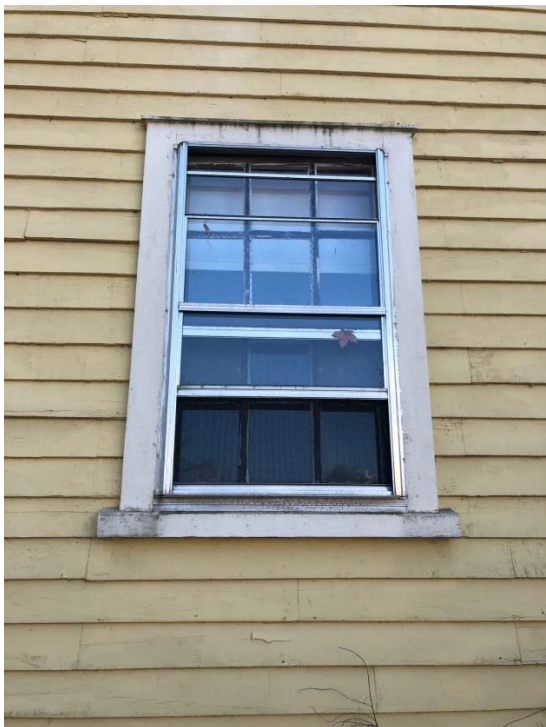
2. Close up photo of window
