Year 3 Annual Report
Massachusetts Small MS4 General Permit
Reporting Period: July 1, 2020-June 30, 2021

In Year 3, Arlington installed 33 infiltration trenches. Arlington continues to apply for grants to construct green infrastructure in public parks, ROWs, and other public spaces.

- New BMP installations for 2021 include 33 new infiltration trenches. These BMP's have been added to the GIS mapping system including: location, date of installation, contractor, dimensions, contaminant removal
- See BMP Data Addendum for As-built information

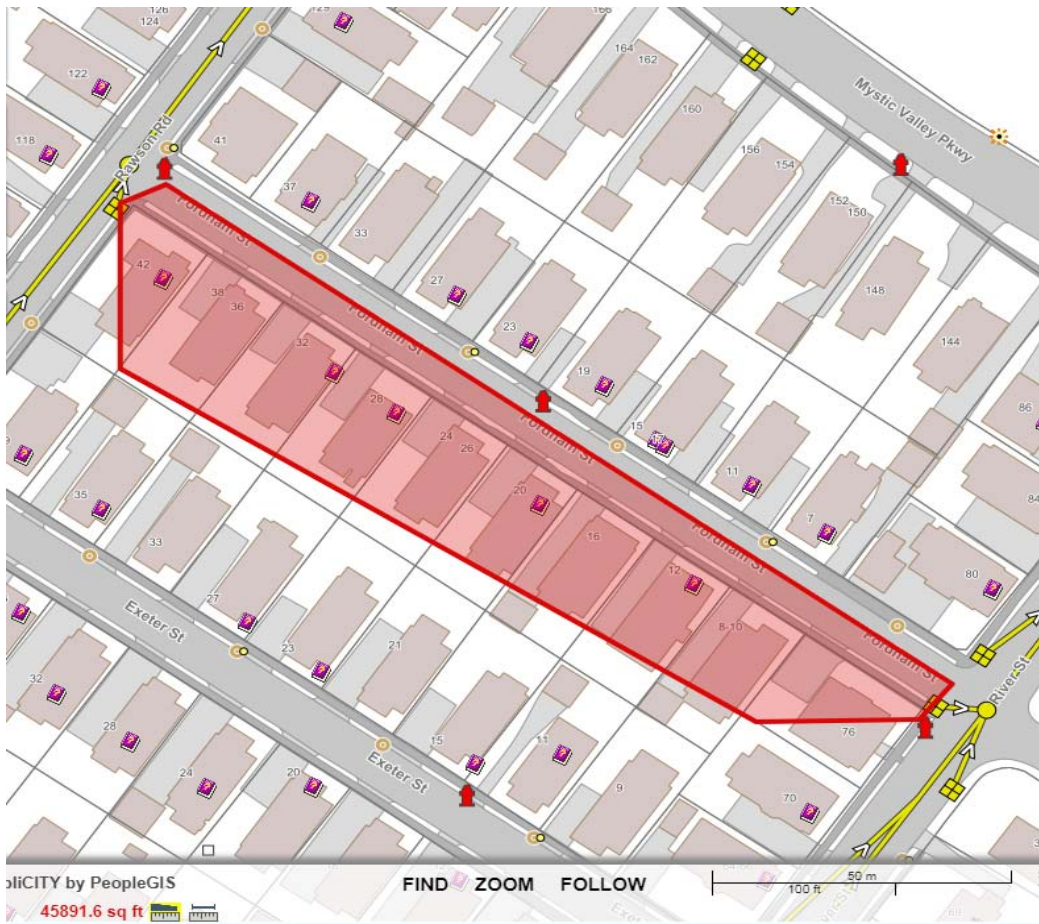
BMP ID: **2021ST#1**
 Location: 76 River Street
 Watershed Area: 45892 sf = 1.05 ac.
 % Impervious Cover: 70% Multi-Family High Density Residential
 BMPType: Street Trench
 Infiltration Rate: 2.41 in/hr

Location 76 River Street

Watershed Area: 1.05 acres

L = feet
 W = feet
 D = feet
 P removal = lb/yr
 N removal = lb/yr
 TSS Removal = lb/yr
 Vol. Reduction = cf

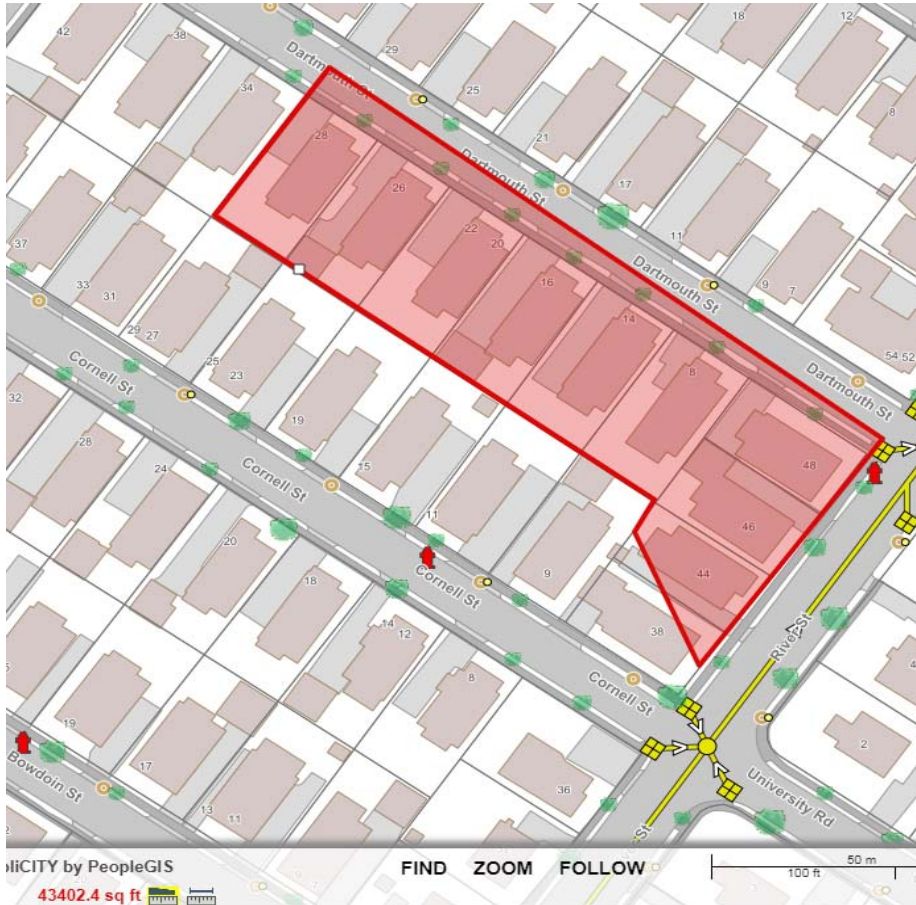
BMP ID: **2021ST#4**
 Location: 48 River Street
 Watershed Area: 43402 sf = 1.00 ac.
 % Impervious Cover: 70% Multi-Family High Density Residential
 BMPType: Street Trench
 Infiltration Rate: 2.41 in/hr

Location 48 River Street
 Watershed Area: 1.00 acres
 BMP Type: Street Trench
 L = 18 feet
 W = 3 feet
 D = 2.58 feet
 P removal = 0.95 lb/yr
 N removal = 5.70 lb/yr
 TSS Removal = 244.54 lb/yr
 Vol. Reductic = 143.00 cf

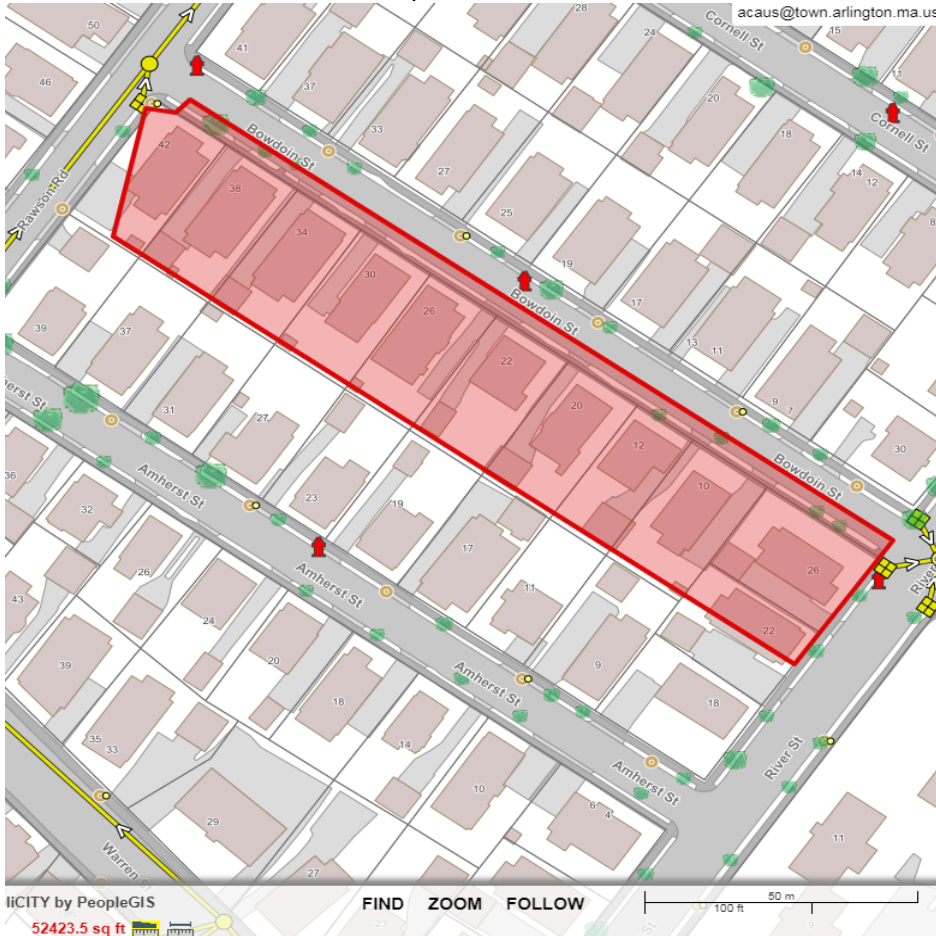
BMP ID: **2021ST#7**
 Location: 26 River Street
 Watershed Area: 52424 sf = 1.20 ac.
 % Impervious Cover: 70% Multi-Family High Density Residential
 BMPType: Street Trench
 Infiltration Rate: 2.41 in/hr

Location 26 River Street

Watershed Area: 1.20 acres
 BMP Type: Street Trench
 L = 18 feet
 W = 3.5 feet
 D = 2 feet
 P removal = 0.94 lb/yr
 N removal = 5.75 lb/yr
 TSS Removal = 254.23 lb/yr
 Vol. Reductic 144.00 cf

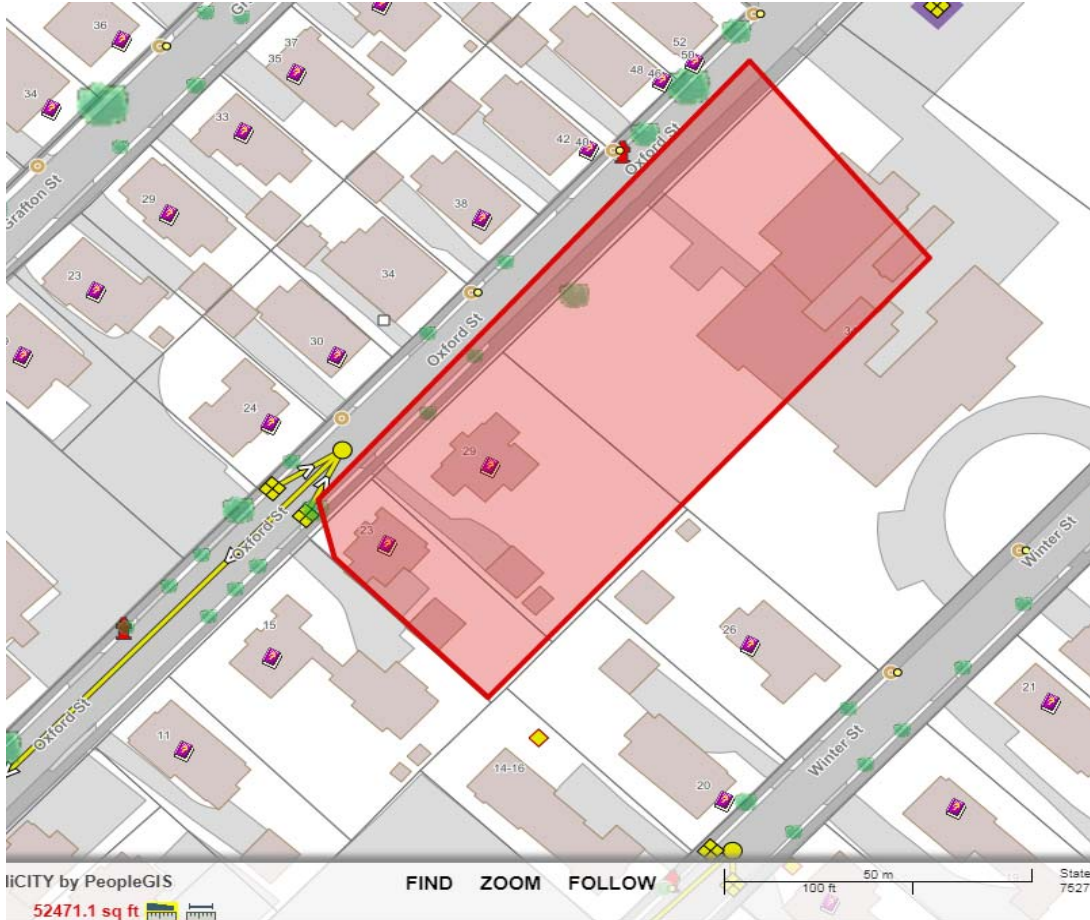
BMP ID: **2021ST#13**
 Location: 23 Oxford Street
 Watershed Area: 52471 sf = 1.20 ac.
 % Impervious Cover: 70% Multi-Family High Density Residential
 BMPType: Street Trench
 Infiltration Rate: 2.41 in/hr

Location 23 Oxford Street
 Watershed Area: 1.20 acres
 BMP Type: Street Trench
 L = 16 feet
 W = 3.5 feet
 D = 2.42 feet
 P removal = 1.00 lb/yr
 N removal = 6.06 lb/yr
 TSS Removal = 267.03 lb/yr
 Vol. Reductic = 152.00 cf

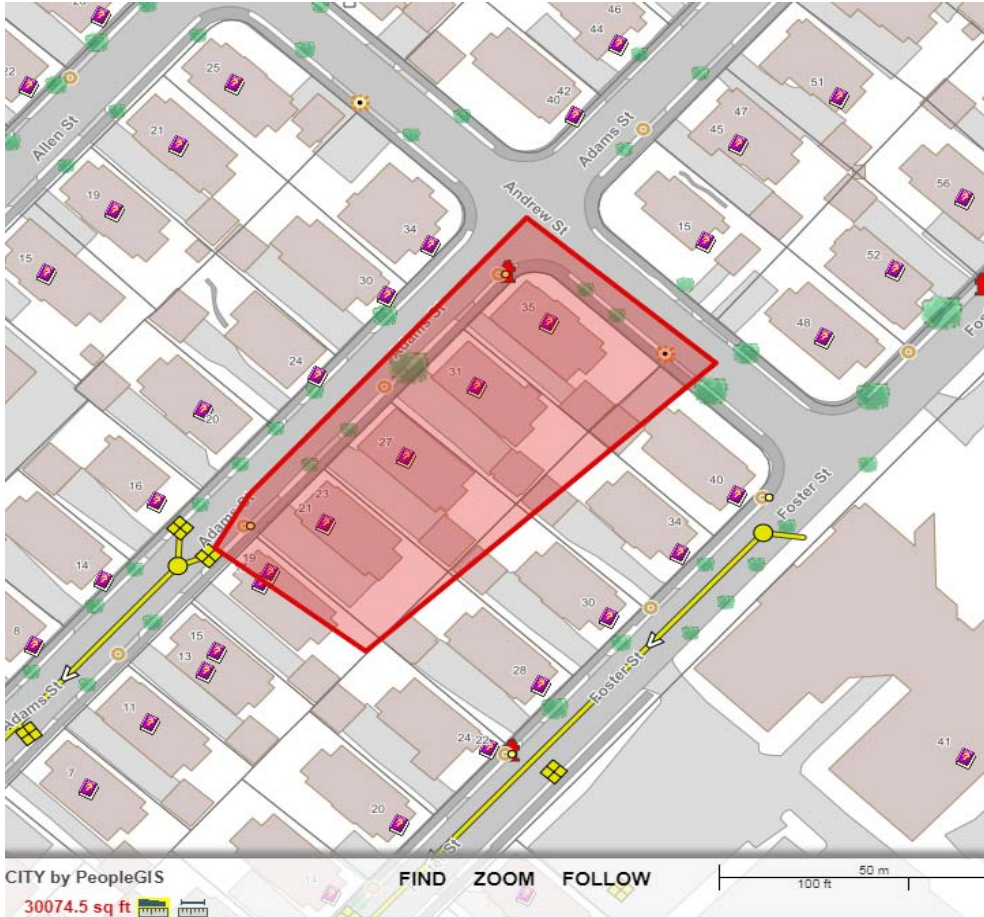
BMP ID: **2021ST#19**
 Location: 17 Adams Street
 Watershed Area: 30075 sf = 0.69 ac.
 % Impervious Cover: 70% Multi-Family High Density Residential
 BMPType: Street Trench
 Infiltration Rate: 2.41 in/hr

Location 17 Adams Street
 Watershed Area: 0.69 acres
 BMP Type: Street Trench
 L = 17 feet
 W = 3 feet
 D = 2 feet
 P removal = 0.67 lb/yr
 N removal = 4.04 lb/yr
 TSS Removal = 171.65 lb/yr
 Vol. Reductic = 101.00 cf

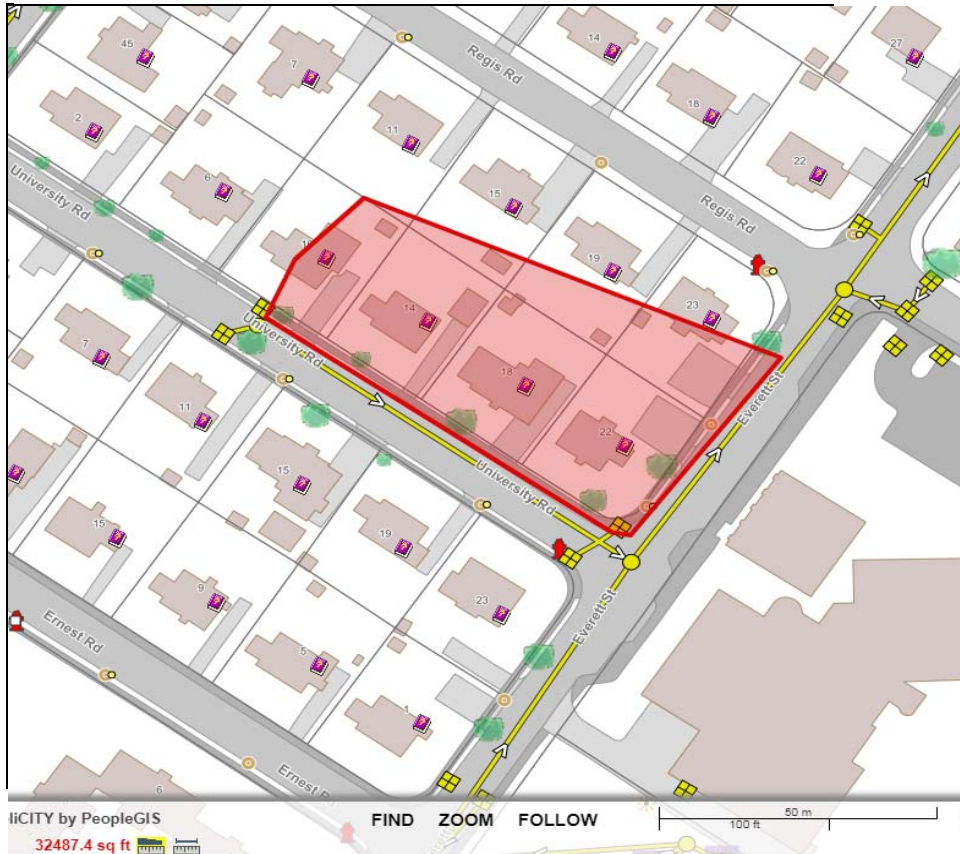
Location 22 University Road

BMType: Street Trench

Infiltration Rate: 2.41 in/hr

Watershed Area: 0.75 acres

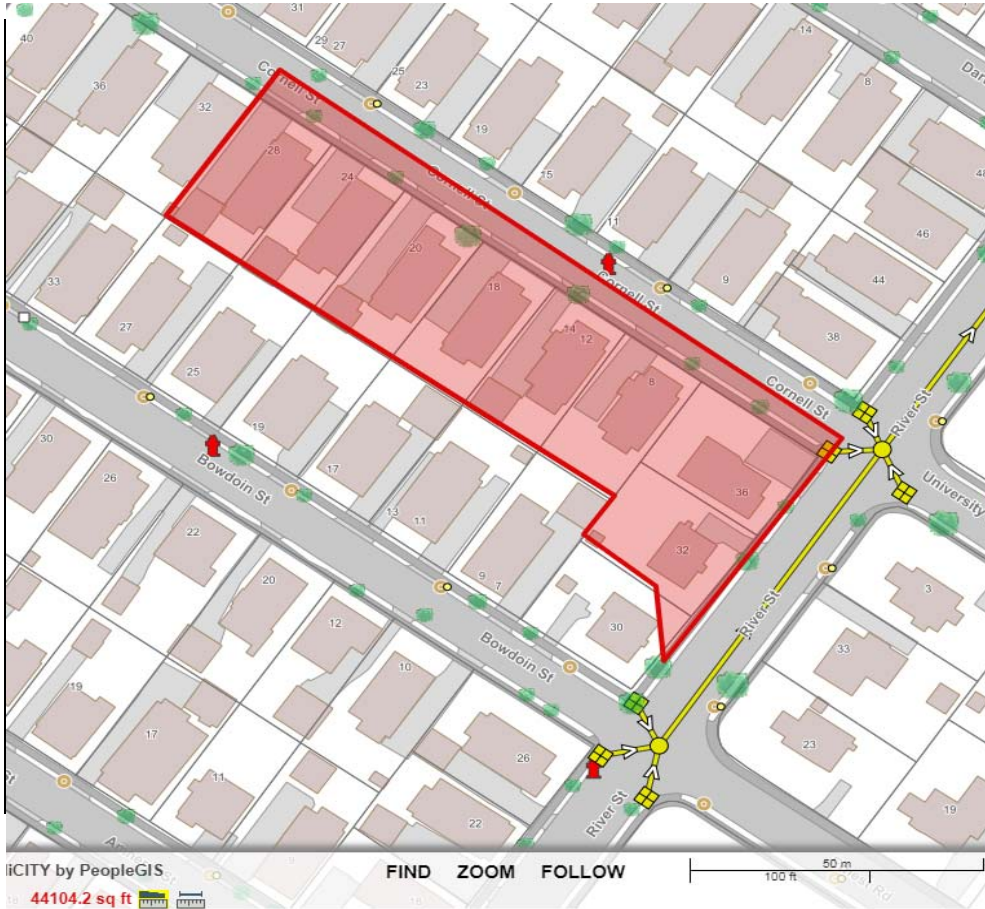
Location 36 River Street

BMPTyp: Street Trench

Infiltration Rate: 2.41 in/hr

Watershed Area: 1.01 acres

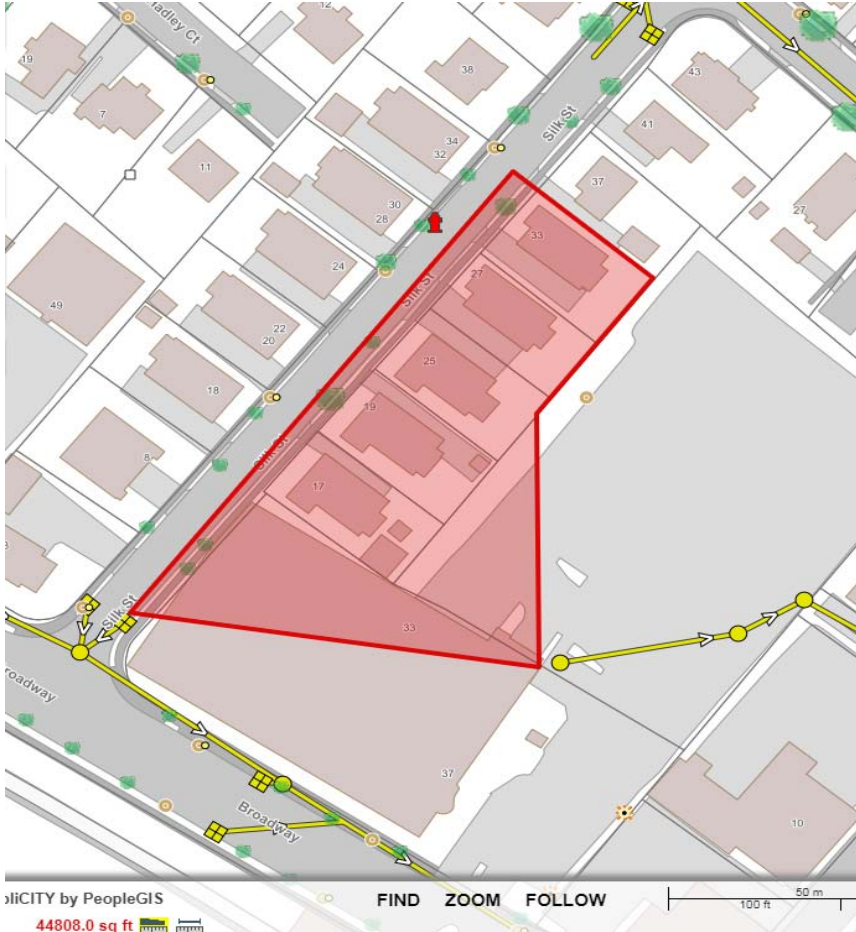
Location 37 Broadway

BMPTyp: Street Trench

Infiltration Rate: 2.41 in/hr

Watershed Area: 1.03 acres

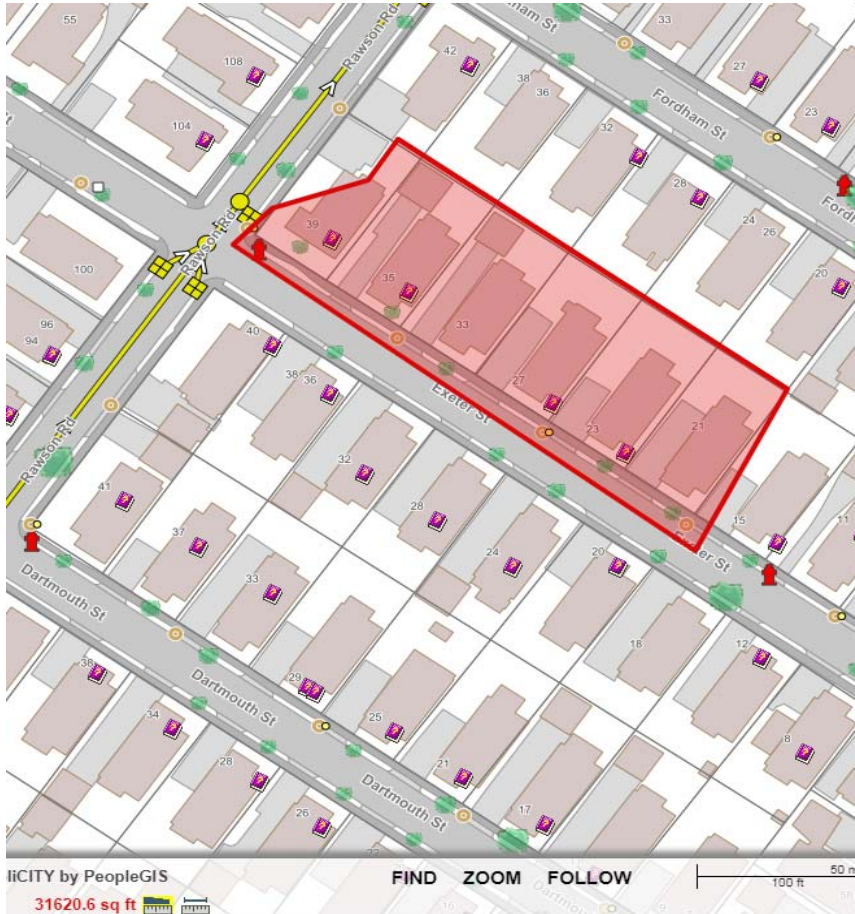
BMP ID: **2021ST#11**
 Location: 39 Exeter Street
 Watershed Area: 31621 sf = 0.73 ac.
 % Impervious Cover: 70% Multi-Family High Density Residential
 BMPType: Street Trench
 Infiltration Rate: 2.41 in/hr

Location 39 Exeter Street
 Watershed Area: 0.73 acres
 BMP Type: Street Trench
 L = 18 feet
 W = 3.5 feet
 D = 2 feet
 P removal = 0.77 lb/yr
 N removal = 4.62 lb/yr
 TSS Removal = 190.61 lb/yr
 Vol. Reductic = 116.00 cf

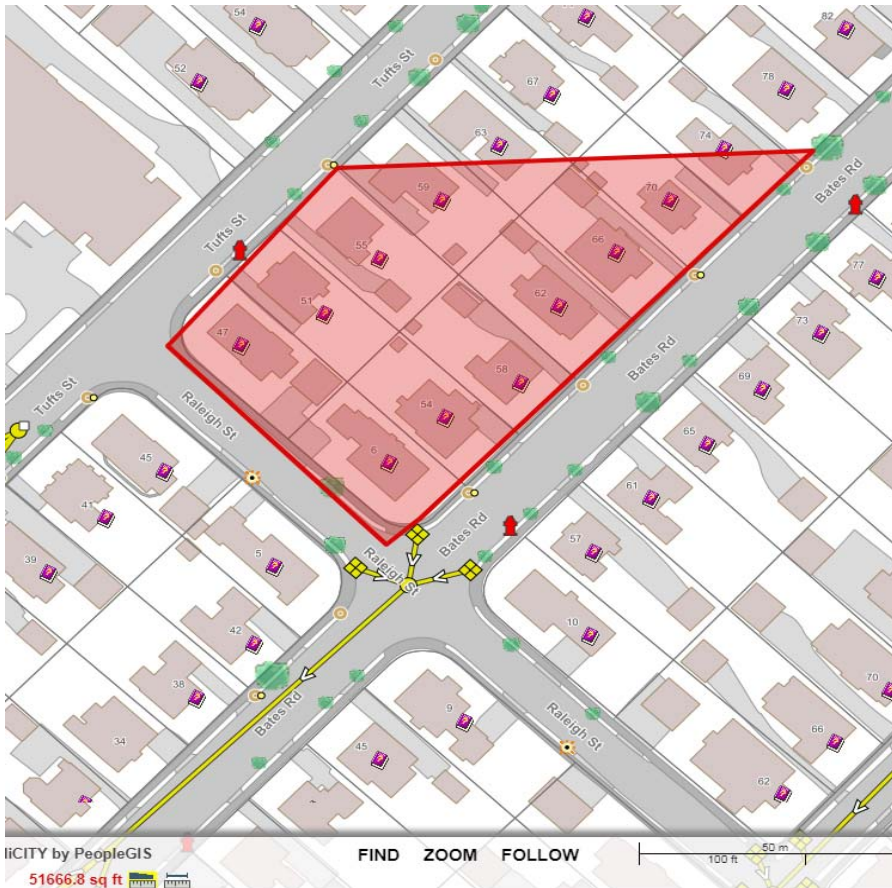
BMP ID: **2021ST#14**
 Location: 6 Raleigh Street
 Watershed Area: 51666 sf = 1.19 ac.
 % Impervious Cover: 70% Multi-Family High Density Residential
 BMPType: Street Trench
 Infiltration Rate: 2.41 in/hr

Location 6 Raleigh Street

Watershed Area: 1.19 acres
 BMP Type: Street Trench
 L = 15 feet
 W = 3 feet
 D = 2.67 feet
 P removal = 0.91 lb/yr
 N removal = 5.54 lb/yr
 TSS Removal = 245.65 lb/yr
 Vol. Reductic = 139.00 cf

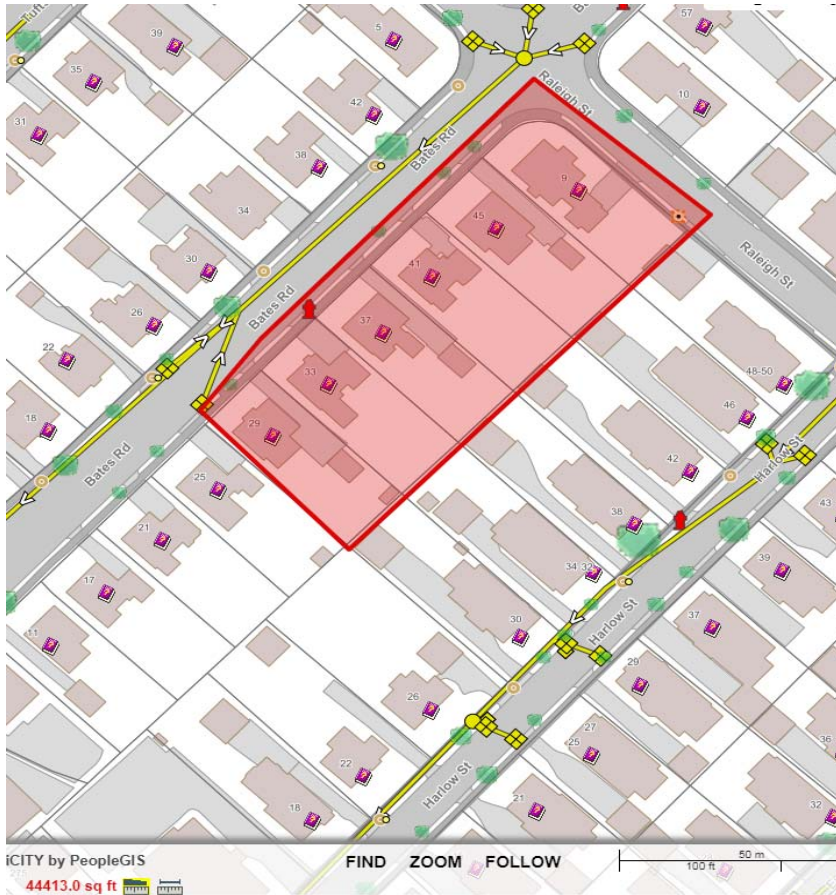
BMP ID: **2021ST#17**
 Location: 29 Bates Road
 Watershed Area: 44413 sf = 0.69 ac.
 % Impervious Cover: 70% Multi-Family High Density Residential
 BMPType: Street Trench
 Infiltration Rate: 2.41 in/hr

Location 29 Bates Road

Watershed Area: 0.69 acres
 BMP Type: Street Trench
 L = 15 feet
 W = 3 feet
 D = 2.67 feet
 P removal = 0.88 lb/yr
 N removal = 5.32 lb/yr
 TSS Removal = 233.64 lb/yr
 Vol. Reductic = 133.00 cf

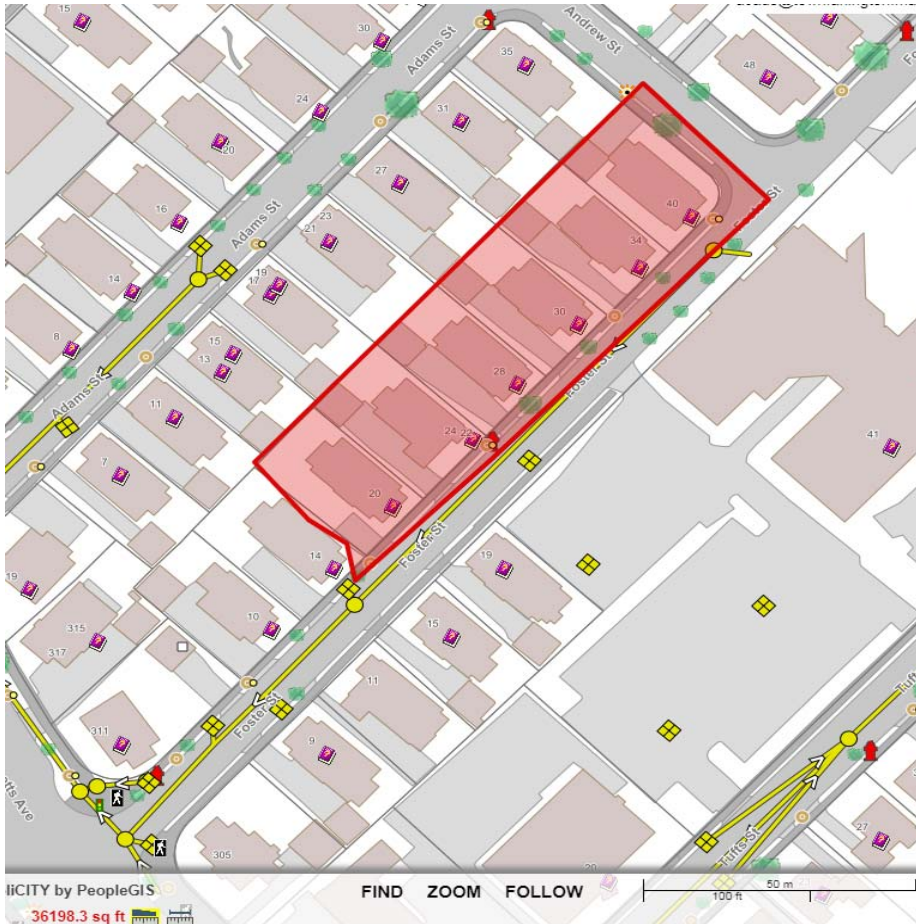
Location 14 Foster Street

BMType: Street Trench

Infiltration Rate: 2.41 in/hr

Watershed Area: 0.83 acres

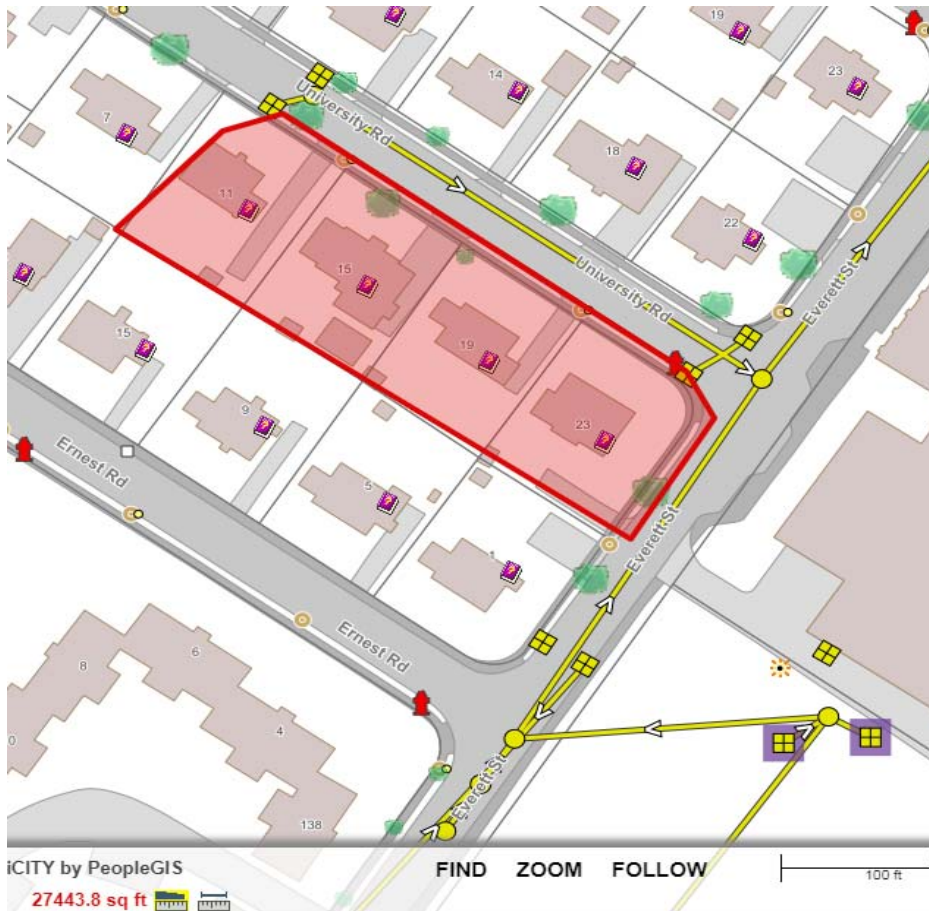
Location 23 University Road

BMPTyp: Street Trench

Infiltration Rate: 2.41 in/hr

Watershed Area: 0.63 acres

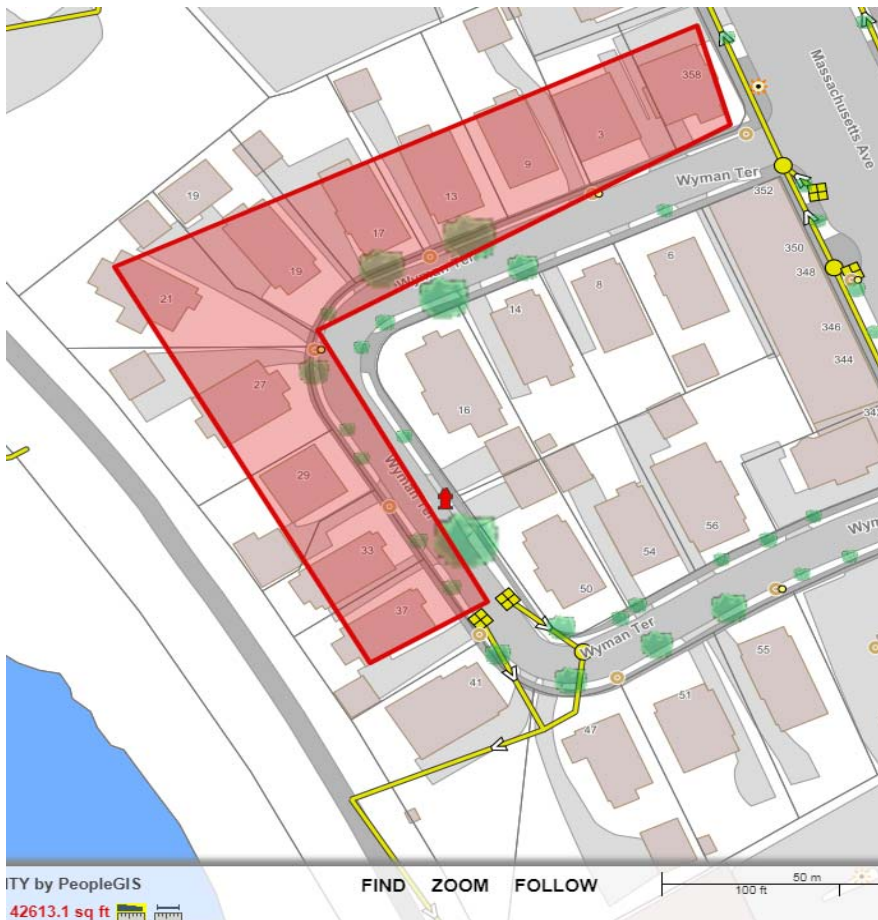
Location 37 Wyman Terrace

BMPTyp: Street Trench

Infiltration Rate: 2.41 in/hr

Watershed Area: 0.98 acres

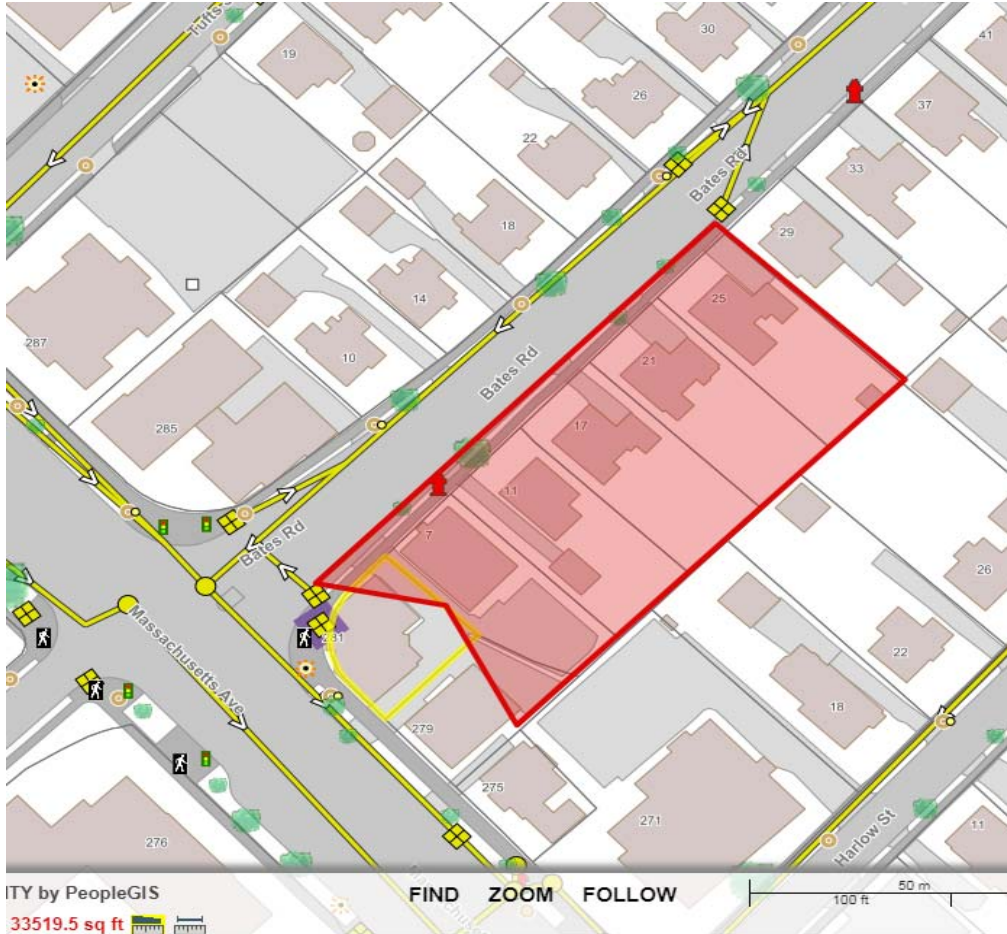
Location 281 Massachusetts Avenue

BMPTyp: Street Trench

Infiltration Rate: 2.41 in/hr

Watershed Area: 0.77 acres

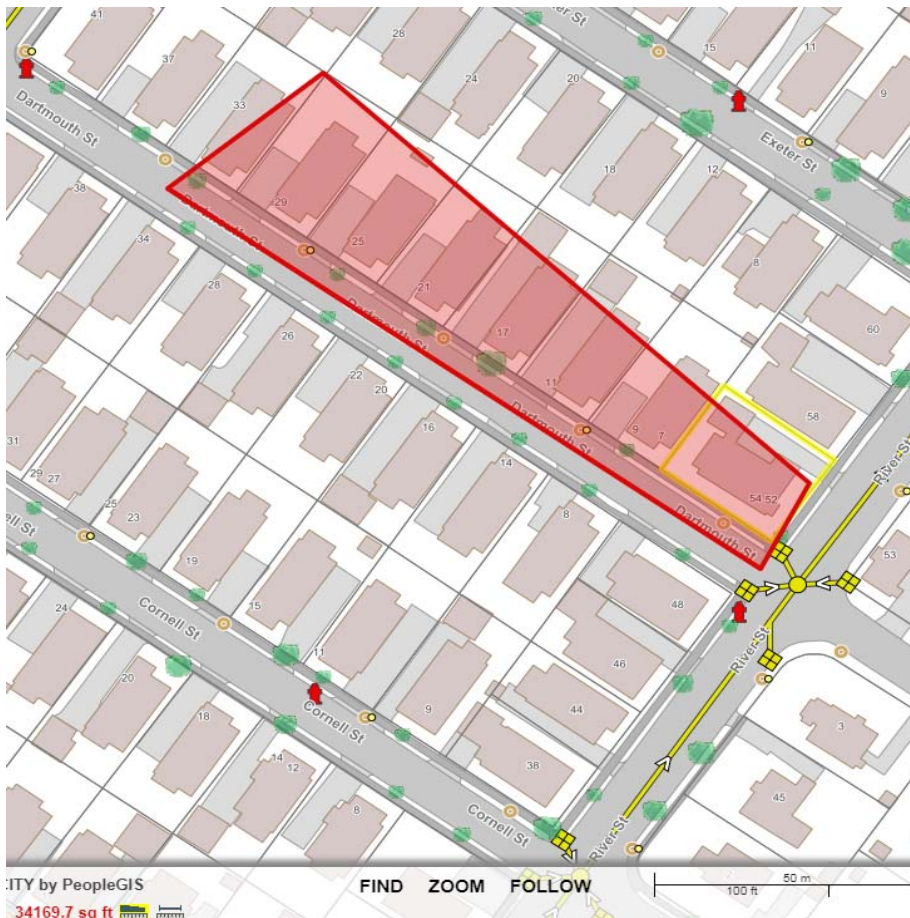
Location 54 River Street

BMPTyp: Street Trench

Infiltration Rate: 2.41 in/hr

Watershed Area: 0.78 acres

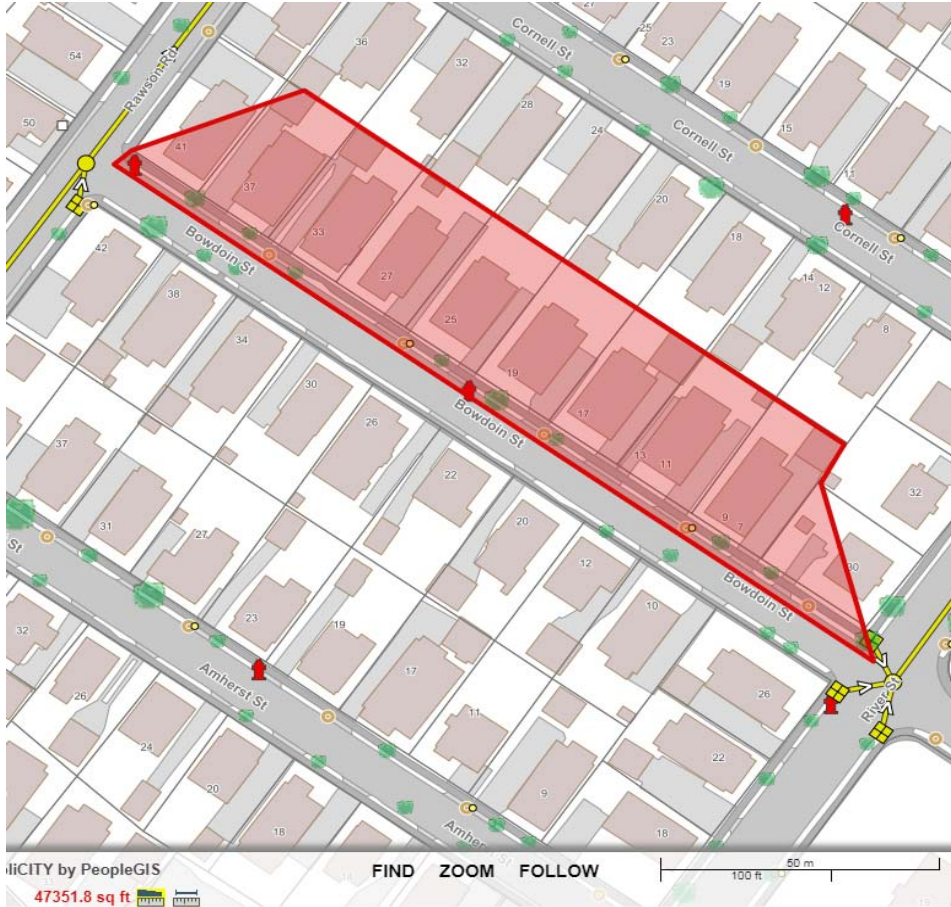
BMP ID: **2021ST#6**
 Location: 30 River Street
 Watershed Area: 47352 sf 1.09 ac.
 % Impervious Cover: 70% Multi-Family High Density Residential
 BMPType: Street Trench
 Infiltration Rate: 2.41 in/hr

Location 30 River Street

Watershed Area: 1.09 acres

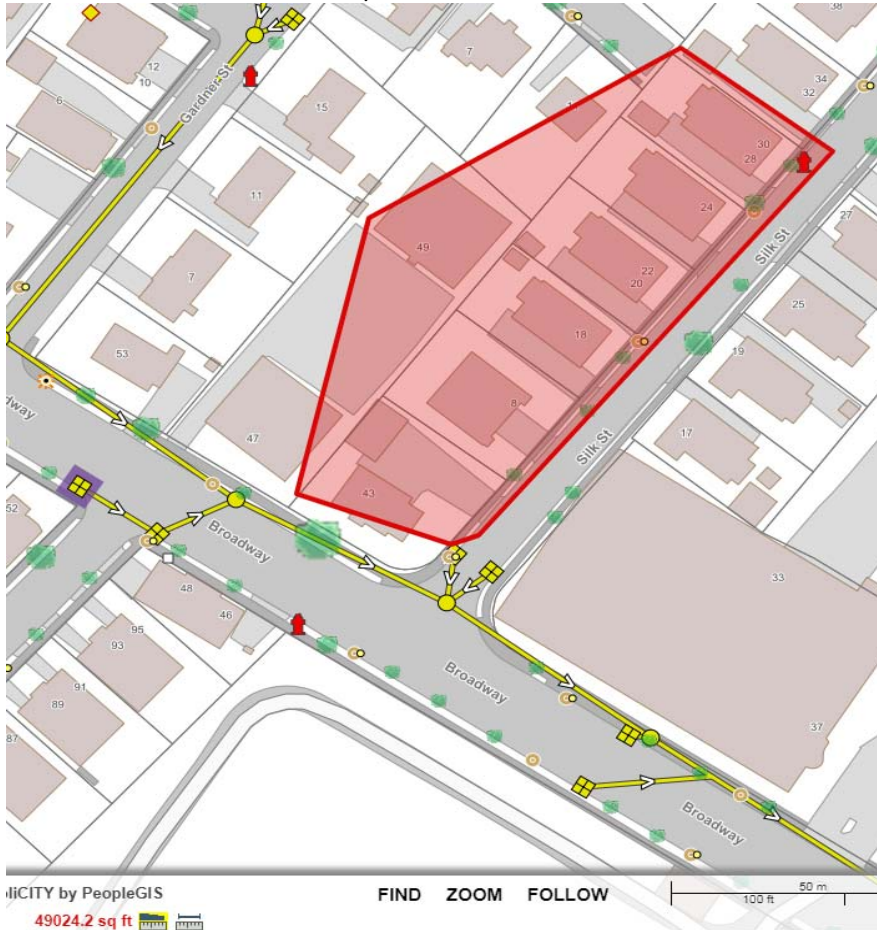
Location 43 Broadway

BMPTyep: Street Trench

Infiltration Rate: 2.41 in/hr

Watershed Area: 1.13 acres

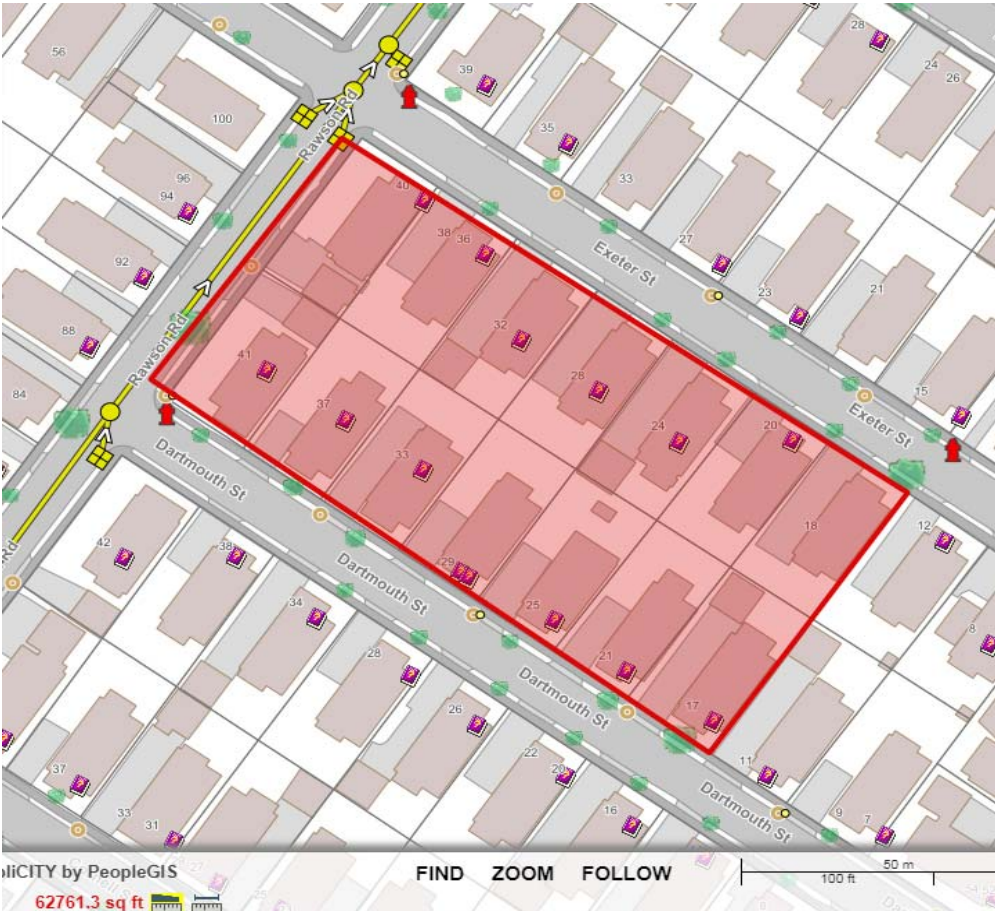
Location 40 Exeter Street
Watershed Area: 1.44 acres

BMPType: Street Trench

Infiltration Rate: 2.41 in/hr

BMP Type: Street Trench

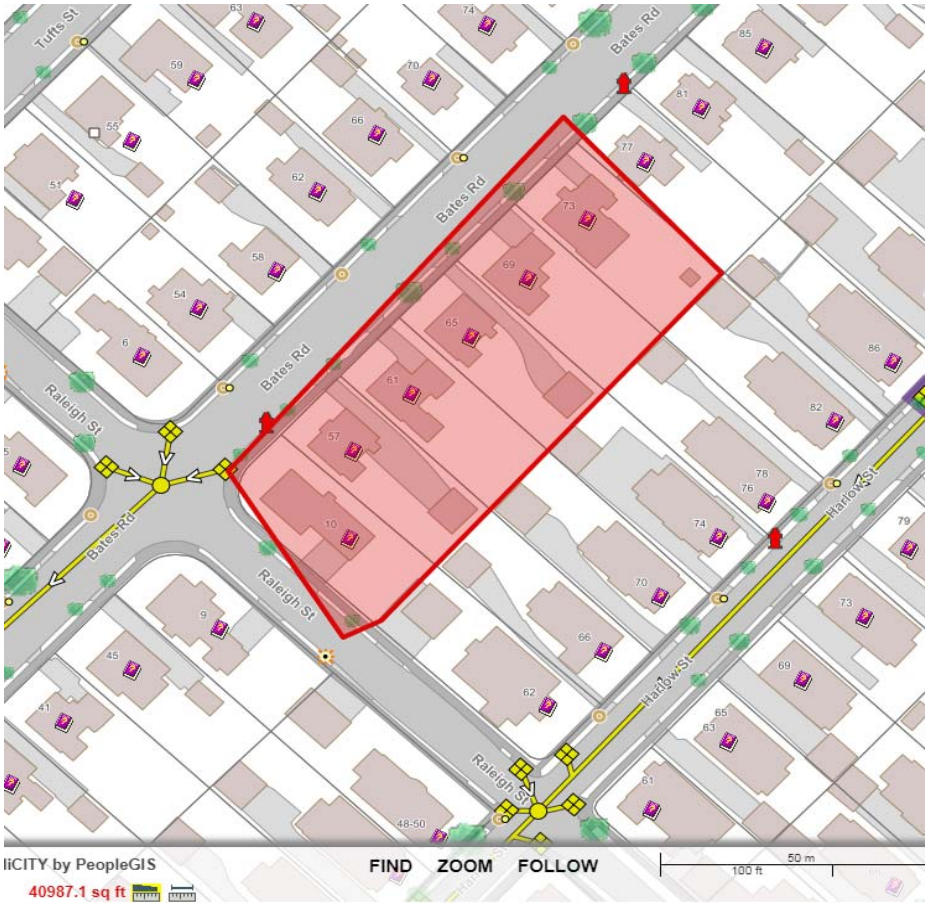
Location 10 Raleigh Street

BMPType: Street Trench

Infiltration Rate: 2.41 in/hr

Watershed Area: 0.94 acres

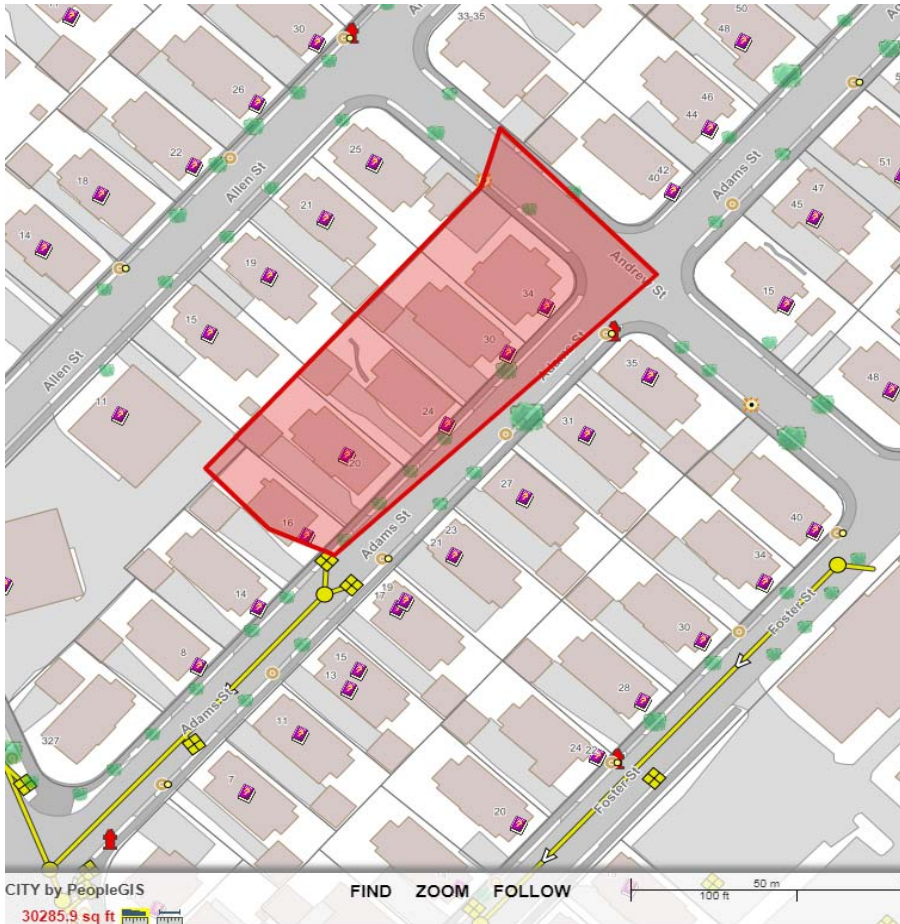
Location 16 Adams Street

BMPTyp: Street Trench

Infiltration Rate: 2.41 in/hr

Watershed Area: 0.70 acres

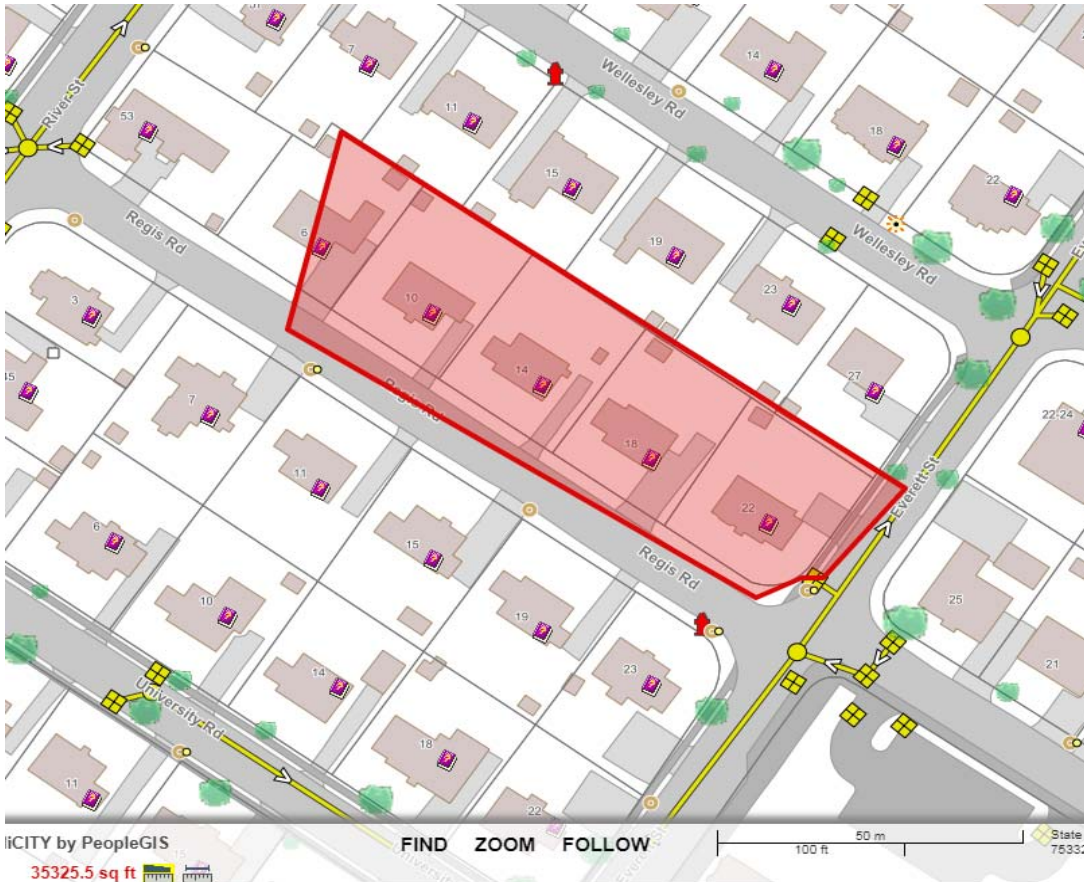
Location 22 Regis Road

BMPTyp: Street Trench

Infiltration Rate: 2.41 in/hr

Watershed Area: 0.81 acres

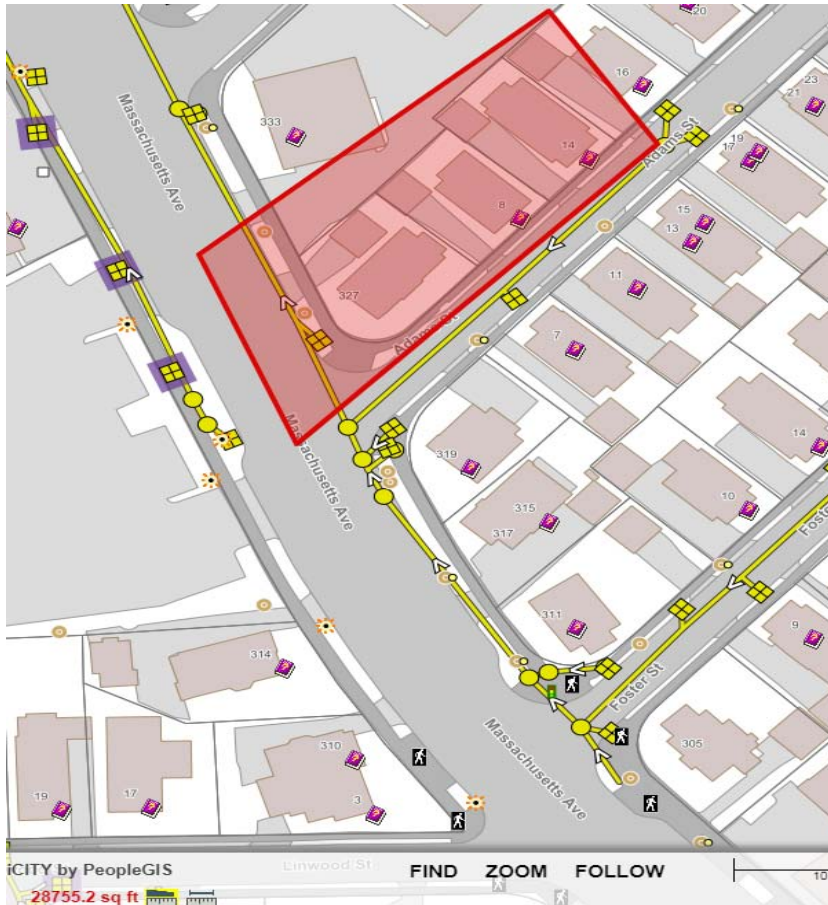
Location 327 Massachusetts Avenue

BMPTyep: Street Trench

Infiltration Rate: 2.41 in/hr

Watershed Area: 0.66 acres
