SUBJECT: Project Manager/DPW Facility Renovation

ADDENDUM NO. 1

Town of Arlington, Massachusetts Department of Public Works Town Yard - Existing Conditions Study

Revised Report

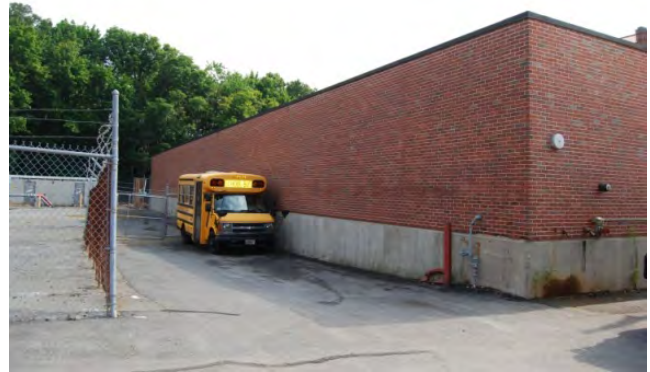
School bus parked in the gas company easement.

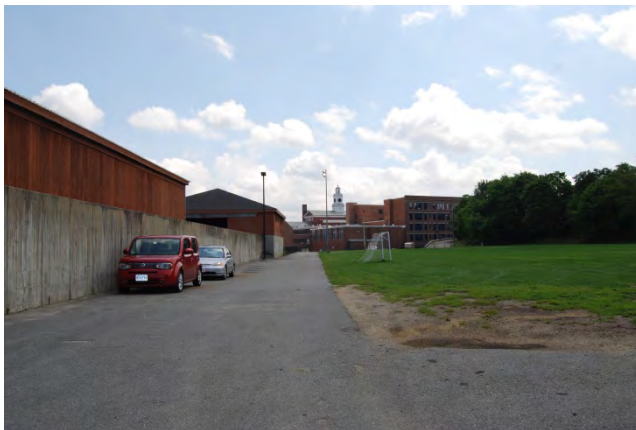
The site shares a border with the athletic fields of the Arlington High School and is an easy access point for students walking to school. This generates significant student pedestrian and bicycle traffic across the DPW site, primarily at the beginning and end of the school day, a situation which is dangerous for the students and a potential liability for the DPW. In addition to serving as a student short cut, the DPW's employee parking lot is used unofficially as a drop off point for parents in the morning and pick up point in the afternoon. The less intense traffic on Grove Street, when compared to Massachusetts Avenue, makes this an inviting spot for parents, but creates cross traffic in the DPW parking lot at the same time that many trade staff are leaving for their work assignments.

Path from the DPW to the high school athletic fields.

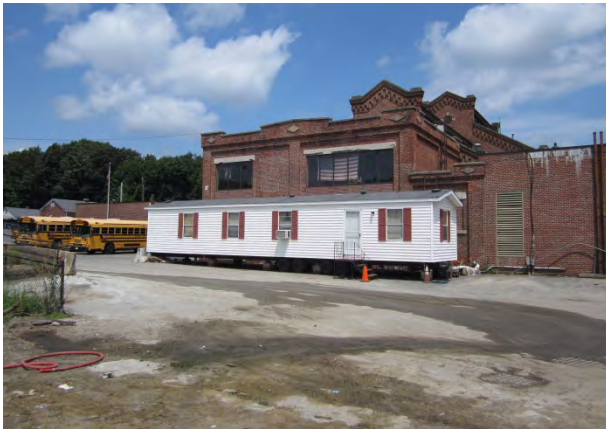
renovation. During this time, the fire company used several maintenance bays for their trucks and the staff used the trailer as their on-call site. While the fire department has returned to their fire house, the trailer has been left behind, occupying a portion of the site that is key to efficient circulation. No plans have been made to remove the trailer as of the time of the site assessment.

Construction trailer left on the site by the AFD.

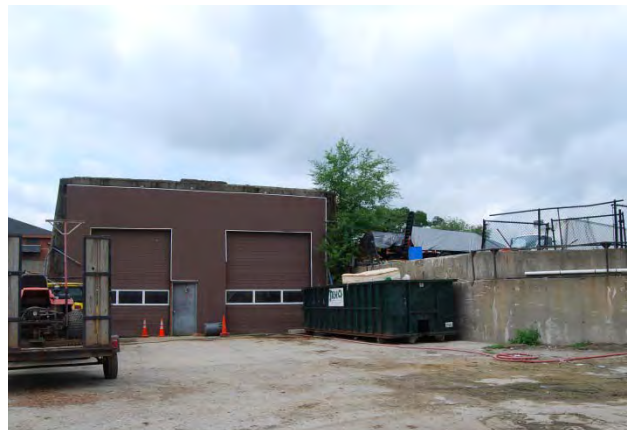
In the 1977 site rehabilitation, a transfer station was built on the site which has since been decommissioned. It is no longer in use with the exception of a CRT television drop off, organized by the DPW. Currently these televisions are left in the middle of the site and not in an organized and covered space. Much of the transfer station has been removed but a single metal panel building that is built into slope of the site around it is still in place as well as open concrete dividers used by the DPW for mulch and other natural storm waste, and the concrete vault which housed the vehicle scale. The transfer station remnants are an impediment to more effective use of that portion of the Yard.

Remaining Transfer Station structure

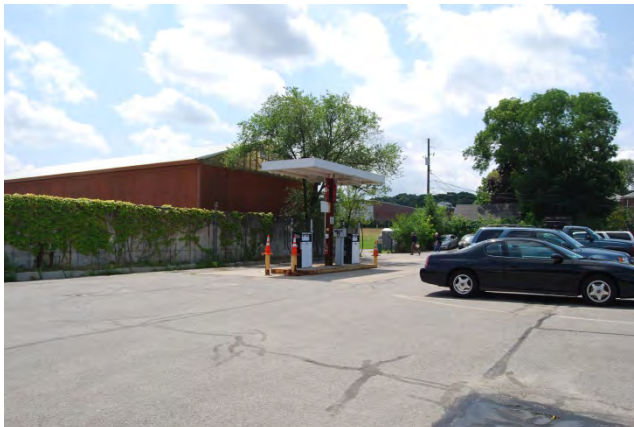
The DPW maintains a fuel island in the employee parking area that serves as a fueling point for all town vehicles. The existing canopy coverage is minimal, and doesn't provide adequate weather protection, creating safety issues with icing during the cold months.

Fuel island located within employee parking lot.

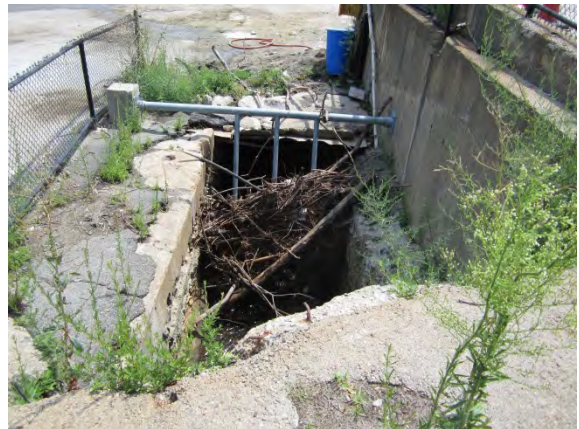
Debris grille in Mill Brook culvert opening.

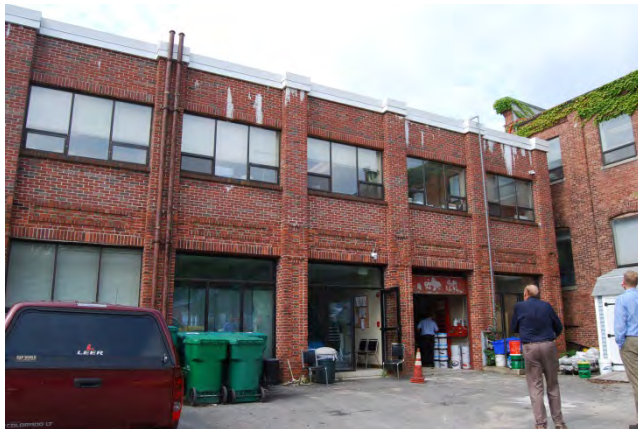
Leaching bricks on the rear of the building.

The masonry and its mortar are in good condition though instances of efflorescence indicate moisture within the walls, typically at copings or roof flashing. The DPW is currently working to remediate this issue.

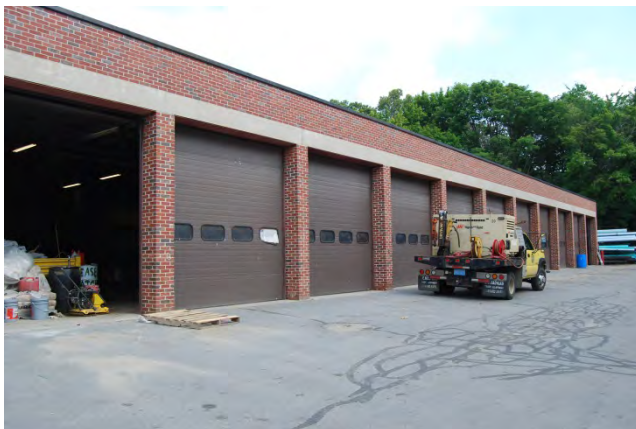
Building C

Building C: This twelve bay garage was constructed in brick and concrete when the site changed hands from the Arlington Gas Company to the Town of Arlington. The building is used mostly for snow fighter storage and has little wear to its envelope. There is some evidence of brick efflorescence but both mortar and bricks are in good condition. Some of the vision panels on the overhead doors, which are not insulated, need replacement and are temporarily covered.

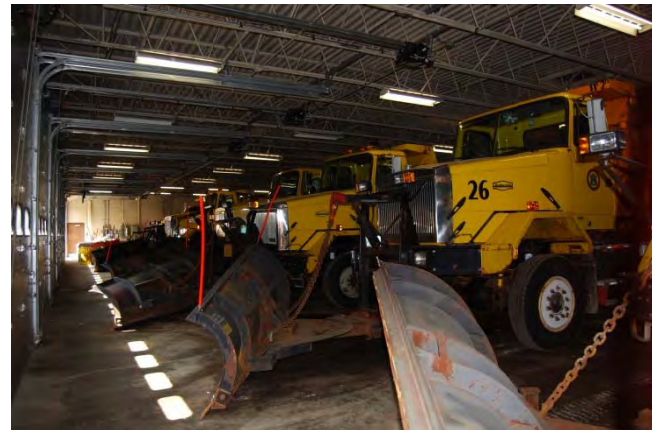
Lighting: Building C's lighting consists primarily of fluorescent, high-bay type fixtures.

Overhead lighting in Building C.

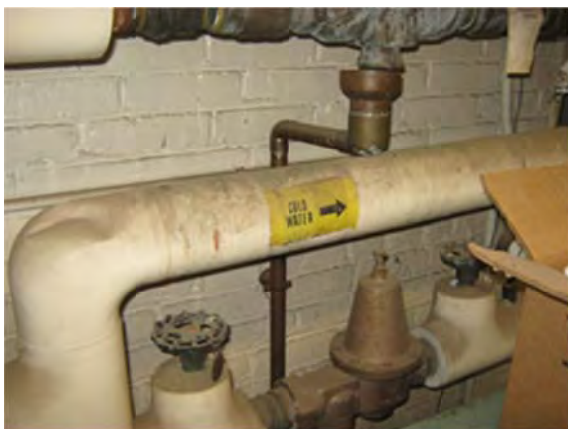
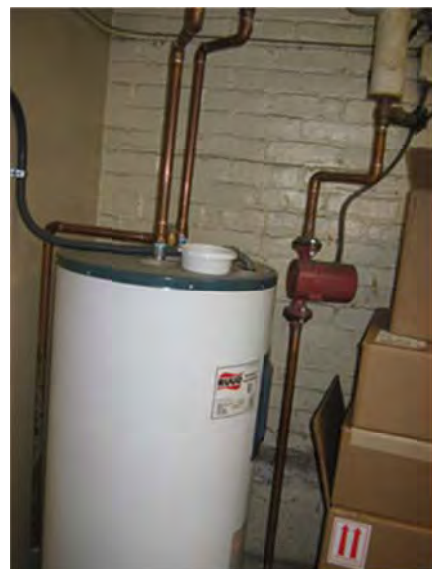
Numerous electric water heaters provide water to hand sinks and fixtures throughout the site.

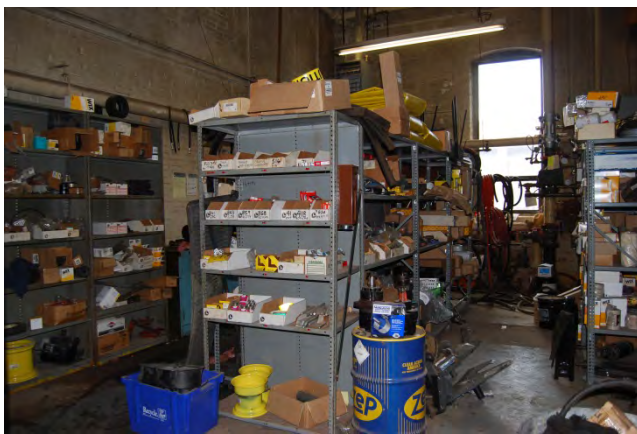
Based on observations made during site visits and interviews with staff, it is has been concluded that the parts inventory for the facility well exceeds what is necessary to operate. There exists no inventory management system or means to process warranty claims when needed. The large parts storage room is unorganized and there is no way of knowing if the parts are all relevant to current vehicles within the fleet. Throughout the facility, especially in the upper levels of Building D, a large number of spare parts are strewn about and left in the open. These parts represent a high monetary value, well in excess of \$150,000. Due to the aforementioned site security issues, these parts are at risk for being lost, ruined or stolen from the property.

Parts Room on Level 1 of Building D.

It is recommended that with the assistance of local vendors, such as NAPA auto parts, that an inventory of parts be completed and much of the stock sold or auctioned off to reduce clutter and generate income. Establishing a relationship with an auto parts vendor will help streamline the ordering process and keep parts inventory closer to the recommended valuation of \$50,000 for a fleet of this size.
