TOWN OF ARLINGTON
REQUEST FOR DESIGNER Qualifications (RFQ)

RFQ #17-43
Department of Public Works Renovation/Addition
AUGUST 3, 2017

Town of Arlington, Massachusetts Department of Public Works Town Yard - Existing Conditions Study

Re: Arlington DPW Facility Existing Conditions Study
51 Grove Street

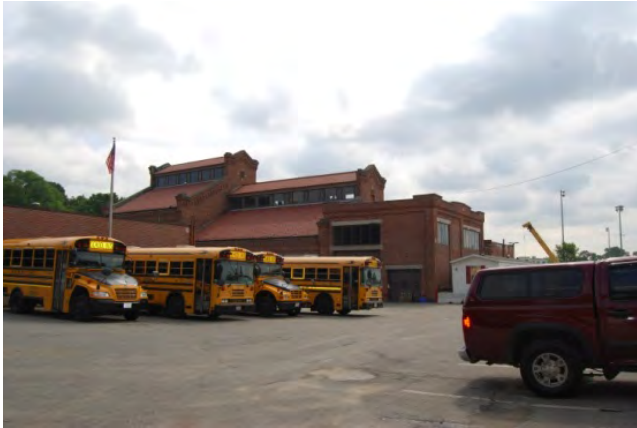
The presence of these non-DPW vehicles on the site creates a crowding and traffic flow problem, as well as a security vulnerability. The site is left unlocked during the weekends to allow bus drivers access to their vehicles. Bus drivers also park on the site in the DPW employee parking area in the morning and afternoon during their regularly scheduled routes. This takes away DPW employee parking, resulting in employee

School buses parked on the site.

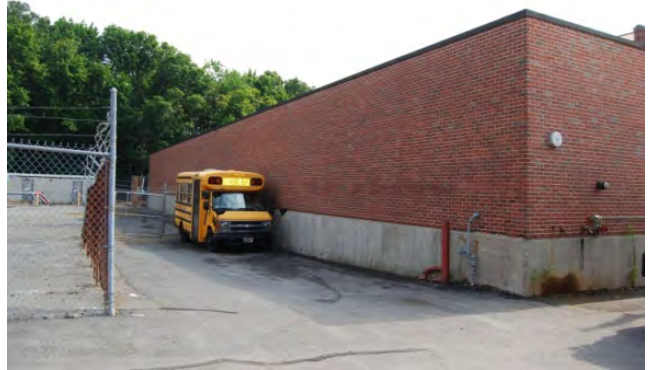
School bus parked in the gas company easement.

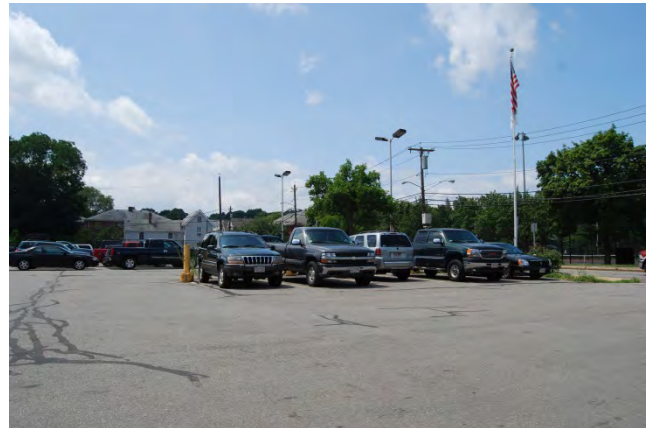
The site shares a border with the athletic fields of the Arlington High School and is an easy access point for students walking to school. This generates significant student pedestrian and bicycle traffic across the DPW site, primarily at the beginning and end of the school day, a situation which is dangerous for the students and a potential liability for the DPW. In addition to serving as a student short cut, the DPW's employee parking lot is used unofficially as a drop off point for parents in the morning and pick up point in the afternoon. The less intense traffic on Grove Street, when compared to Massachusetts Avenue, makes this an inviting spot for parents, but creates cross traffic in the DPW parking lot at the same time that many trade staff are leaving for their work assignments.

Employee parking area used as a student drop-off.

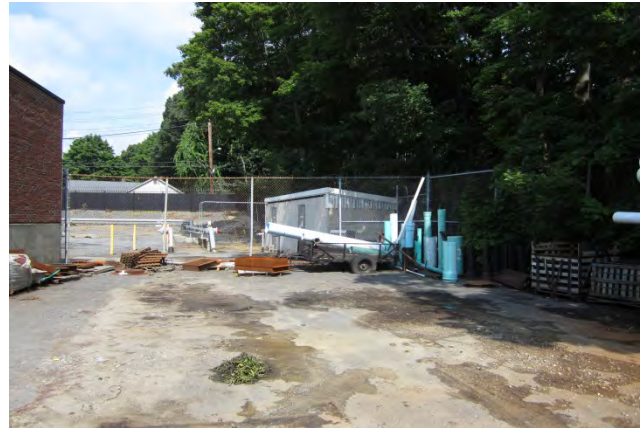
The North East corner of the site borders with a property that remains in the hands of National Grid along Grove Street. Periodically, an 18 wheel tractor trailer backs into the DPW Yard via a legal easement to deposit gas odorant, requiring the site to be relatively clear and open for its arrival. This access is complicated by the presence of school buses and various non-departmental vehicles.

Easement allows access for odorant deposit.

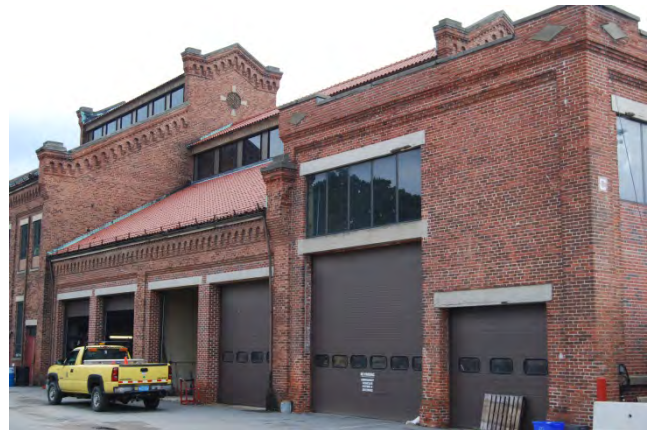
Good tile condition on the North side of the building.

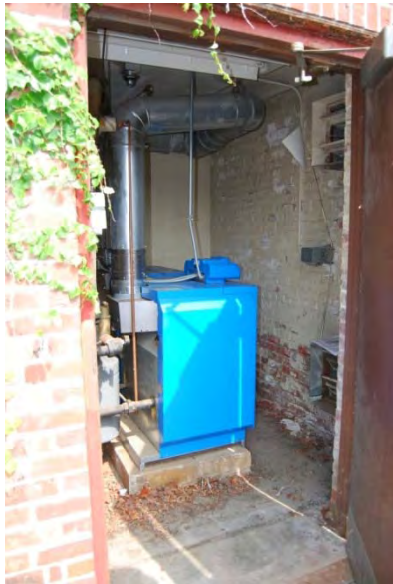
HVAC Systems: The offices of Building A are served by a single zone, gas fired, packaged DX roof top unit (RTU) that provides both heating and cooling throughout the second floor. The RTU is operational and was part of renovation in the late 1990s. In addition to the RTU, a hot water heating system, via gas fired boiler, provides heat to the street level shop and storage areas, as well as supplemental heat to the 2nd floor offices. The shop areas are provided with several hot water unit heaters. All hot water piping appears to be 50 to 60-years-old. There are two Buderus boilers allowing one to serve as a back-up in case of failure.

Building A's boilers

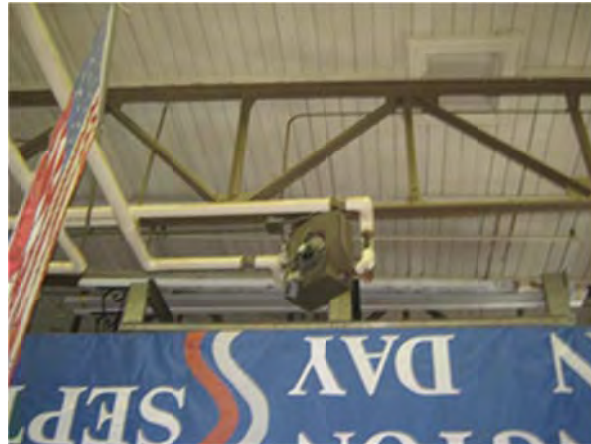
Heaters located in the Sign Shop of Building A

The sign and sewer shops are not equipped with any kind of ventilation system for adequate exhaust of shop dust or paint fumes. Storage areas are partially below grade, with noticeably high humidity and are also not equipped with ventilation.

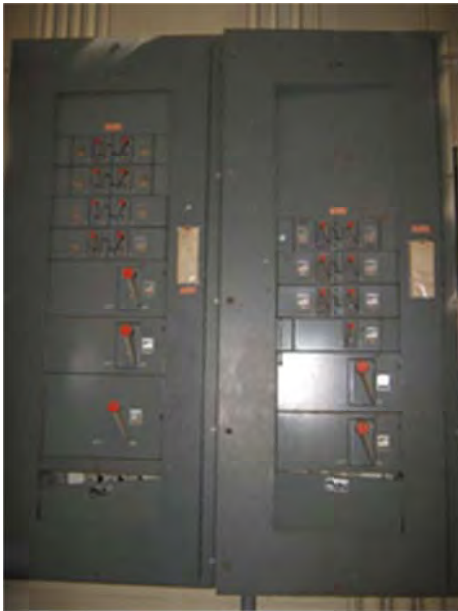
Electrical panels located in Building B.

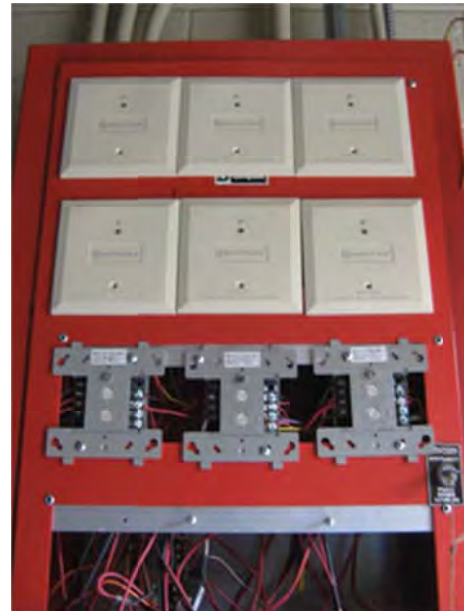
Fire Alarm panels located in Building B.

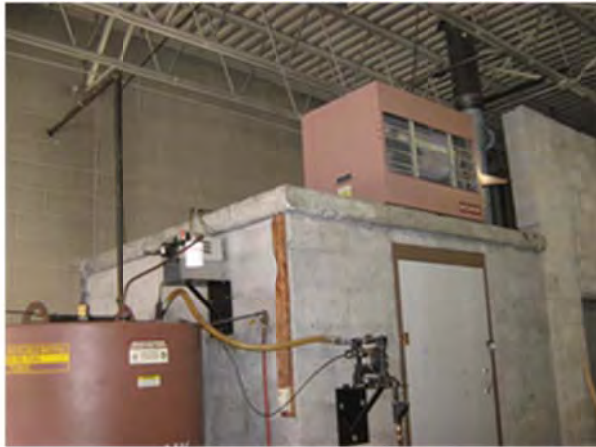
Waste Oil Heater in Building C

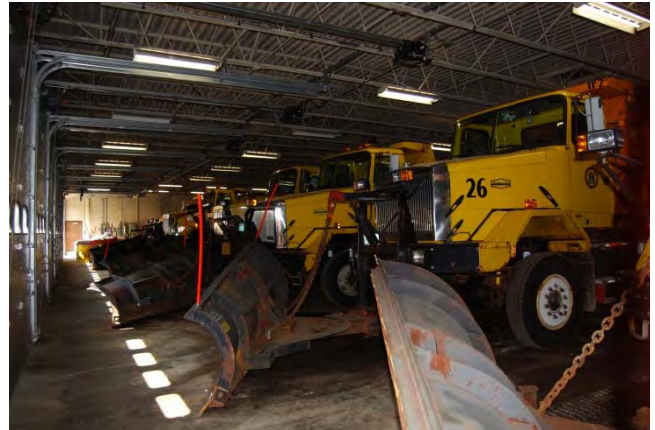
Overhead lighting in Building C.

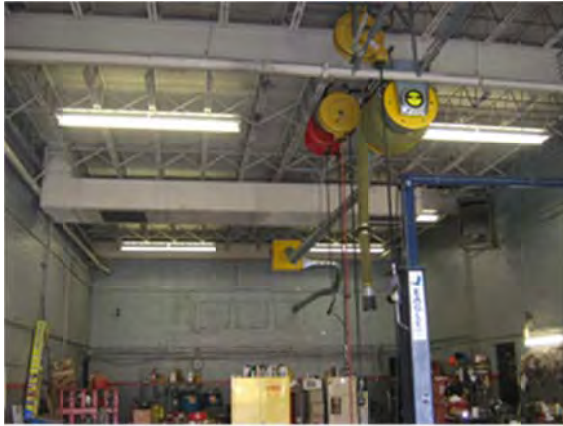
The maintenance bays used for vehicle maintenance are equipped with vehicle exhaust systems. The exhaust fans are operational. The bay areas do not have carbon monoxide / dioxide monitoring tied into control of rooftop exhaust fans. The Second floor stair areas are provided with heat only and no

Vehicle Exhaust and Ductwork

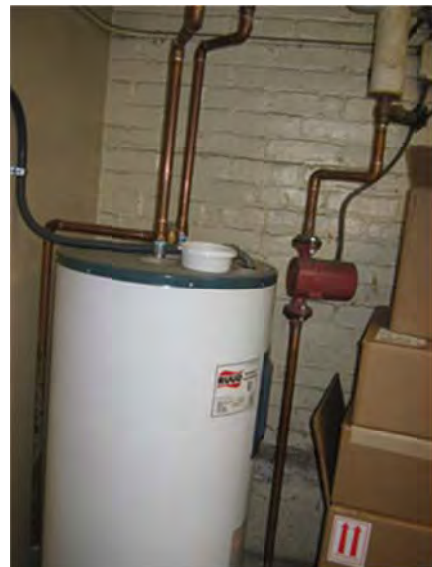
Numerous electric water heaters provide water to hand sinks and fixtures throughout the site.

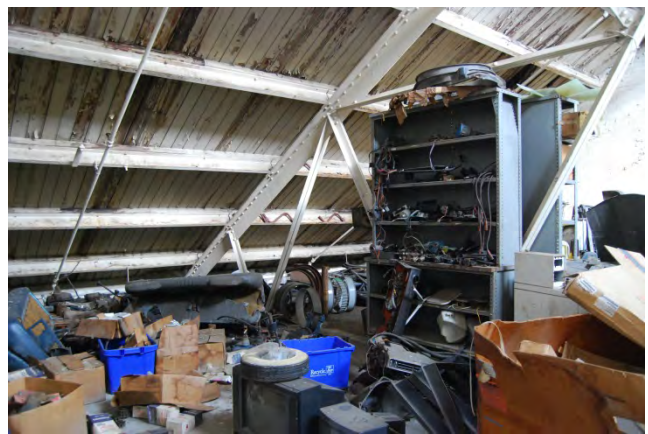
Based on observations made during site visits and interviews with staff, it is has been concluded that the parts inventory for the facility well exceeds what is necessary to operate. There exists no inventory management system or means to process warranty claims when needed. The large parts storage room is unorganized and there is no way of knowing if the parts are all relevant to current vehicles within the fleet. Throughout the facility, especially in the upper levels of Building D, a large number of spare parts are strewn about and left in the open. These parts represent a high monetary value, well in excess of \$150,000. Due to the aforementioned site security issues, these parts are at risk for being lost, ruined or stolen from the property.

Miscellaneous parts and equipment on Level 2 of Building D.

It is recommended that with the assistance of local vendors, such as NAPA auto parts, that an inventory of parts be completed and much of the stock sold or auctioned off to reduce clutter and generate income. Establishing a relationship with an auto parts vendor will help streamline the ordering process and keep parts inventory closer to the recommended valuation of \$50,000 for a fleet of this size.

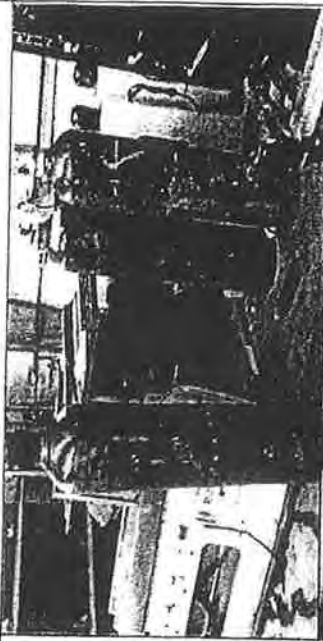
| Recommendation Number | Location | Recommendation | Date Completed or Action Planned | Photo Documentation |
|---|---|--|--|--|
| 2011-10-09 | Public Works | To prevent potential injury to staff, compressed air tanks should be secured together and against a wall | WE STORED THIS BACK IN PLACE | |

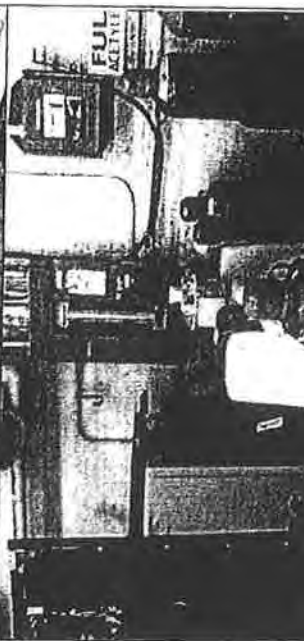
| Recommendation Number | Location | Recommendation | Date Completed or Action Planned | Photo Documentation |
|---|---|--|--|--|
| 2011-10-10 | Public Works | To reduce fire potential and ensure prompt access to panels, items should not be stored within 36 inches of the electrical panel in the mechanic's bay | WE WILL MOVE THIS STOCK TO THE OTHER SHOP. WILL BE DONE DEC. 9, 2011 | |
