Town of Arlington Minuteman Bikeway Planning Project

INTRODUCTION

APPENDIX A: EXISTING CONDITIONS

APPENDIX B: BRIDGE OVER ALEWIFE BROOK ASSESSMENT

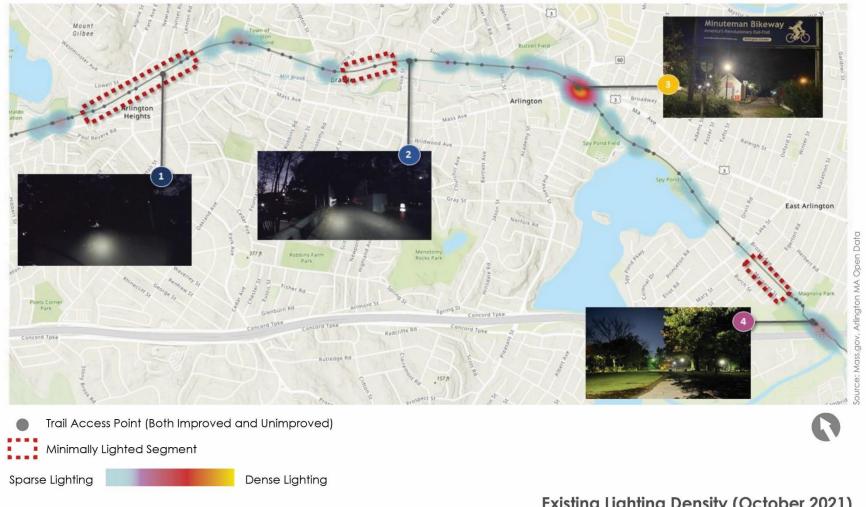
Figure 9: Existing Lighting Density

Lighting along the Bikeway is generally sparse. Notable lighting along or adjacent to the Bikeway is found at the following locations in **Table 6**. Relevant photos are referenced in **Table 7**. Existing lighting density is illustrated in **Figure 9**, which shows lighting density along the path from sparse to densely lit areas. Minimally lighted segments are large stretches of the path where no adjacent lighting was observed or adjacent lighting may be present but illuminance (amount of light striking a surface, such as pavement) is minimized by vegetation, topography and other trailside features.

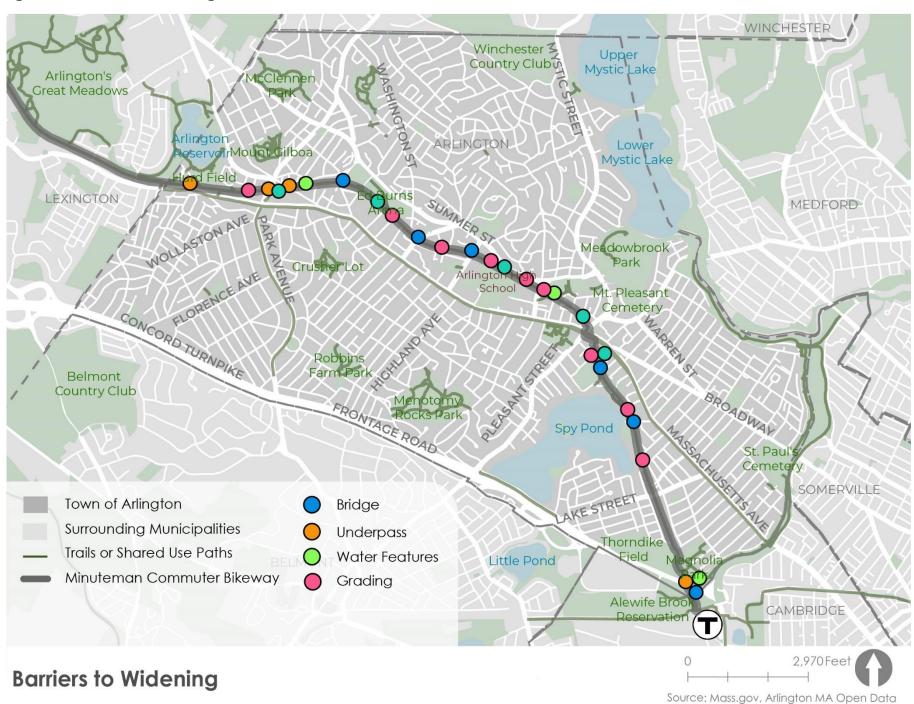
Figure 11: Barriers to Widening

The feasibility of widening depends on several factors. Primarily, as mentioned previously, the ability to widen within the MBTA right of way depends on coordination with and approval by the MBTA. Feasibility is also dependent on existing barriers, such as grade-separated crossings like bridges or underpasses, water features, adjacent property lines, and grading. Depending on the unique characteristics of these barriers, they may be more or less of an obstruction to widening. For example, if the existing paved Bikeway is constrained by adjacent property that belongs to the Town, widening in that direction may be feasible. A summary of the main types of barriers is provided in **Table 21**. Relevant photos are referenced in **Table 22**. The locations of barriers to widening are shown in **Figure 11**. A segment-by-segment summary of the barriers and locations can be found in **Appendix A**.
