# STORMWATER – KEEPING IT CLEAN!

ARLINGTON, MASSACHUSETTS

Presented by Robert Descheneau, P.E.  
Fay, Spofford & Thorndike

- Arlington Storm Drain and Sanitary Sewer
- Evolution of the Illicit Discharge Detection & Elimination Program (IDDE)
- Stormwater Sampling & Analysis – Methods and implementation
- Investigations – Identifying Illicit Connections
- Design & Construction – Rehabilitation techniques
- Outfalls Investigated and Rehabilitated

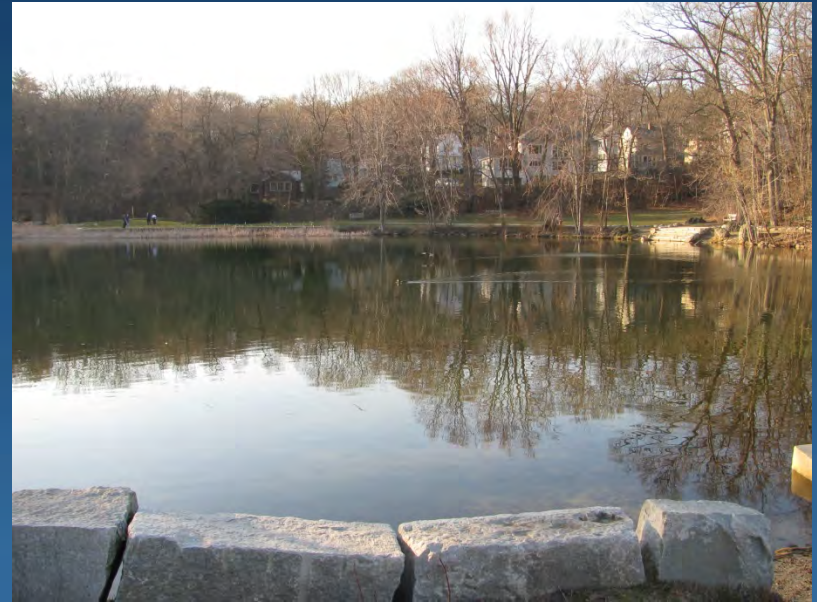
# Arlington Storm Drain System

- Some parts over 100 years old
- Discharges stormwater to surface waters in Arlington
- Little or no treatment prior to discharge

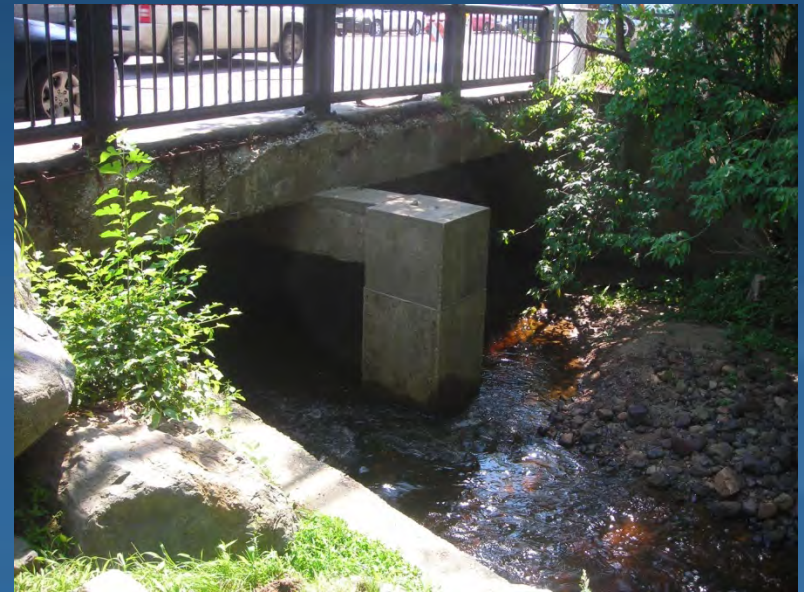
# Arlington Storm Drain System

- Approximately 518,000 LF = 98 miles of storm drain pipe
- The majority of the 170 outfalls discharge to
  - Mill Brook (53 Outfalls)
  - Mystic Lake
  - Mystic River
  - Alewife Brook
  - Spy Pond

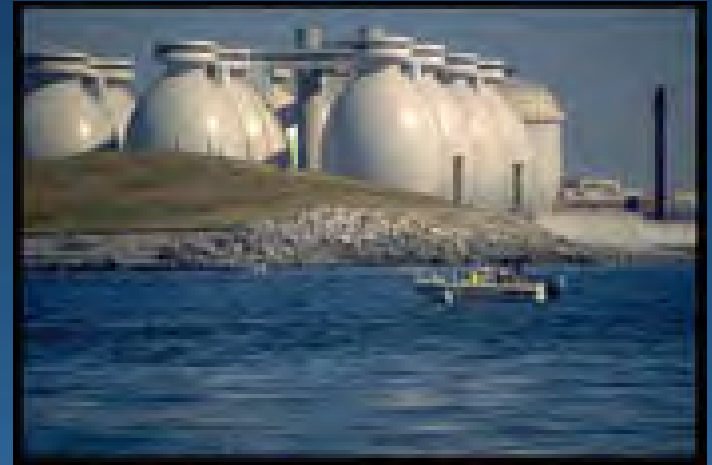
# Arlington Sewer System

- Approximately 567,000 LF = 107 miles of sewer pipe
- Some parts over 100 years old
- Discharges to MWRA interceptors
- Wastewater treated at Deer Island Treatment Plant

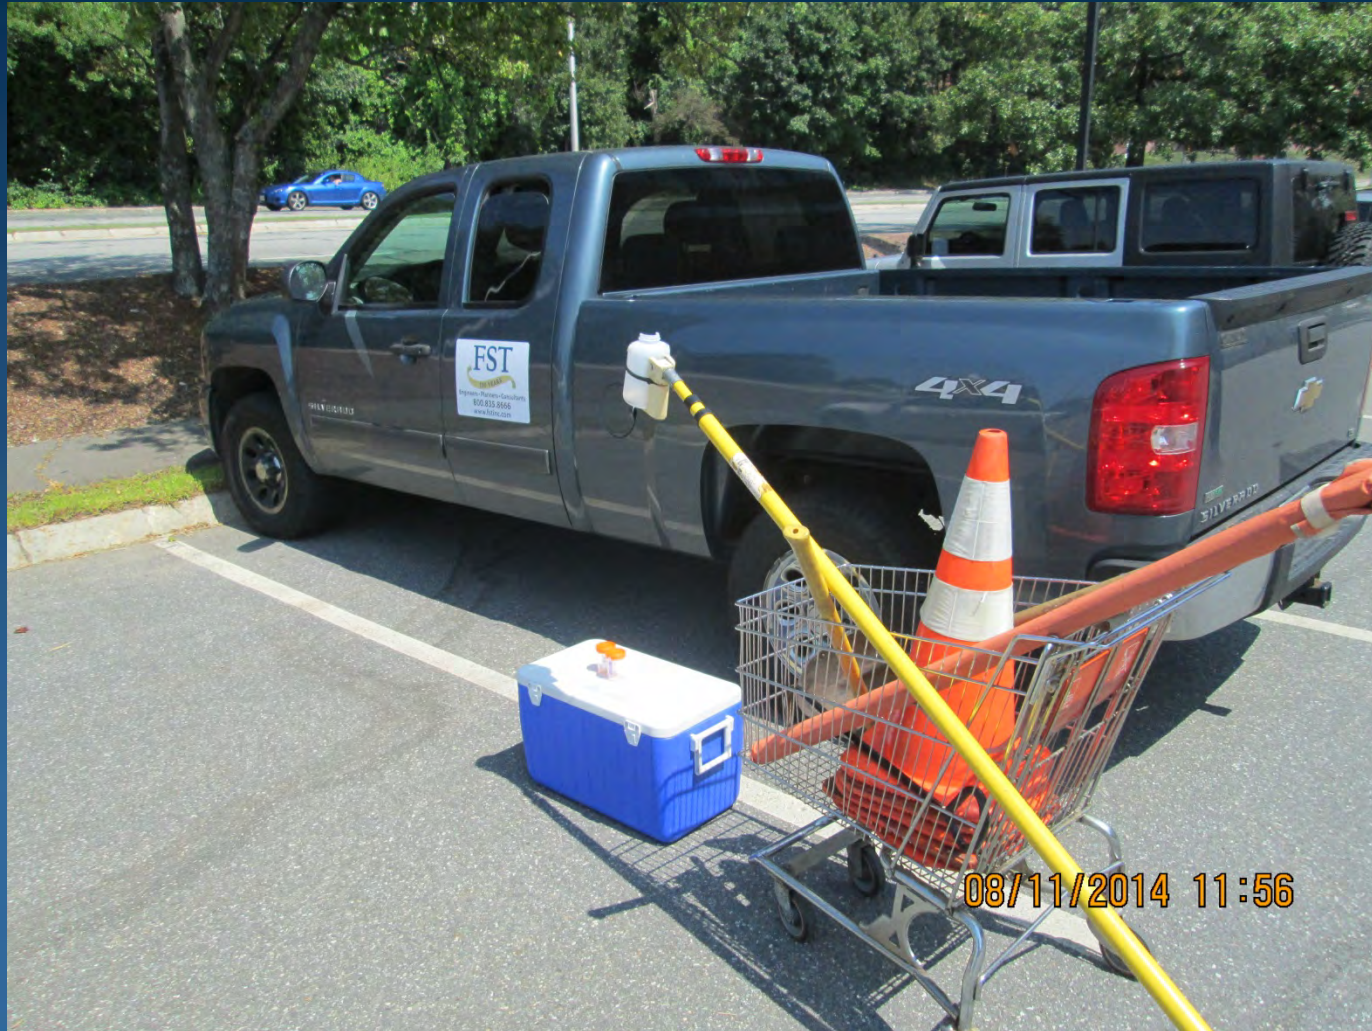
# Equipment

- Protocol
  - 72 hours – No rain or snow melt
  - 6 hour sampling window
  - Sterile sample jars
  - Samples analyzed by State certified laboratory

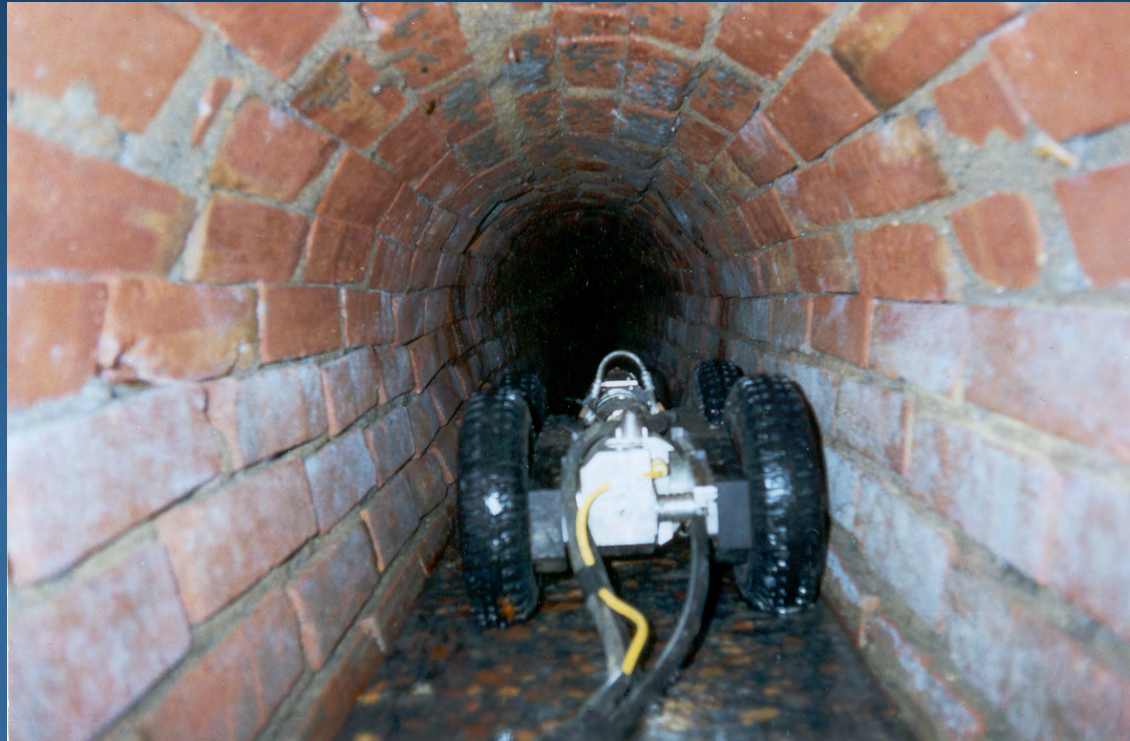
# Investigation Method

- Closed Circuit Television (CCTV) Inspection
  - Sewer and Storm Drain

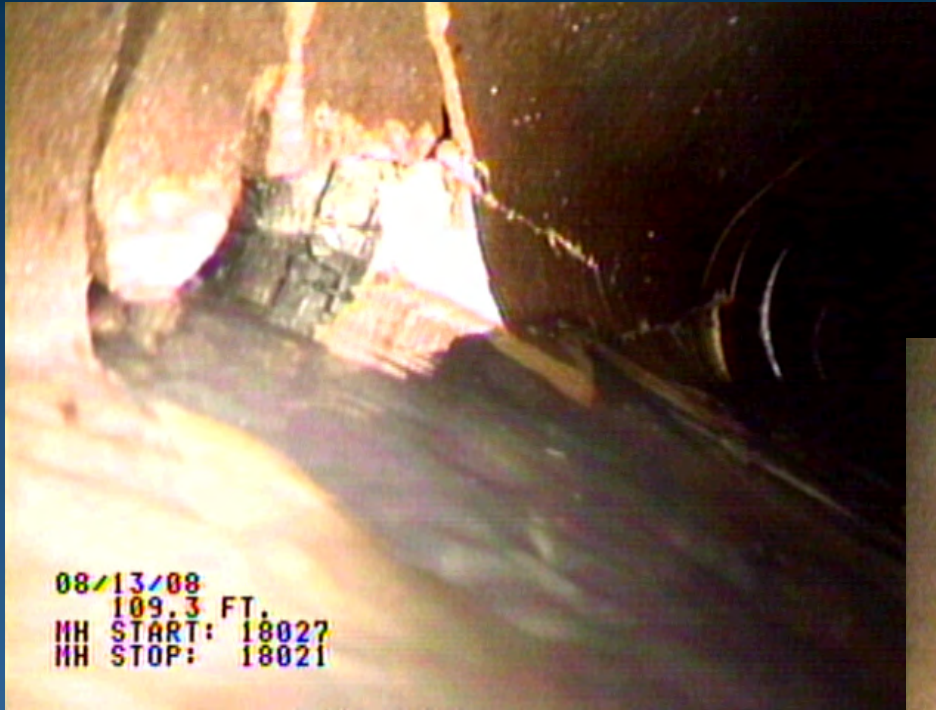
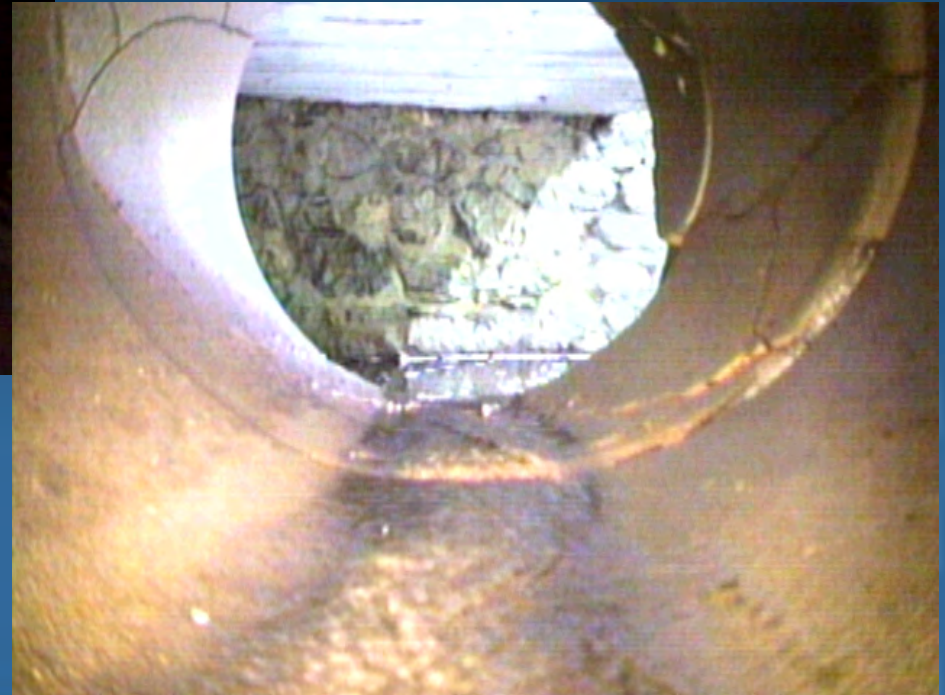
# Mainline Structural Defects

- Mainline Sewers/Drains
  - Cracked/Broken Pipe
  - Root Intrusion
  - Sags
  - Separated/Offset Joints
  - Mineral Deposits
  - Active Infiltration
- Defective Services
  - Same Defects as Mainline

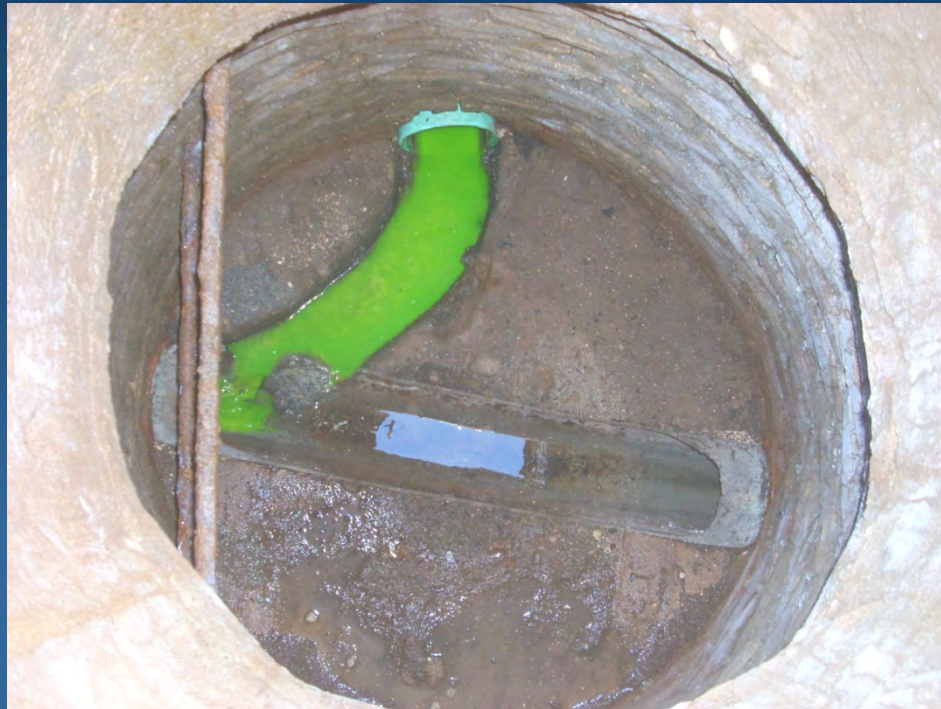
# Investigation Method

- Dyed Water Testing
  - Mainline sewer and sewer service laterals

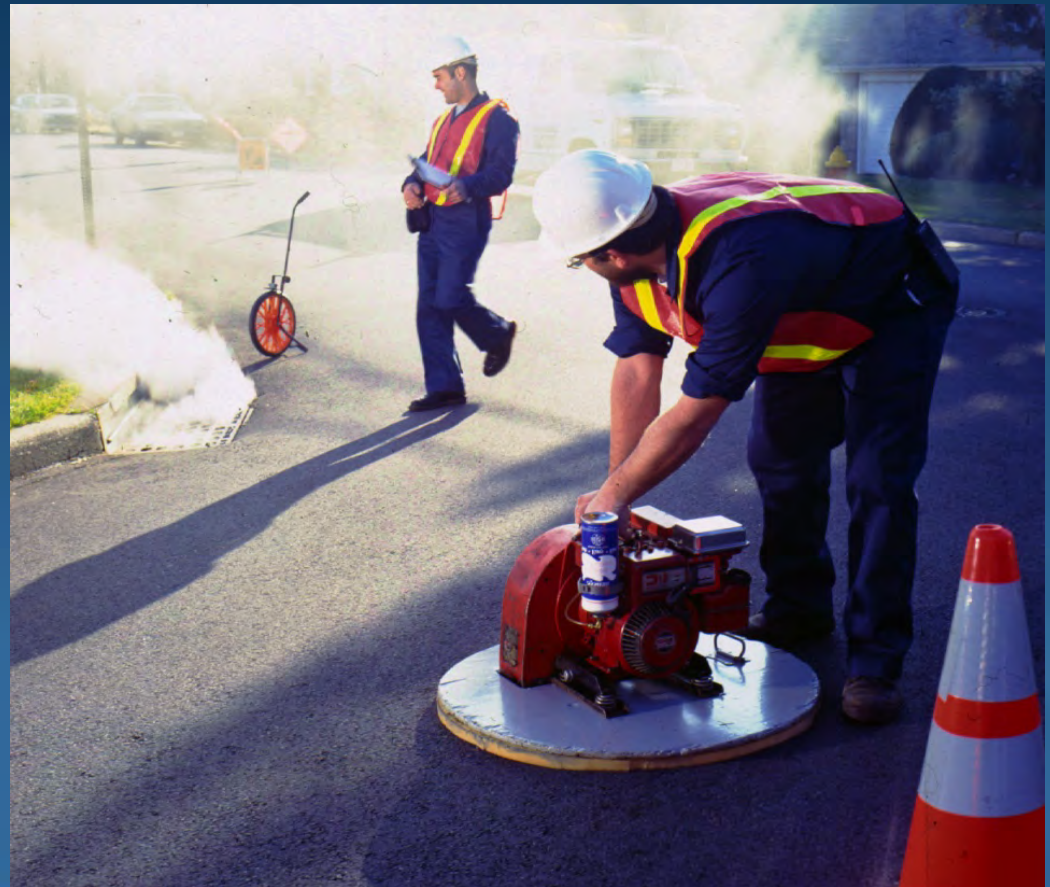
# Investigation Method

- Smoke Testing
  - Storm Drain
