**Report of the Transportation Advisory Committee
to the
Arlington Board of Selectmen**

6 June, 2005

Downing Square Trial

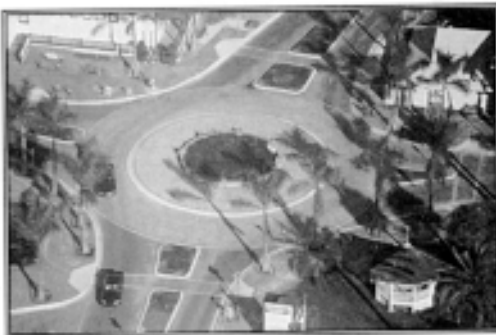
This Fort Pierce, Florida, roundabout was constructed to reduce speeding, improve safety, and enhance the aesthetics of the community.

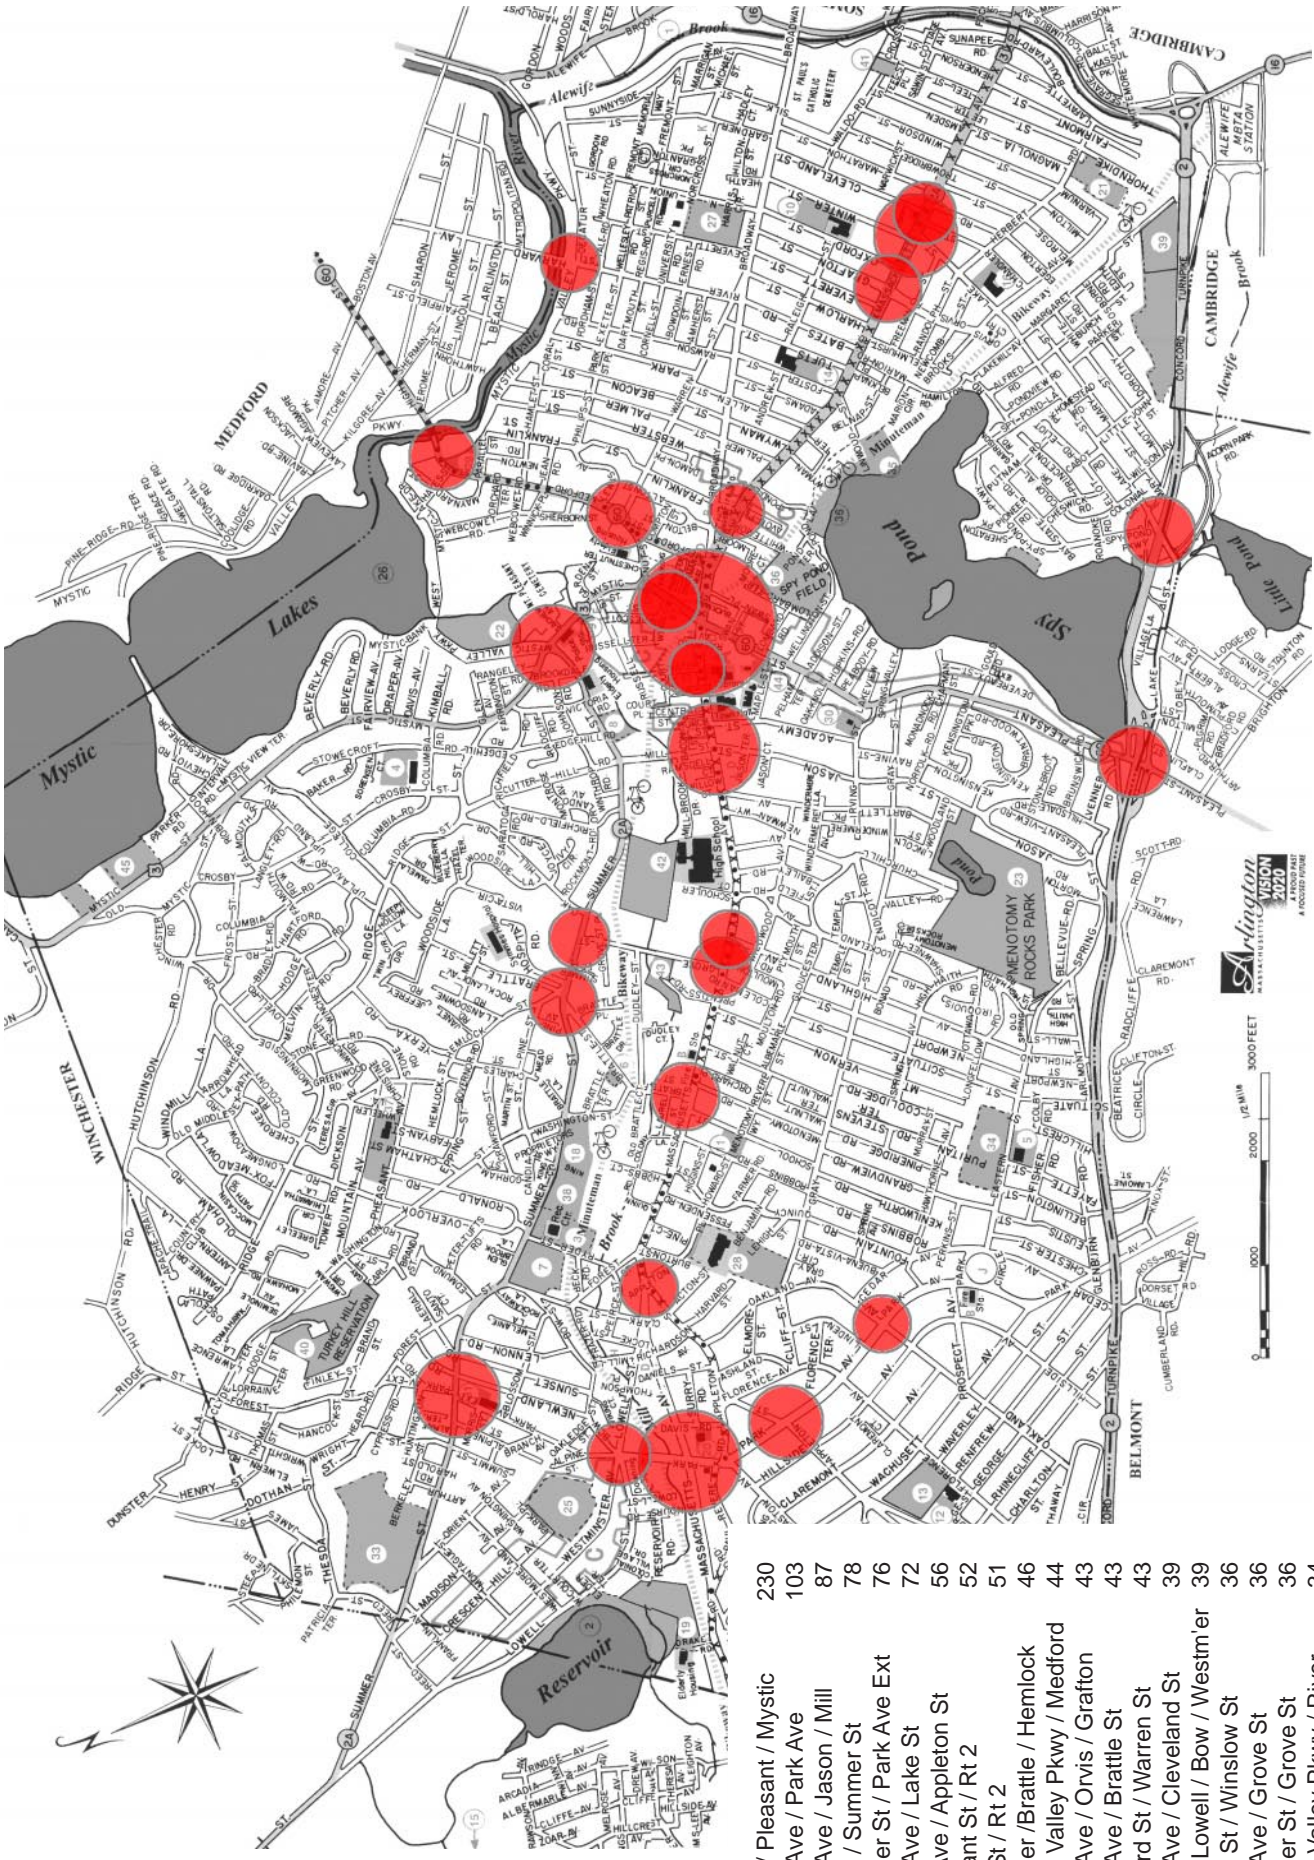
Crash "Hot Spots" Town of Arlington (1990-2001)

Notes:
 1. Crash information comes from summaries of motor vehicle accident reports filed with the Commonwealth. It covers the 12 years from 1990-2001.
 2. This chart only shows the 25 "hot spots" with 30 or more crashes; it does not depict all crashes that occurred. These "hot spots" account for approximately 16% of all reported crashes.

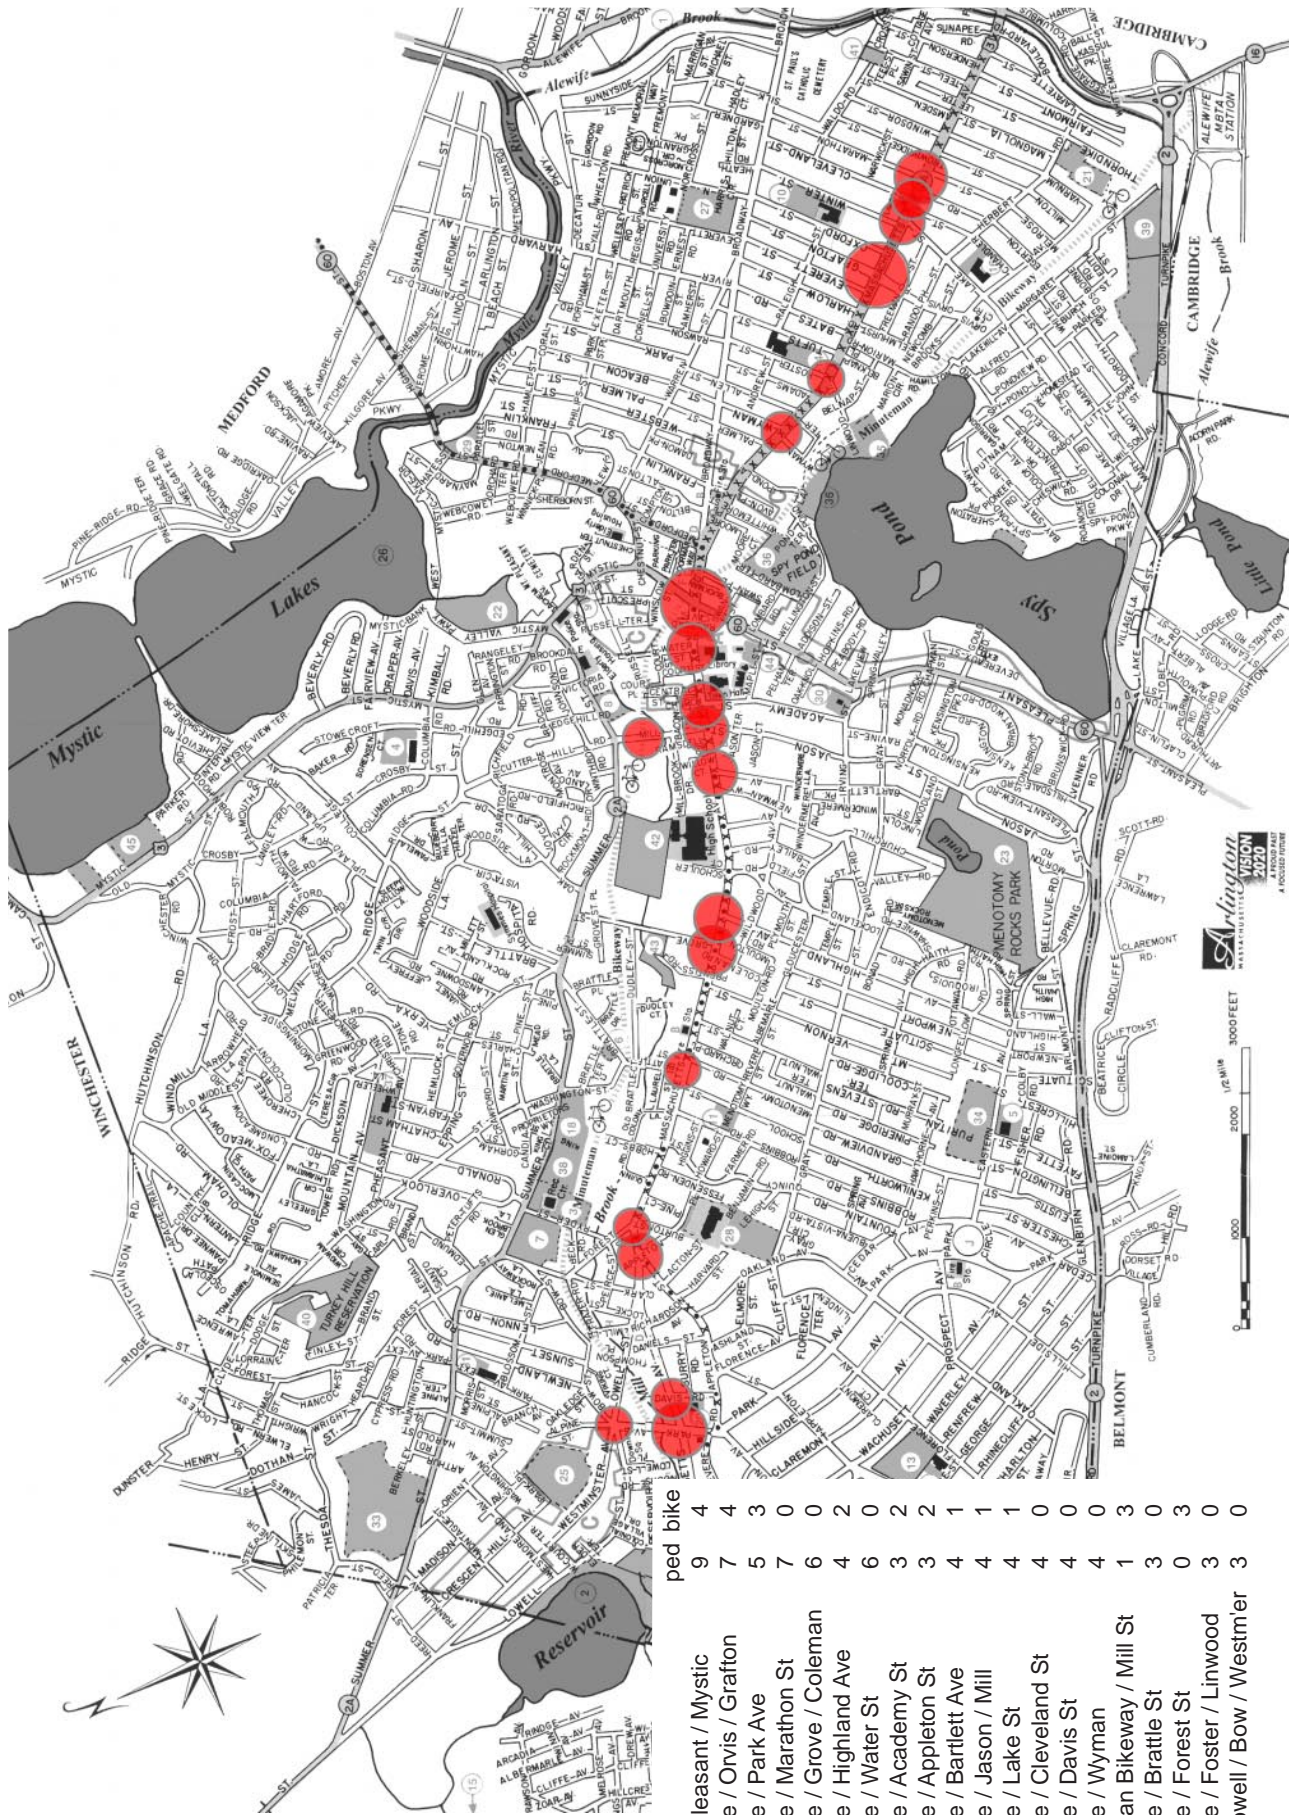
- Notes:
- Crash information comes from summaries of motor vehicle / pedestrian and motor vehicle / bicycle accident reports filed with the Commonwealth. It does not include pedestrian or bicycle falls, or collisions where no motor vehicle was involved. It covers the 12 years from 1990-2001.
 - This chart shows the 20 "hot spots" with 3 or more reported crashes; it does not depict all crashes that occurred. These "hot spots" account for approximately 36% of all reported motor vehicle / pedestrian crashes and approximately 18% of all motor vehicle / bicycle crashes.
