Final Application for FY20 CPA funding

2020 Proposed Restoration Work on the Old Burying Ground

OLD BURYING GROUND & TOMBS AT MOUNT PLEASANT CEMETERY PRESERVATION PLAN

ARLINGTON, MASSACHUSETTS **2018**

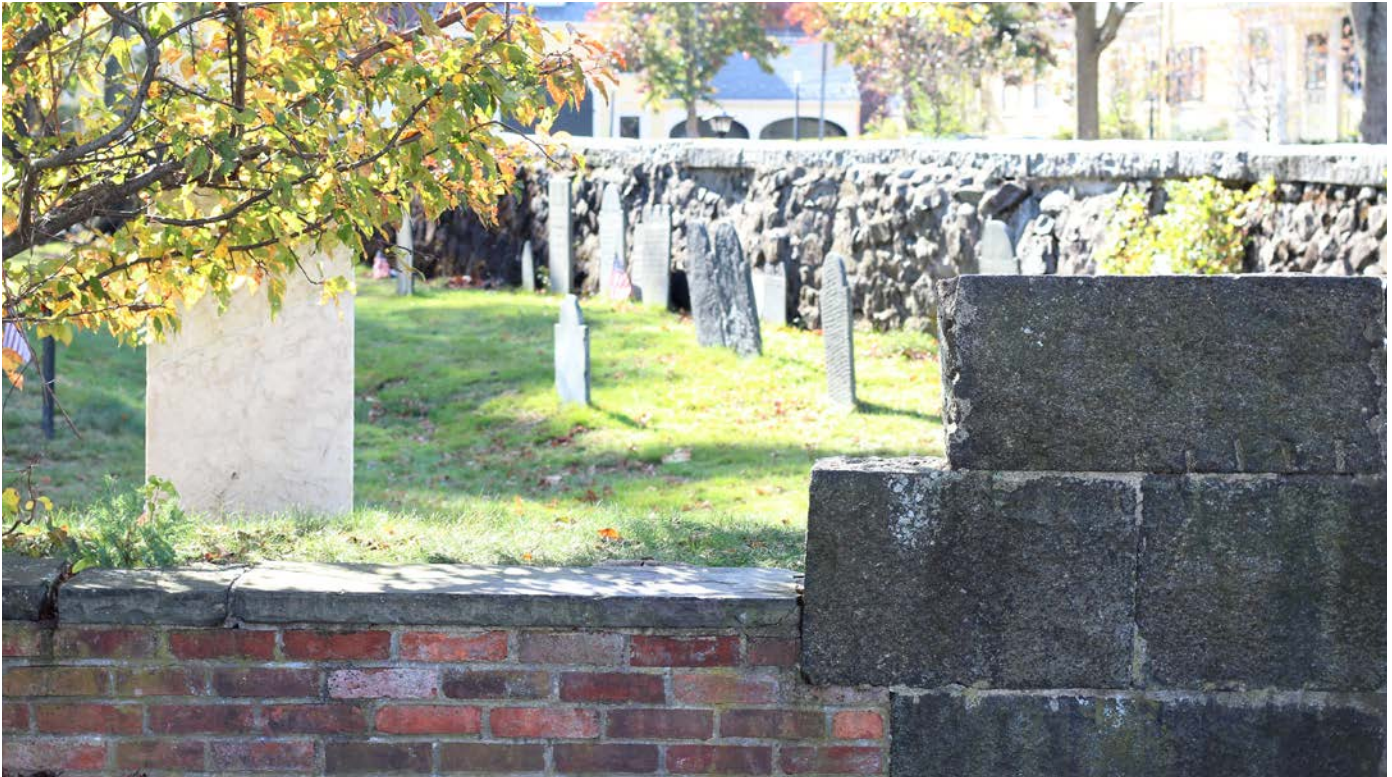
OBC Walls Vary in Their Construction and Condition; View of Brick, Granite Block and Fieldstone Walls Beyond

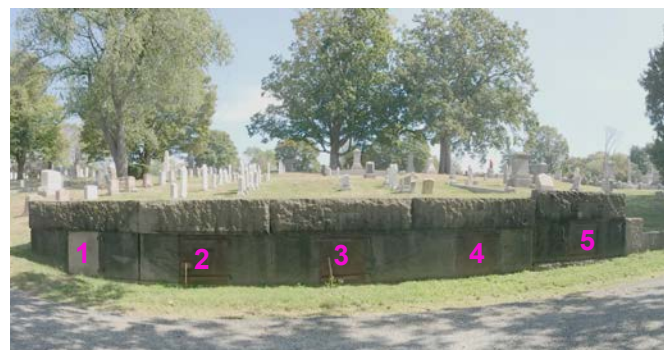
The row of five mound tombs are constructed with masonry walls with stone slab ceilings. The top of the tombs are covered with turf and soil. Brick masonry located on the west side wall is failing. There are many open joints that are missing mortar. The front stones are shifting outward. Four tomb doors are rusted and inoperable, and one tomb door is missing.

Five Mound Tombs at Mount Pleasant Cemetery

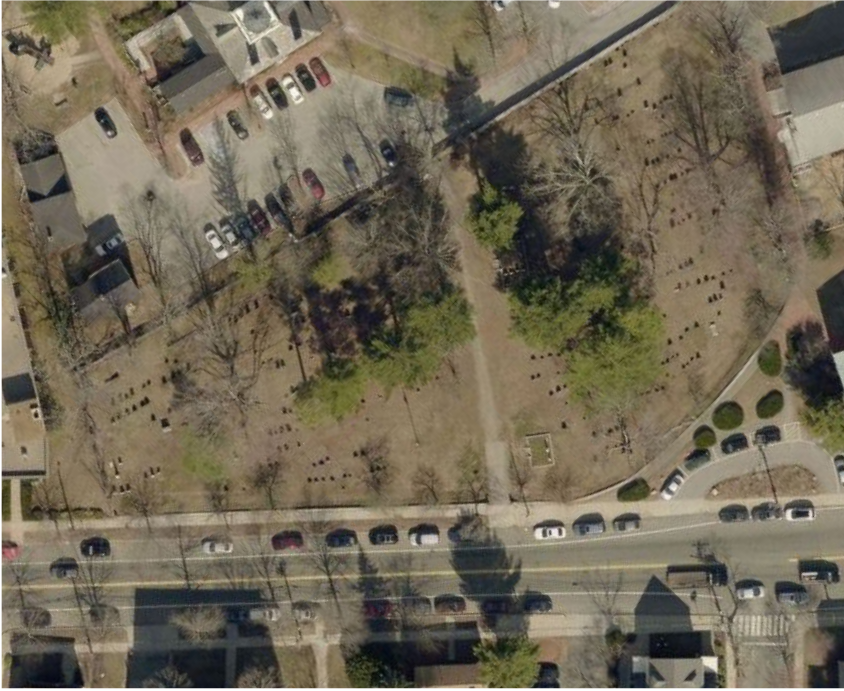
The soils at OBG are infertile, poorly drained and compacted. These conditions have affected the quality of lawns and the health of trees. A detailed soils report prepared by Pine and Swallow, soil scientists, is included in the Appendix. ➤

OBG Lawn in Poor Condition

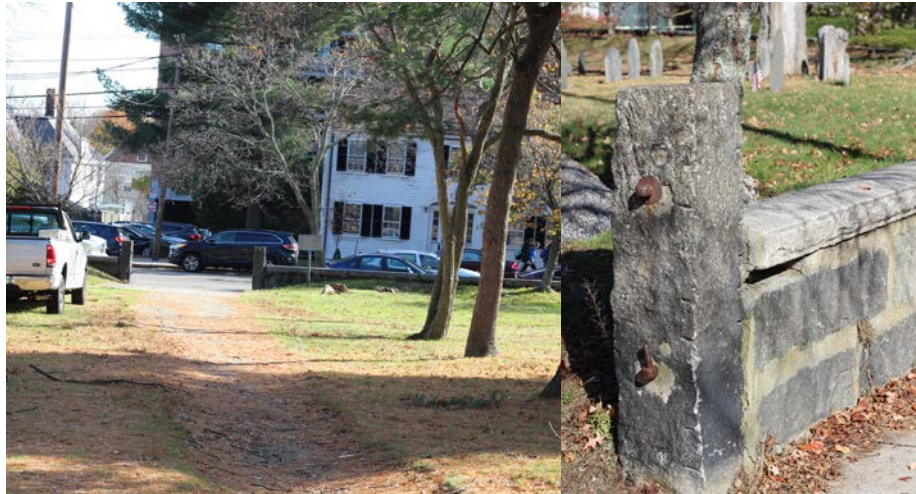
1. Pleasant Street entrance

There are two pedestrian access points into the burying ground, one at Pleasant Street and one at Peg Spengler Way. Rusted metal hinges remain as evidence that gates once existed. The eleven-foot wide Pleasant Street entrance is flanked by two granite posts. The four-foot wide Peg Spengler Way entrance features a granite gate post which at one time supported a gate. A rusted two and one half inch diameter metal pipe located on the opposite side of the entrance was most likely a contemporary improvement installed to secure the former gate. Security has not been an issue. ➤

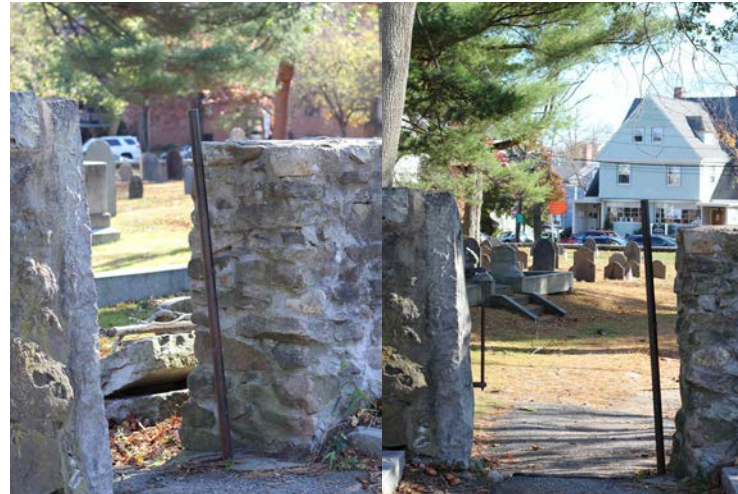
2. Peg Spengler Way entrance

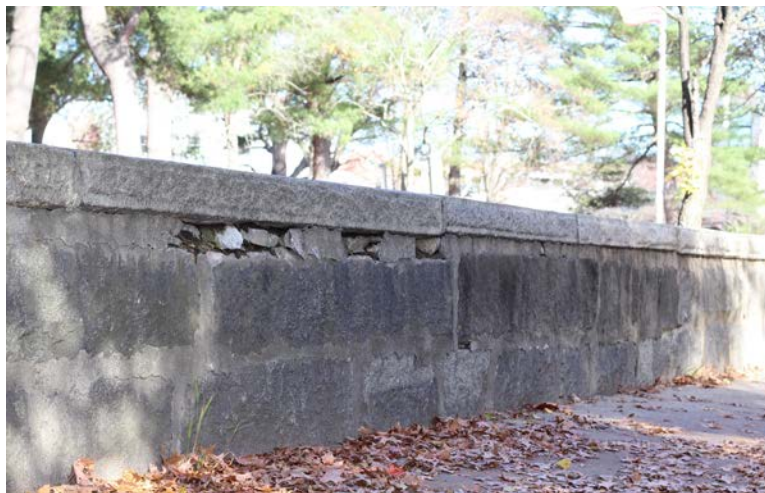
4. Pleasant Street wall - mortar missing from joints

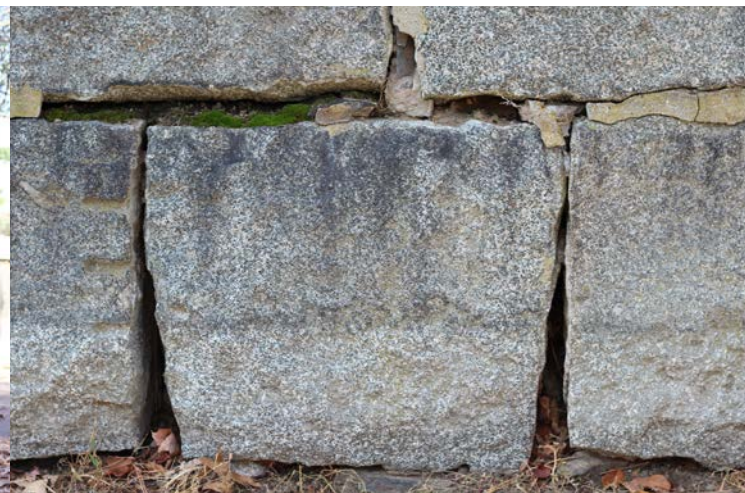
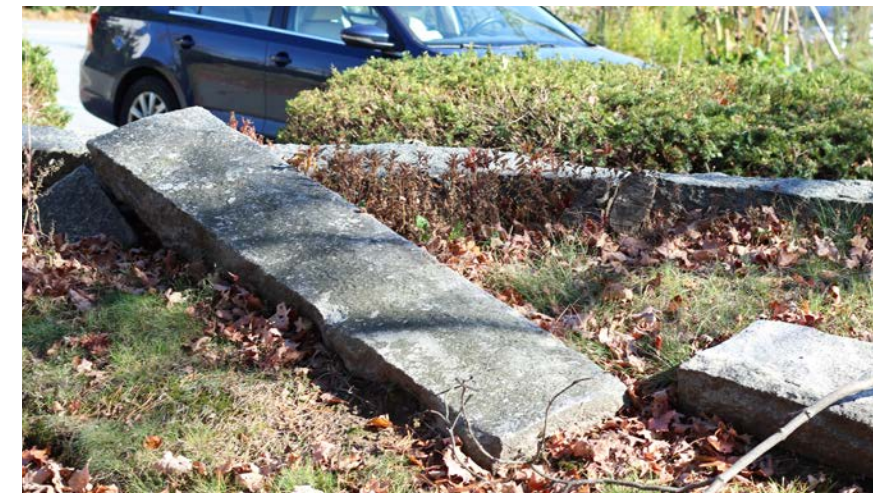
5. Coping stones lying next to wall

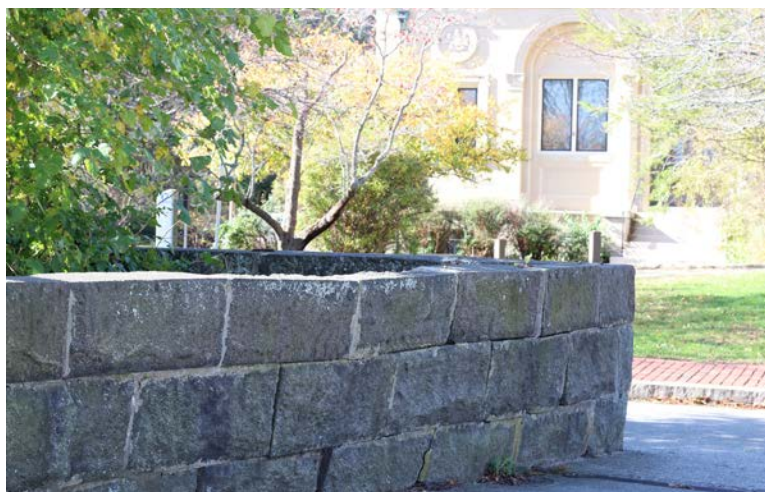
6. Northeast wall - stone, area of bulging

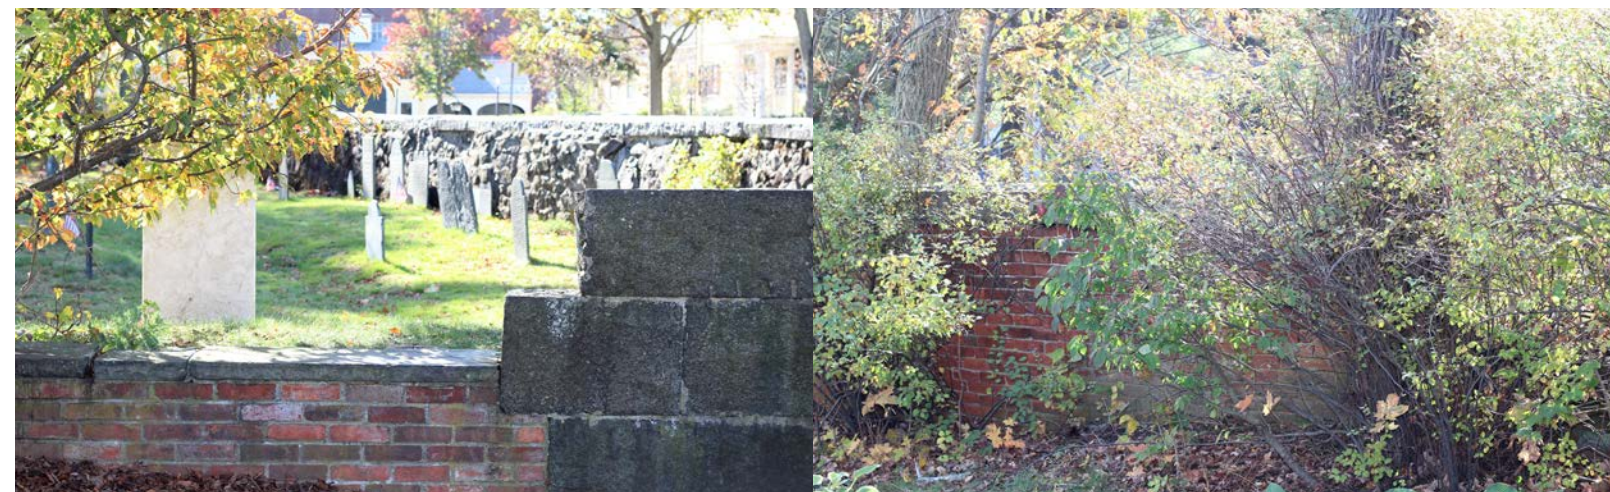
7. Northeast wall - brick

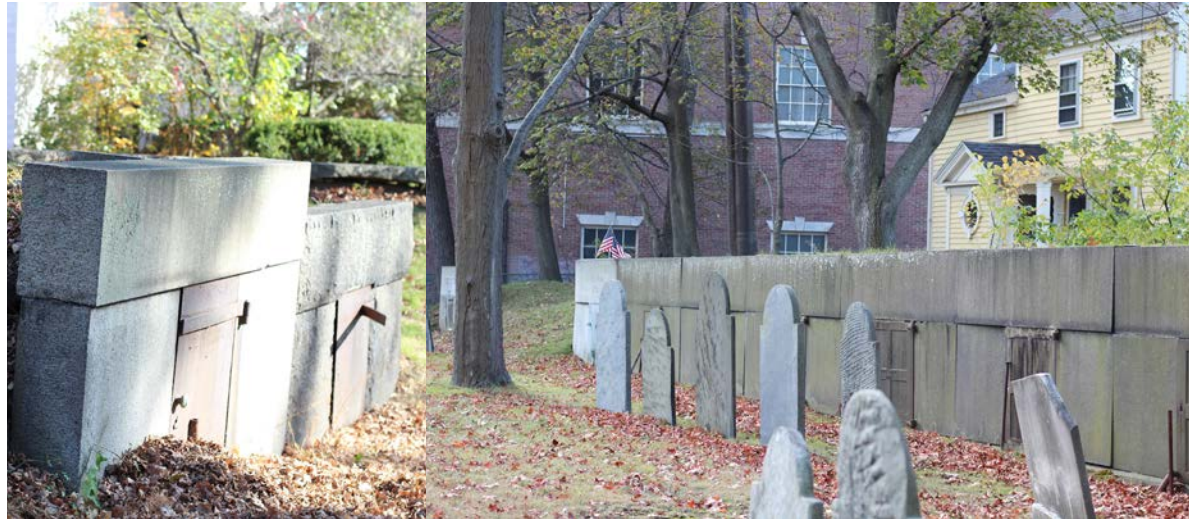
8. Interior tomb walls

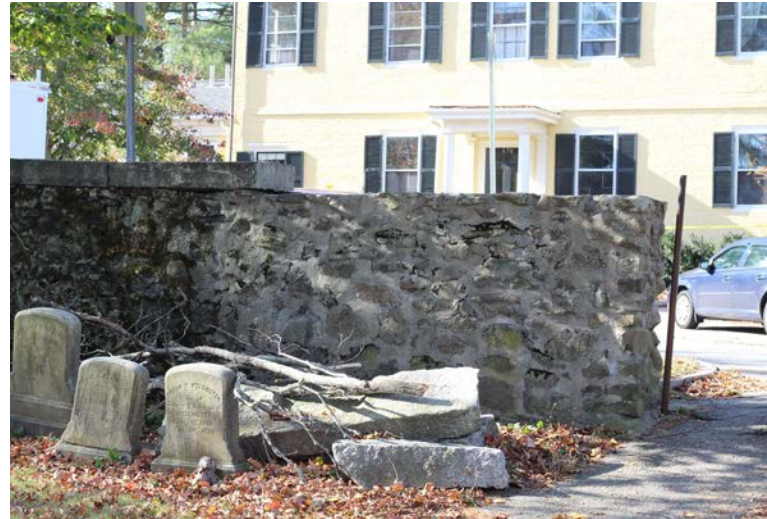
9. Peg Spengler Way wall - stone, moss growth

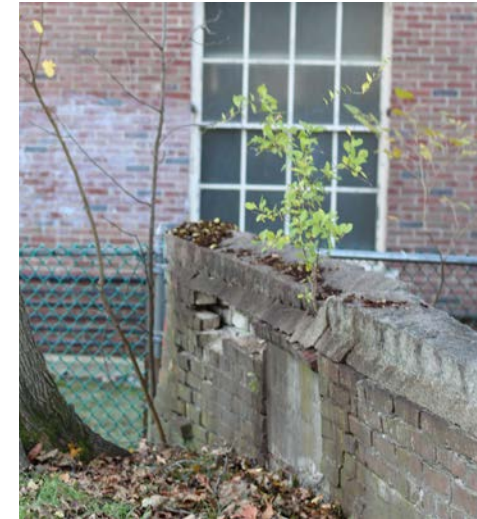
10. Peg Spengler Way wall - brick

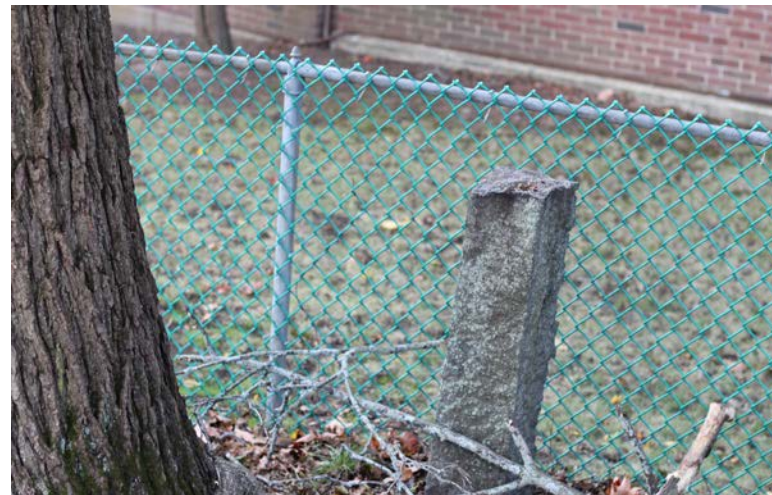
12. Granite posts, missing iron rail

Granite posts with rail anchors at the western boundary suggest a former fence ran along this location. The posts are in good condition despite rust stains from the anchors. A four-foot height green chain link fence is set along the border of the Verizon property. It is unclear who owns the fence, but it appears to be located on the abutters property.

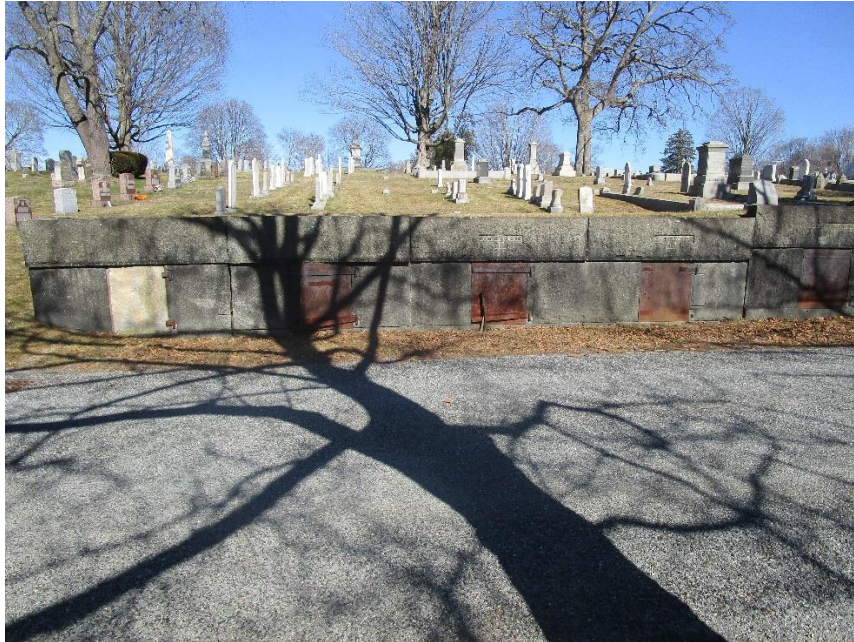
The five tombs are structurally interdependent, sharing common walls and a continuous front wall. The iron door at Tomb 1 is missing but the pintels remain in the granite.

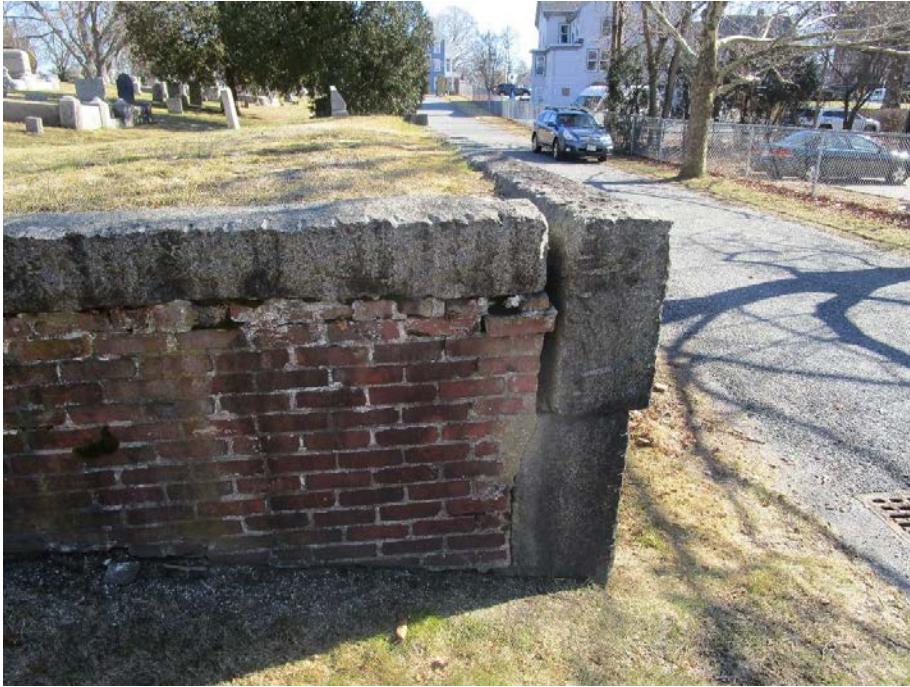
The brick retaining wall is leaning outward and the upper courses are debonded.

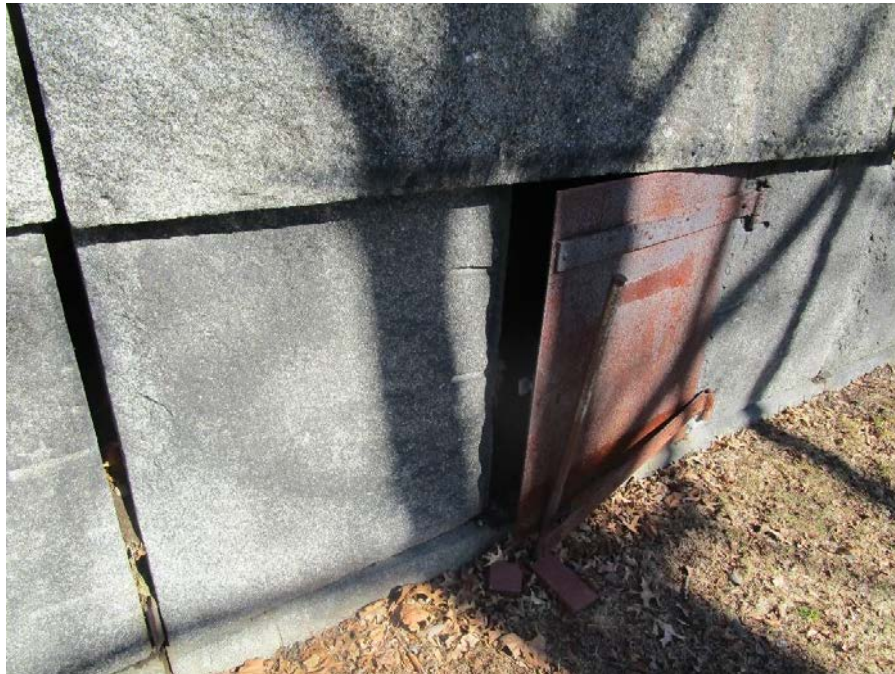
The metal doors are badly corroded and the straps securing them to the hinges are either missing or detaching from the sheet metal. The door closure system – a bar hammered into the ground is not very secure.

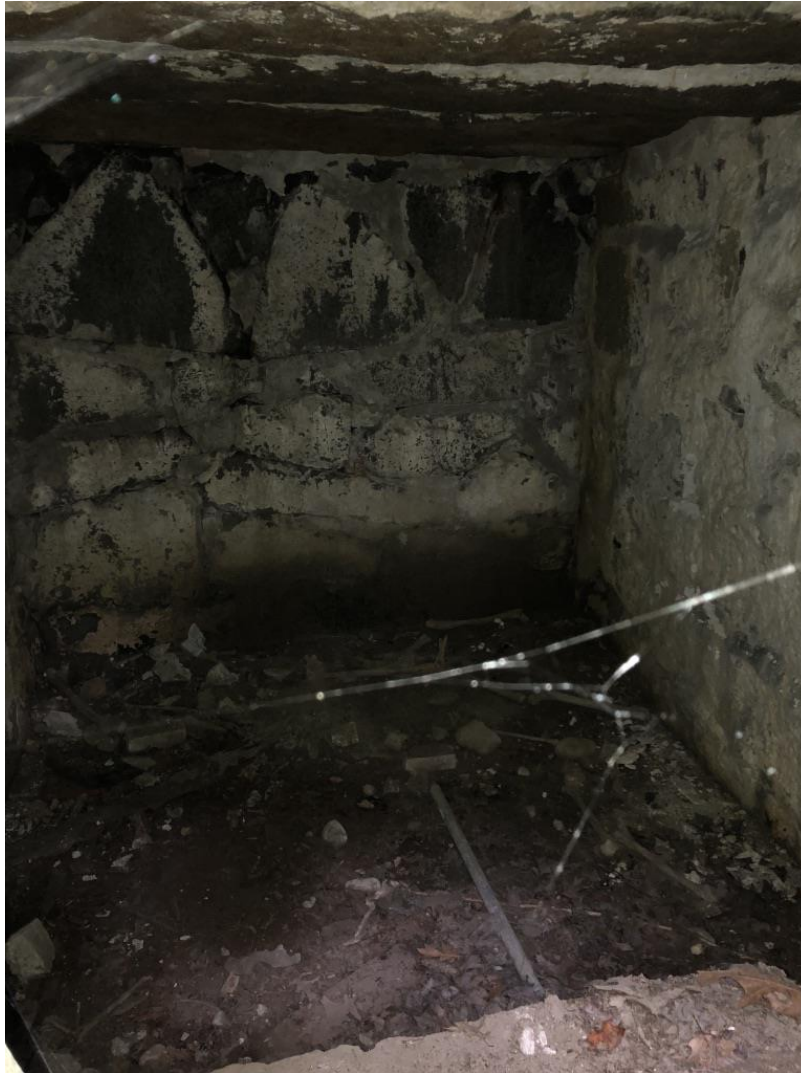
Interior view of Seth Frost Tomb with well-constructed rear wall that is in good condition. Note that granite roof slabs are supported by the side wall which is also in good condition. The last slab at the rear is wider and is supported by both the sidewalls and the rear wall. This detail is the same for all of the flat slab tombs. Ref SKA 2 below for dimensions and location of grade on the front and back of the tombs.
