# ROBBINS LIBRARY

## EXTERIOR ENVELOPE REPAIRS - PHASE IA BID NO.19-58

ROBBINS LIBRARY  
TOWN OF  
ARLINGTON  
700 MASSACHUSETTS AVENUE  
ARLINGTON MA, 02476

EXTERIOR  
ENVELOPE  
REPAIRS -  
PHASE IA  
BID NO. 19-58

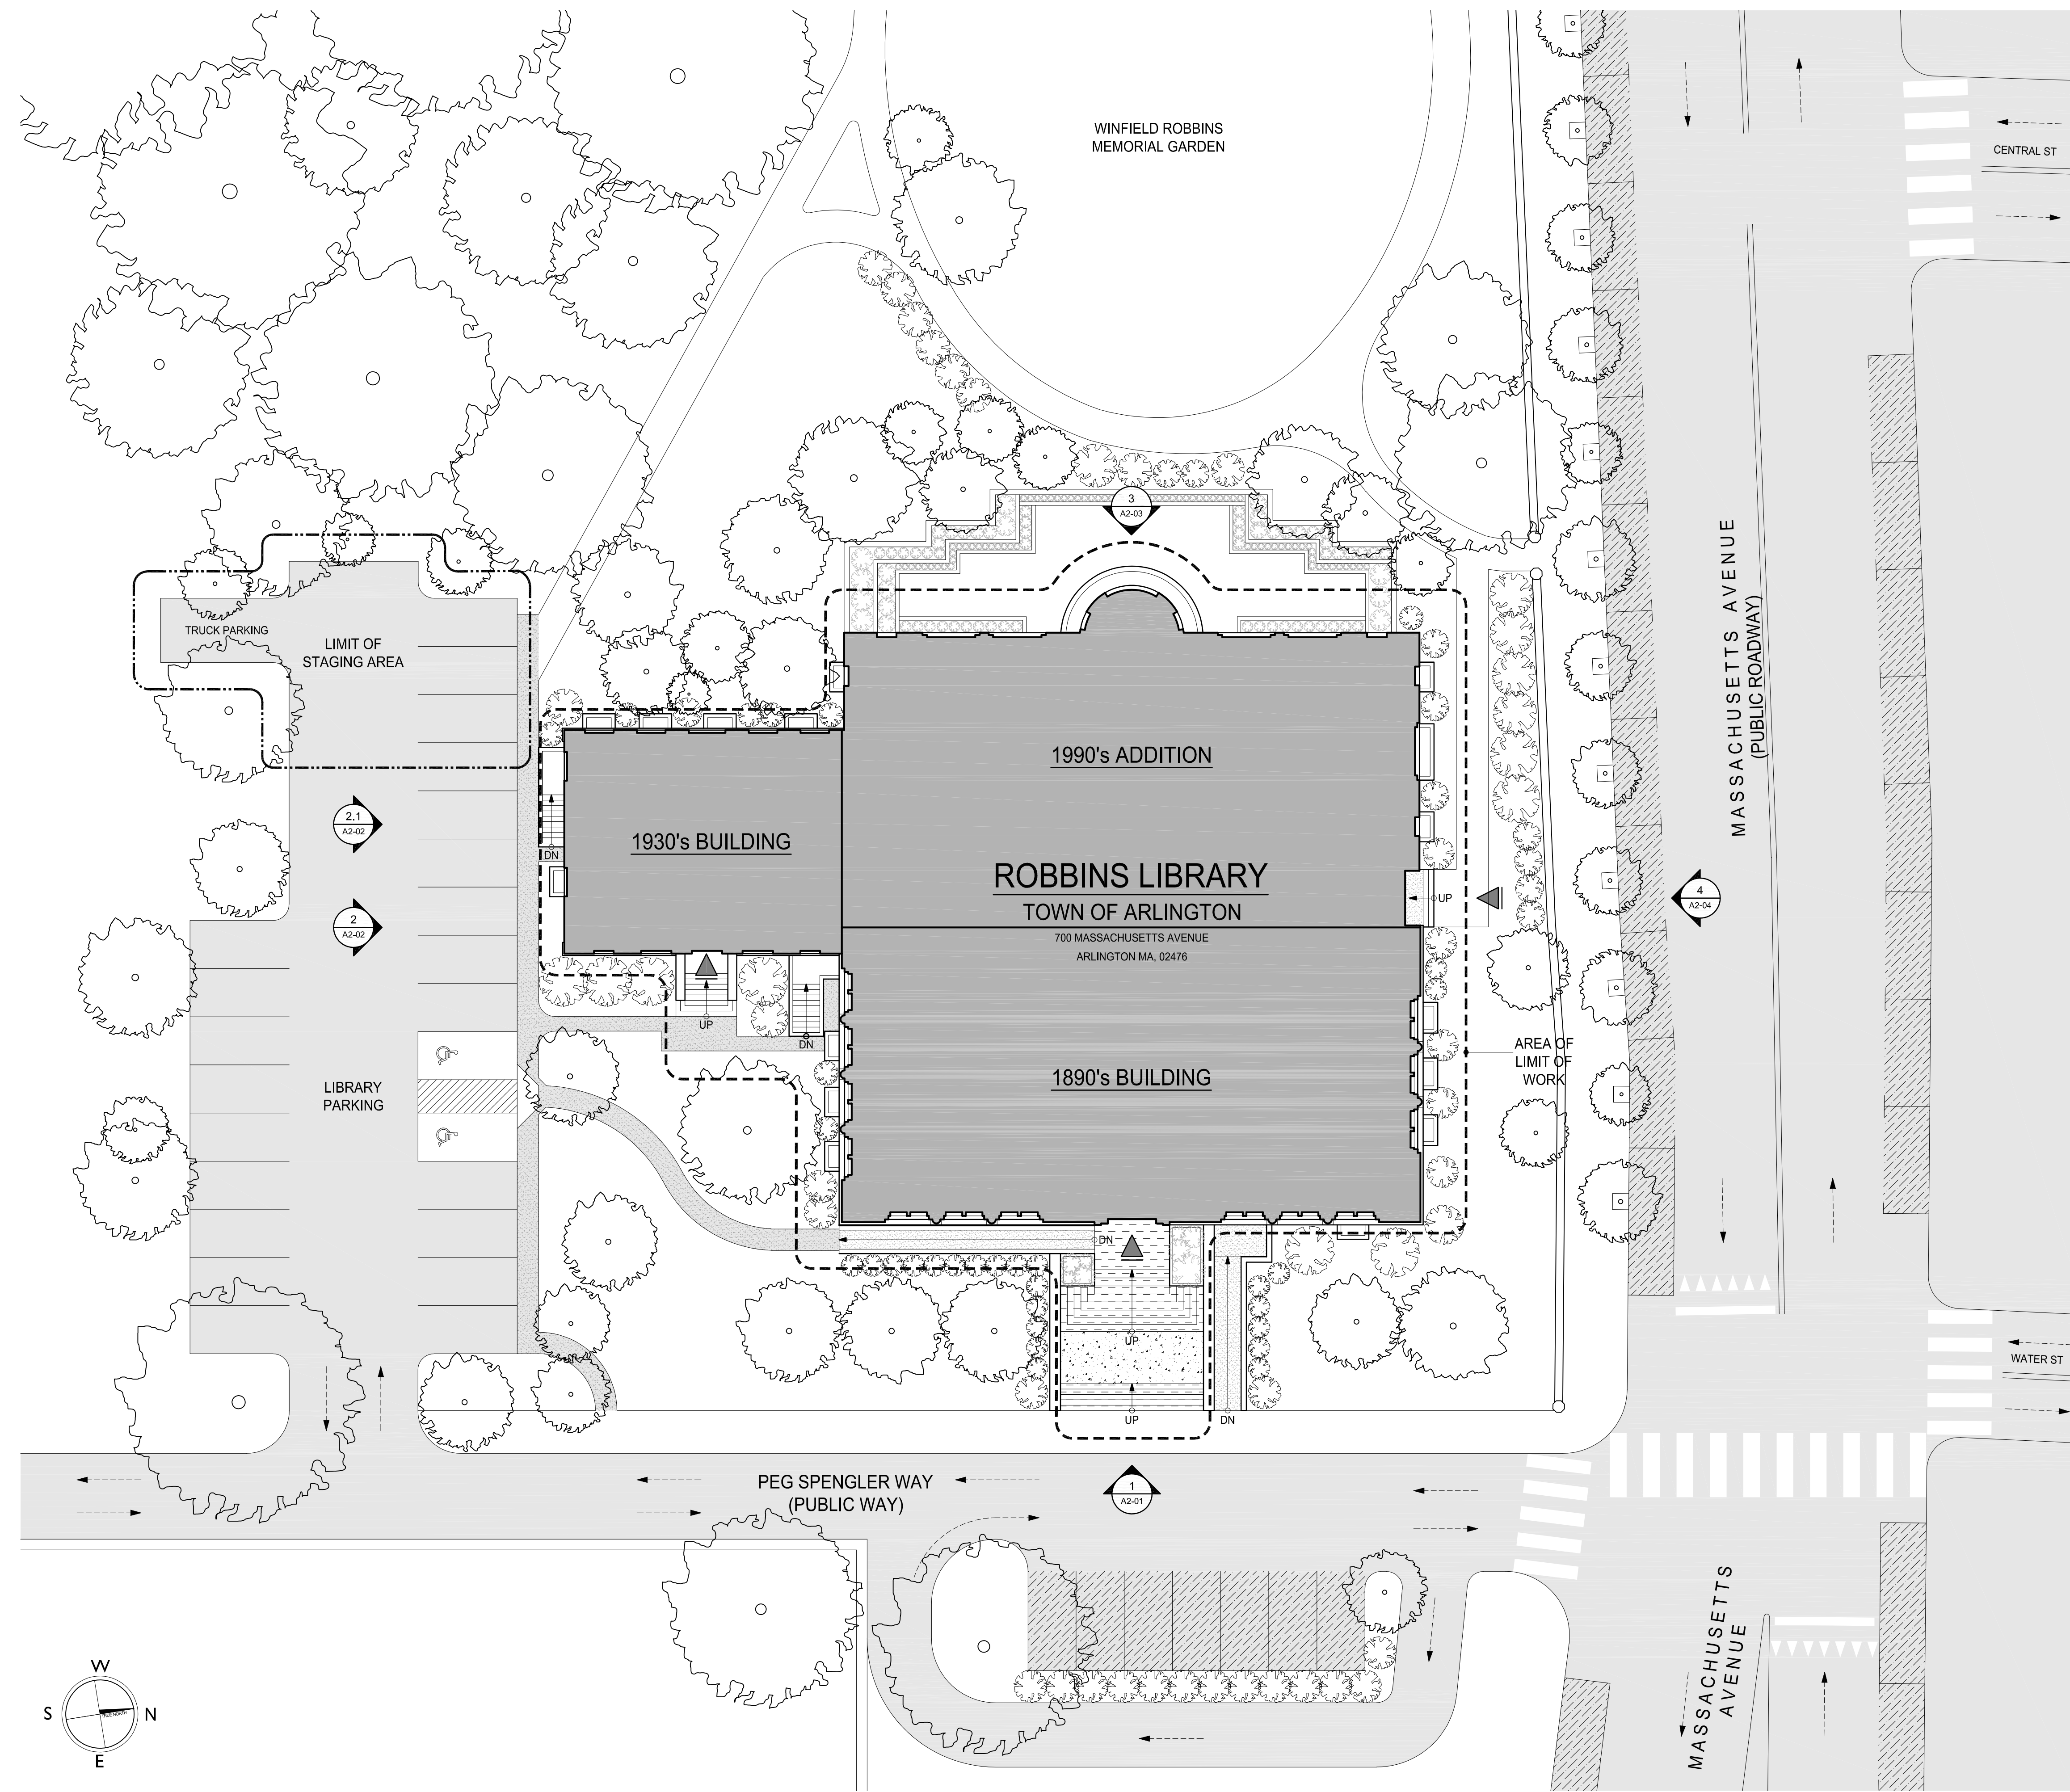
**1 EXISTING SITE PLAN**  
SCALE: 1/16"=1'-0"

1. PROTECT ALL EXISTING GRASS, SHRUBS AND TREES WITHIN AND IN PROXIMITY TO THE LIMIT OF WORK AREA INCLUDING, CONTRACTOR'S STORAGE, LAY-DOWN AND FENCED AREAS. DO NOT OPERATE MACHINERY UNDERNEATH TREE CANOPIES, TYPICAL. REPAIR OR REPLACE ALL DAMAGED AREAS TO THE SATISFACTION OF THE OWNER.

4. CONTRACTOR TO PROVIDE A SITE UTILIZATION PLAN SHOWING FINAL FENCING, PROTECTION, STAGING, DUMPSTER, STORAGE, ETC., FOR OWNER AND ARCHITECT'S APPROVAL PRIOR TO MOBILIZATION. LOCATIONS SHALL MINIMIZE DISRUPTIONS TO THE LIBRARY SCHEDULE, THE BUILDING AND THE SURROUNDING TO FULLEST EXTENT POSSIBLE.

5. CONTRACTOR STORAGE AND LAY-DOWN AREA TO BE LIMITED TO THE AREA BETWEEN THE CONTRACTORS FENCE AND THE BUILDING ON THE SOUTH AND EAST SIDES OF THE BUILDING.

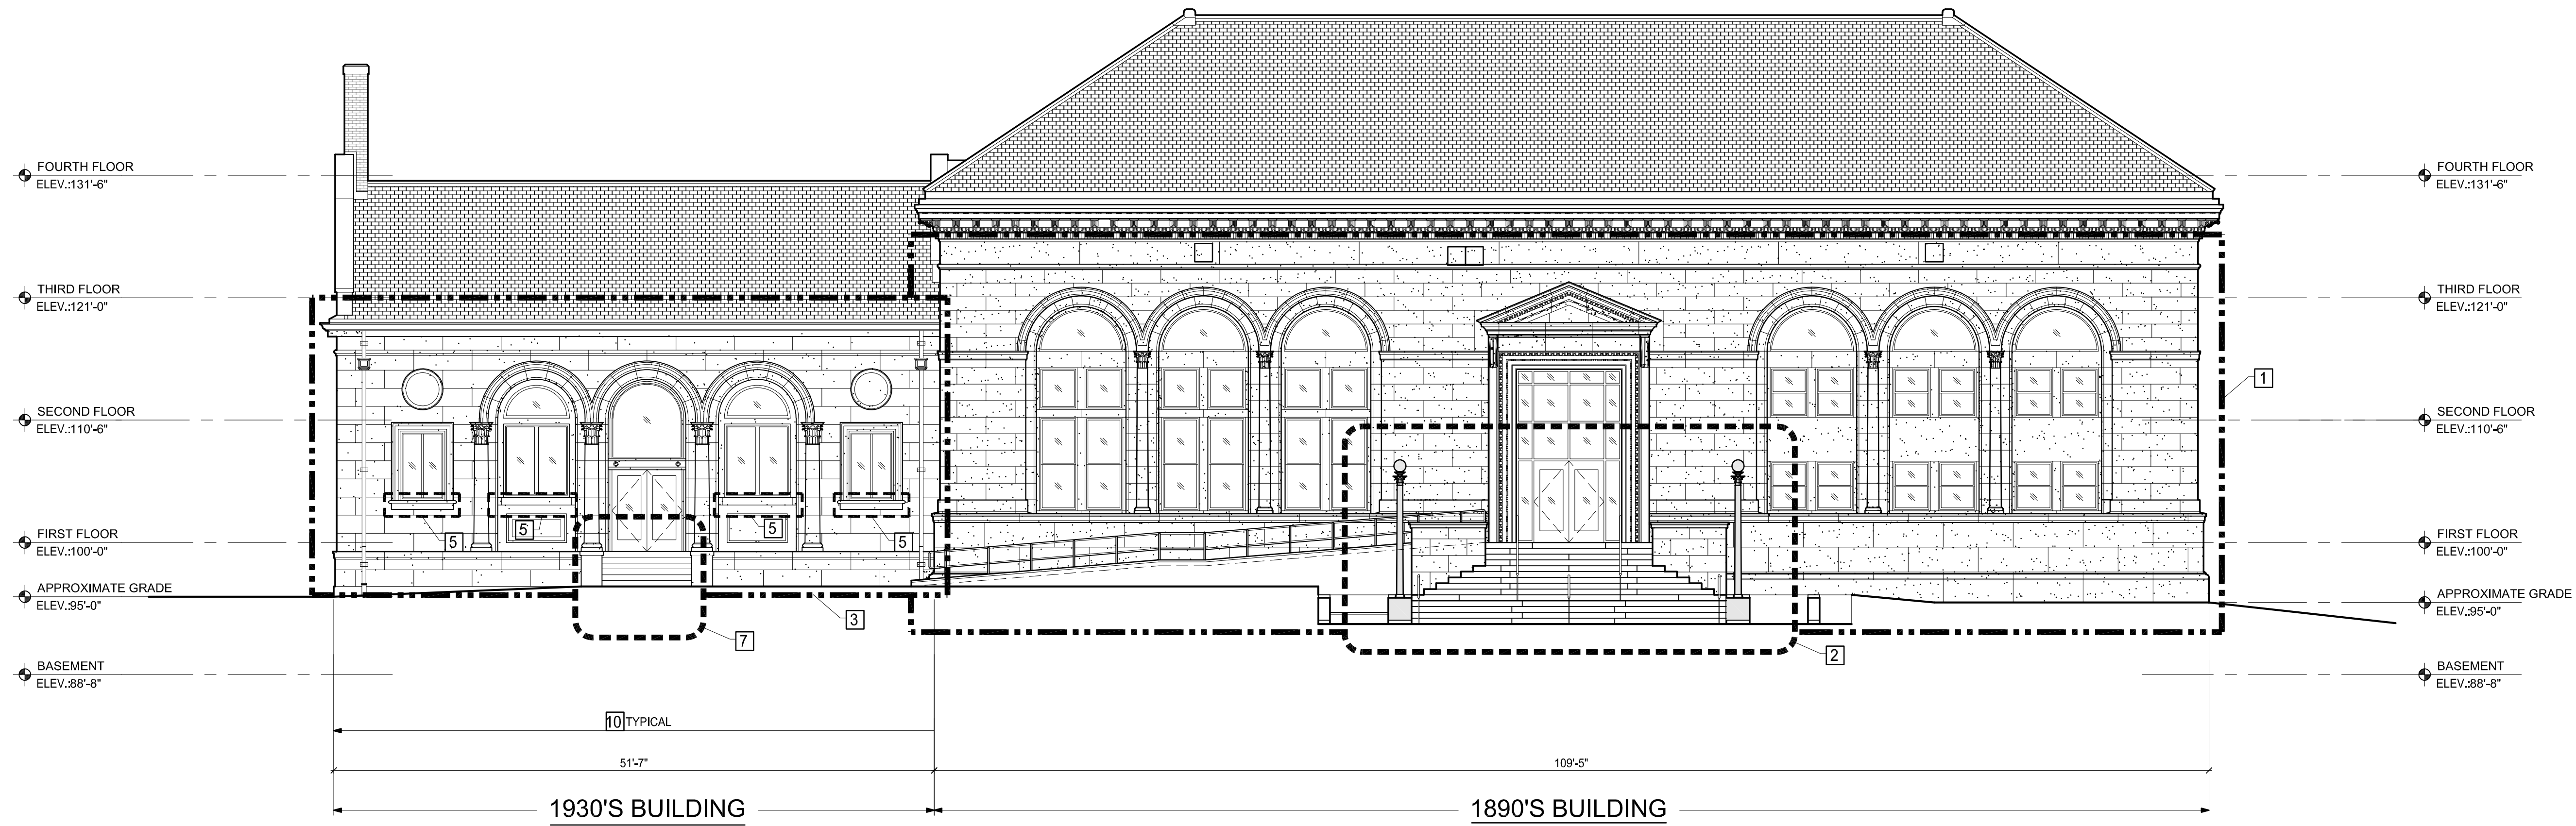
**1 EAST EXTERIOR ELEVATION**  
SCALE: 1/8"=1'-0"

| <p><b>1.</b> ROUTE AND CLEAN EXISTING CRACKS IN ANY SANDSTONE (1890'S BUILDING) DETAIL OR ELEMENT, AND FILL CRACKS WITH INJECTION RESTORATION REPAIR MORTAR. TOTAL QUANTITY OF 50 LINEAL FEET IN SELECT AND RANDOM LOCATIONS ACROSS ALL ELEVATIONS AS SELECTED BY ARCHITECT. REFER TO UNIT PRICES - SPECIFICATION 01 22 00.</p> <p><b>2.</b> REPLACE EXISTING SEALANT AND MORTAR JOINTS OF THE EXTERIOR GRANITE STONE STAIRS AT MAIN ENTRANCE OF THE 1890'S LIBRARY BUILDING. CUT, REMOVE AND DISPOSE OF 100% ALL EXISTING VERTICAL AND HORIZONTAL JOINT SEALANTS, INCLUDING UNDERLYING MORTAR A MINIMUM OF 1-1/2-INCHES OR UNTIL SOUND MORTAR FROM ALL GRANITE STONE STAIRS. APPLY NEW POINTING MORTAR TO WITHIN 1/2-INCH OF THE SURFACE AND APPLY POLYURETHANE SEALANT TO ALL GRANITE STONE JOINTS. STAIRS SHALL BE POWER WASHED CLEANED. SEE ENLARGE PLAN 1/A4-01 AND DETAIL 5a &amp; 5b / A4-01.</p> <p><b>3.</b> ROUTE AND CLEAN EXISTING CRACKS IN ANY ARCHITECTURAL CAST STONE ( 1930S BUILDING ) DETAIL OR ELEMENT, AND FILL CRACKS WITH INJECTION RESTORATION REPAIR MORTAR. TOTAL QUANTITY OF 25 LINEAL FEET IN SELECT AND RANDOM LOCATIONS ACROSS ALL ELEVATION SELECTED BY THE ARCHITECT. SEE DETAIL 1a &amp; 1b / A4-01. REFER TO UNIT PRICE - SPECIFICATION 01 22 00.</p> <p><b>4.</b> REMOVE AND DISPOSE OF EXISTING ARCHITECTURAL CAST STONE WINDOW HEAD IN TWO (2) LOCATIONS AS SELECTED BY THE ARCHITECT. TEMPORARILY SHORE AND SUPPORT OPENING, FABRICATE AND INSTALL NEW REINFORCED ARCHITECTURAL PRECAST HEADER TO MATCH SIZE, TEXTURE, AND COLOR. SEE DETAIL 9a / A4-01. REFER TO UNIT PRICE - SPECIFICATION 01 22 00 AND DEDUCT ALTERNATE NO. 3</p> <p><b>5.</b> CUT OUT AND DISPOSE SPALLS, CHIPS AND DELAMINATIONS IN THE ARCHITECTURAL CAST STONE WINDOW SILL. CUT OUT A MINIMUM 1/2" DEEP &amp; SQUARE OFF ALL EDGES. CLEAN SURFACE &amp; APPLY SINGLE COMPONENT, CEMENTITIOUS MINERAL BASED REPAIR MORTAR TOTAL QUANTITY OF 208 CUBIC INCHES IN SELECT AND RANDOM LOCATIONS ACROSS ALL ELEVATION SELECTED BY THE ARCHITECT. REFER TO UNIT PRICE - SPECIFICATION 01 22 00.</p> <p><b>6.</b> RE-SEAL EXISTING ALUMINUM SPANDREL PANELS, AND GLASS PANELS AS IDENTIFIED AT 1990'S BUILDING. SEE DETAIL 8a &amp; 8b / A4-01</p> <p>a. CUT, REMOVE &amp; DISPOSE OF EXISTING RUBBER GASKETS FLUSH WITH PANEL FRAME. SEE DETAIL 8a / A4-01</p> <p>b. APPLY NEW BACKER ROD WHERE GASKETS ARE MISSING BETWEEN THE PANEL AND FRAME.</p> <p>c. CLEAN AND PRIME SURFACES AND APPLY NON-SAG SINGLE COMPONENT SILICONE SEALANT. COLOR TO BE SELECTED BY ARCHITECT FROM FULL RANGE OF CUSTOM COLORS.</p> <p>d. REFER TO DEDUCT ALTERNATE NO. 2.</p> | <p><b>7.</b> CUT OUT AND DISPOSE SPALLS, CHIPS AND DELAMINATION IN THE ARCHITECTURAL CAST IN PLACE STONE EXIT STAIRS OF THE 1930'S BUILDING. CUT OUT A MINIMUM 1" DEEP &amp; SQUARE OFF ALL EDGES. CLEAN SURFACE &amp; APPLY SINGLE COMPONENT, CEMENTITIOUS MINERAL BASED REPAIR MORTAR.</p> <p><b>8.</b> REPLACE EXISTING SEALANT AND MORTAR JOINTS AT THE EXIT STAIRS OF THE 1930'S BUILDING. CUT, REMOVE AND DISPOSE OF 100% ALL EXISTING VERTICAL AND HORIZONTAL JOINT SEALANTS, INCLUDING UNDERLYING MORTAR A MINIMUM OF 1-1/2-INCHES OR UNTIL SOUND MORTAR FROM ALL ARCHITECTURAL CAST IN PLACE STONE STAIRS AND LANDING. APPLY NEW POINTING MORTAR TO WITHIN 1/2-INCH OF THE SURFACE AND APPLY POLYURETHANE SEALANT TO ALL CAST IN PLACE STONE STAIRS AND LANDING JOINTS. STAIRS SHALL BE POWER WASHED CLEANED. SEE DETAIL 3 &amp; 4 / A4-01.</p> <p><b>DEDUCT ALTERNATES:</b></p> <p><b>1.</b> DEDUCT ALTERNATE NO.1 - ELIMINATE ALL REPAIR WORK ASSOCIATED WITH THE ENTRY/EXIT STAIRS OF THE 1930'S BUILDING, INCLUDING REPLACING EXISTING SEALANT AND MORTAR JOINTS, ALL AS INCLUDED IN NOTES 7 AND 8.</p> <p><b>2.</b> DEDUCT ALTERNATE NO.2 - ELIMINATE ALL WORK ASSOCIATED TO RESEAL THE EXISTING ALUMINUM SPANDREL PANELS FOR THE 1990'S BUILDING, ALL AS INCLUDED IN NOTE 6.</p> <p><b>3.</b> DEDUCT ALTERNATE NO.3 - ELIMINATE TWO (2) LOCATIONS OF WORK ASSOCIATED WITH REPLACING ARCHITECTURAL CAST STONE WINDOW HEAD, ALL AS INCLUDED IN NOTE 4.</p> |

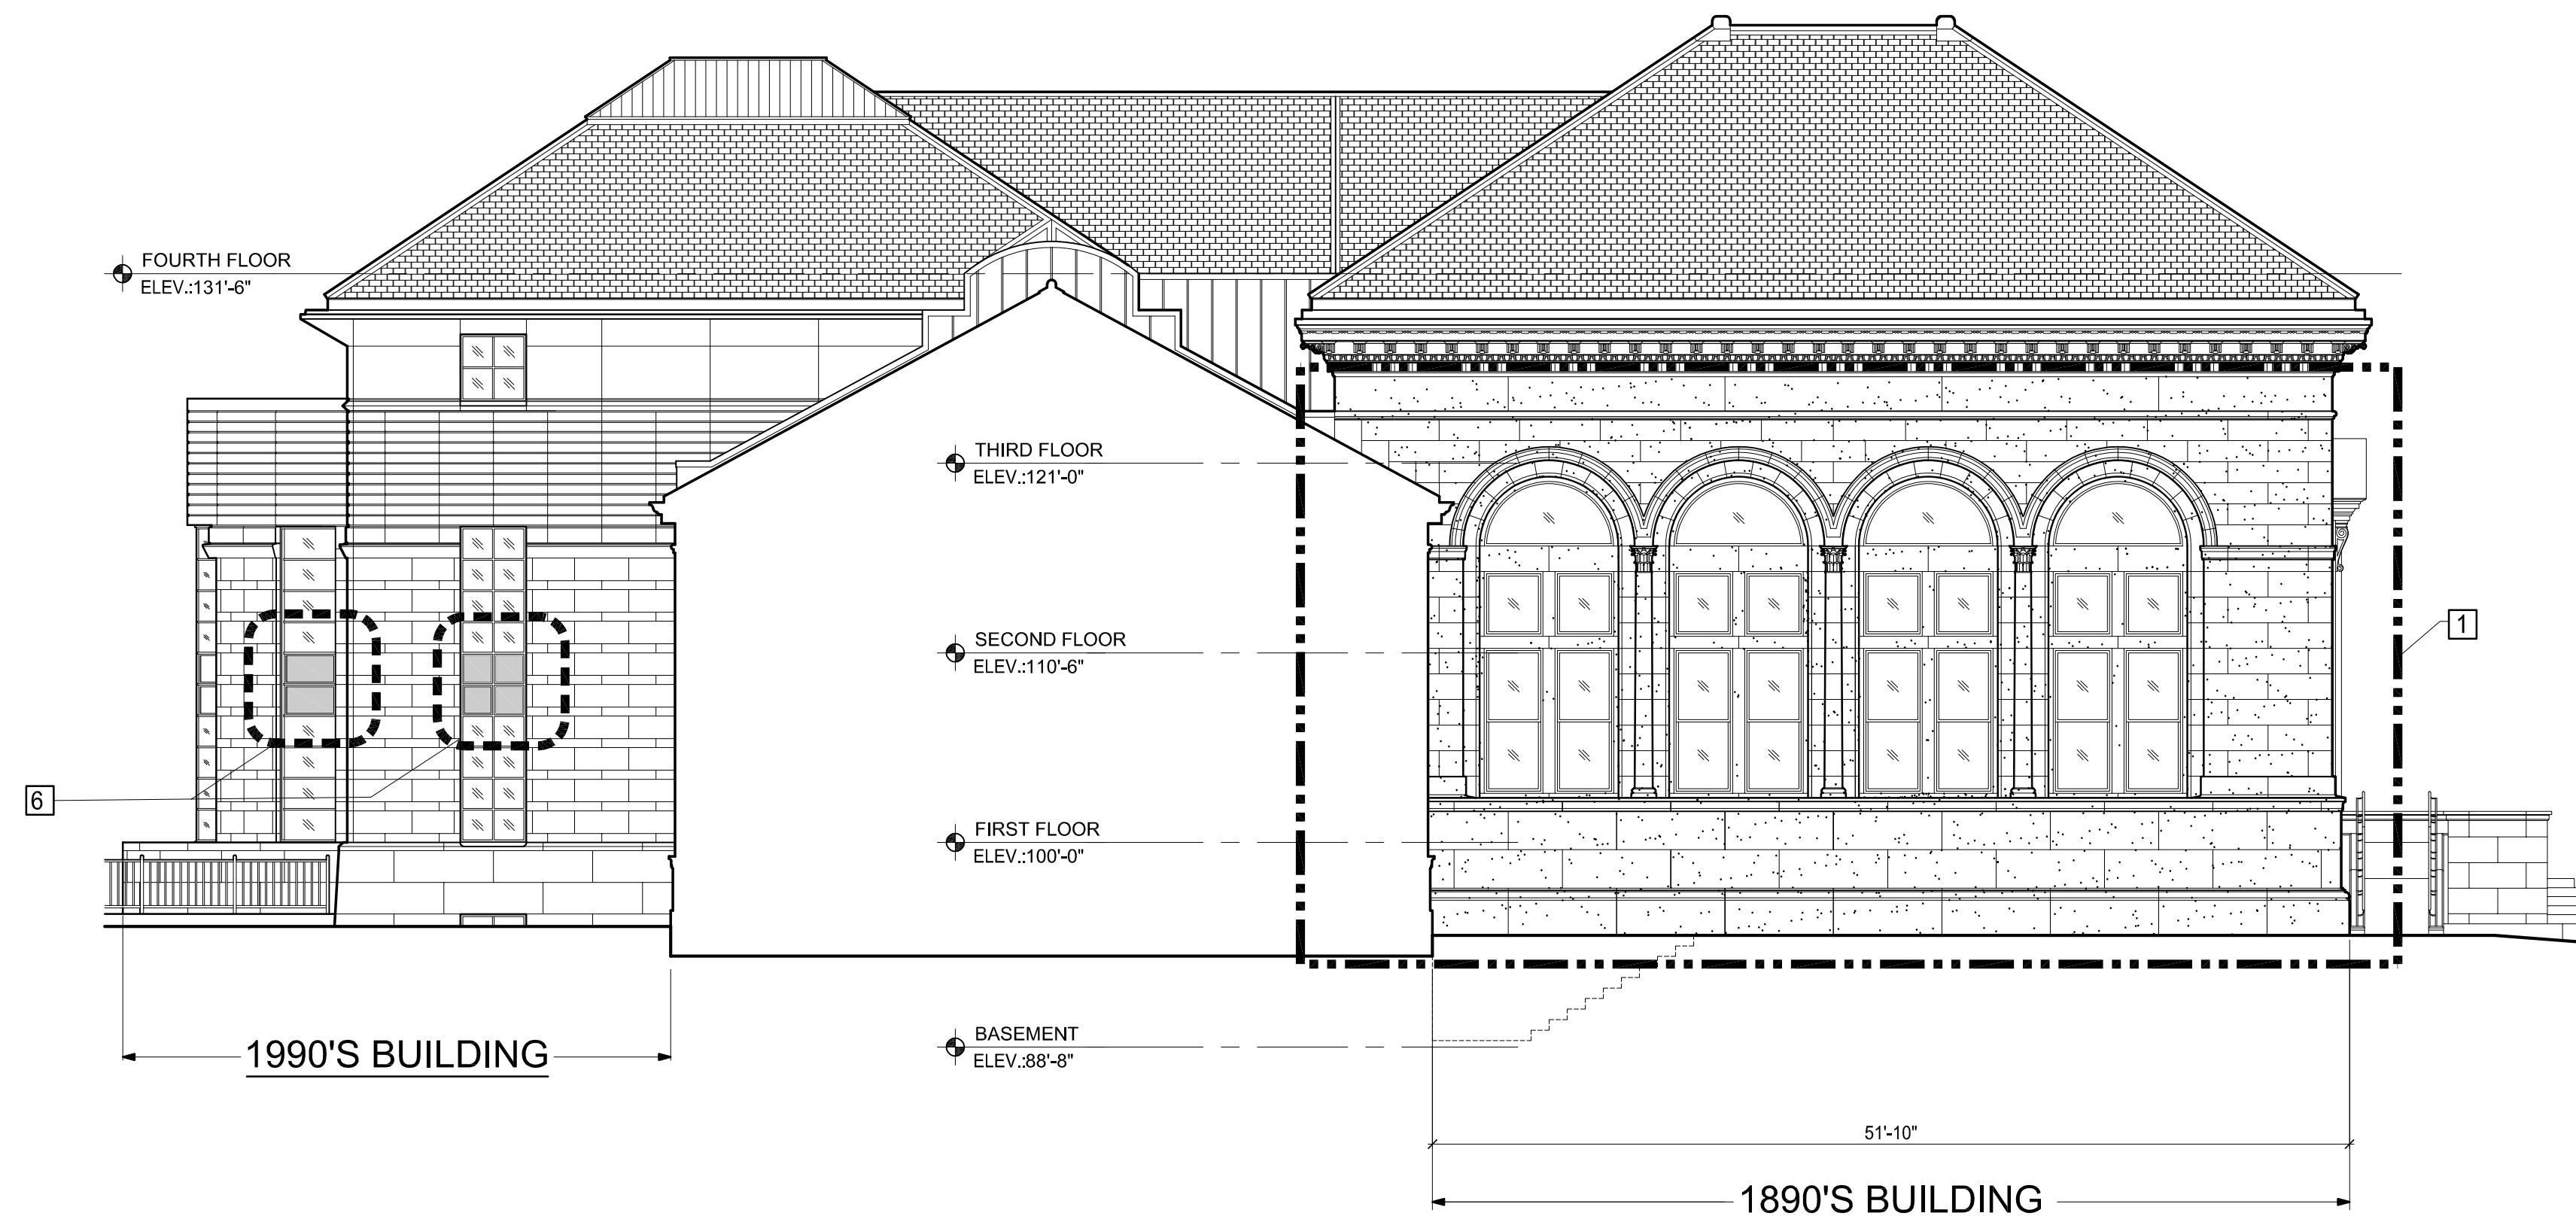
**2 SOUTH EXTERIOR ELEVATION**  
SCALE: 1/8"=1'-0"

1. ROUTE AND CLEAN EXISTING CRACKS IN ANY SANDSTONE (1890'S BUILDING) DETAIL OR ELEMENT, AND FILL CRACKS WITH INJECTION RESTORATION REPAIR MORTAR. TOTAL QUANTITY OF 50 LINEAL FEET IN SELECT AND RANDOM LOCATIONS ACROSS ALL ELEVATIONS AS SELECTED BY ARCHITECT. REFER TO UNIT PRICES - SPECIFICATION 01 22 00.

2. REPLACE EXISTING SEALANT AND MORTAR JOINTS OF THE EXTERIOR GRANITE STONE STAIRS AT MAIN ENTRANCE OF THE 1890'S LIBRARY BUILDING. CUT, REMOVE AND DISPOSE OF 100% ALL EXISTING VERTICAL AND HORIZONTAL JOINT SEALANTS, INCLUDING UNDERLYING MORTAR A MINIMUM OF 1-1/2-INCHES OR UNTIL SOUND MORTAR FROM ALL GRANITE STONE STAIRS. APPLY NEW POINTING MORTAR TO WITHIN 1/2-INCH OF THE SURFACE AND APPLY POLYURETHANE SEALANT TO ALL GRANITE STONE JOINTS. STAIRS SHALL BE POWER WASHED CLEANED. SEE ENLARGE PLAN 1/A4-01 AND DETAIL 5a & 5b / A4-01.

3. ROUTE AND CLEAN EXISTING CRACKS IN ANY ARCHITECTURAL CAST STONE (1930'S BUILDING) DETAIL OR ELEMENT, AND FILL CRACKS WITH INJECTION RESTORATION REPAIR MORTAR. TOTAL QUANTITY OF 25 LINEAL FEET IN SELECT AND RANDOM LOCATIONS ACROSS ALL ELEVATION SELECTED BY THE ARCHITECT. SEE DETAIL 1a & 1b / A4-01. REFER TO UNIT PRICE - SPECIFICATION 01 22 00.

5. CUT OUT AND DISPOSE SPALLS, CHIPS AND DELAMINATIONS IN THE ARCHITECTURAL CAST STONE WINDOW SILL. CUT OUT A MINIMUM 1/2" DEEP & SQUARE OFF ALL EDGES. CLEAN SURFACE & APPLY SINGLE COMPONENT, CEMENTITIOUS MINERAL BASED REPAIR MORTAR TOTAL QUANTITY OF 208 CUBIC INCHES IN SELECT AND RANDOM LOCATIONS ACROSS ALL ELEVATION SELECTED BY THE ARCHITECT. REFER TO UNIT PRICE - SPECIFICATION 01 22 00.

8. REPLACE EXISTING SEALANT AND MORTAR JOINTS AT THE EXIT STAIRS OF THE 1930'S BUILDING. CUT, REMOVE AND DISPOSE OF 100% ALL EXISTING VERTICAL AND HORIZONTAL JOINT SEALANTS, INCLUDING UNDERLYING MORTAR A MINIMUM OF 1-1/2-INCHES OR UNTIL SOUND MORTAR FROM ALL ARCHITECTURAL CAST IN PLACE STONE STAIRS AND LANDING. APPLY NEW POINTING MORTAR TO WITHIN 1/2-INCH OF THE SURFACE AND APPLY POLYURETHANE SEALANT TO ALL CAST IN PLACE STONE STAIRS AND LANDING JOINTS. STAIRS SHALL BE POWER WASHED CLEANED. SEE DETAIL 3 & 4 / A4-01.

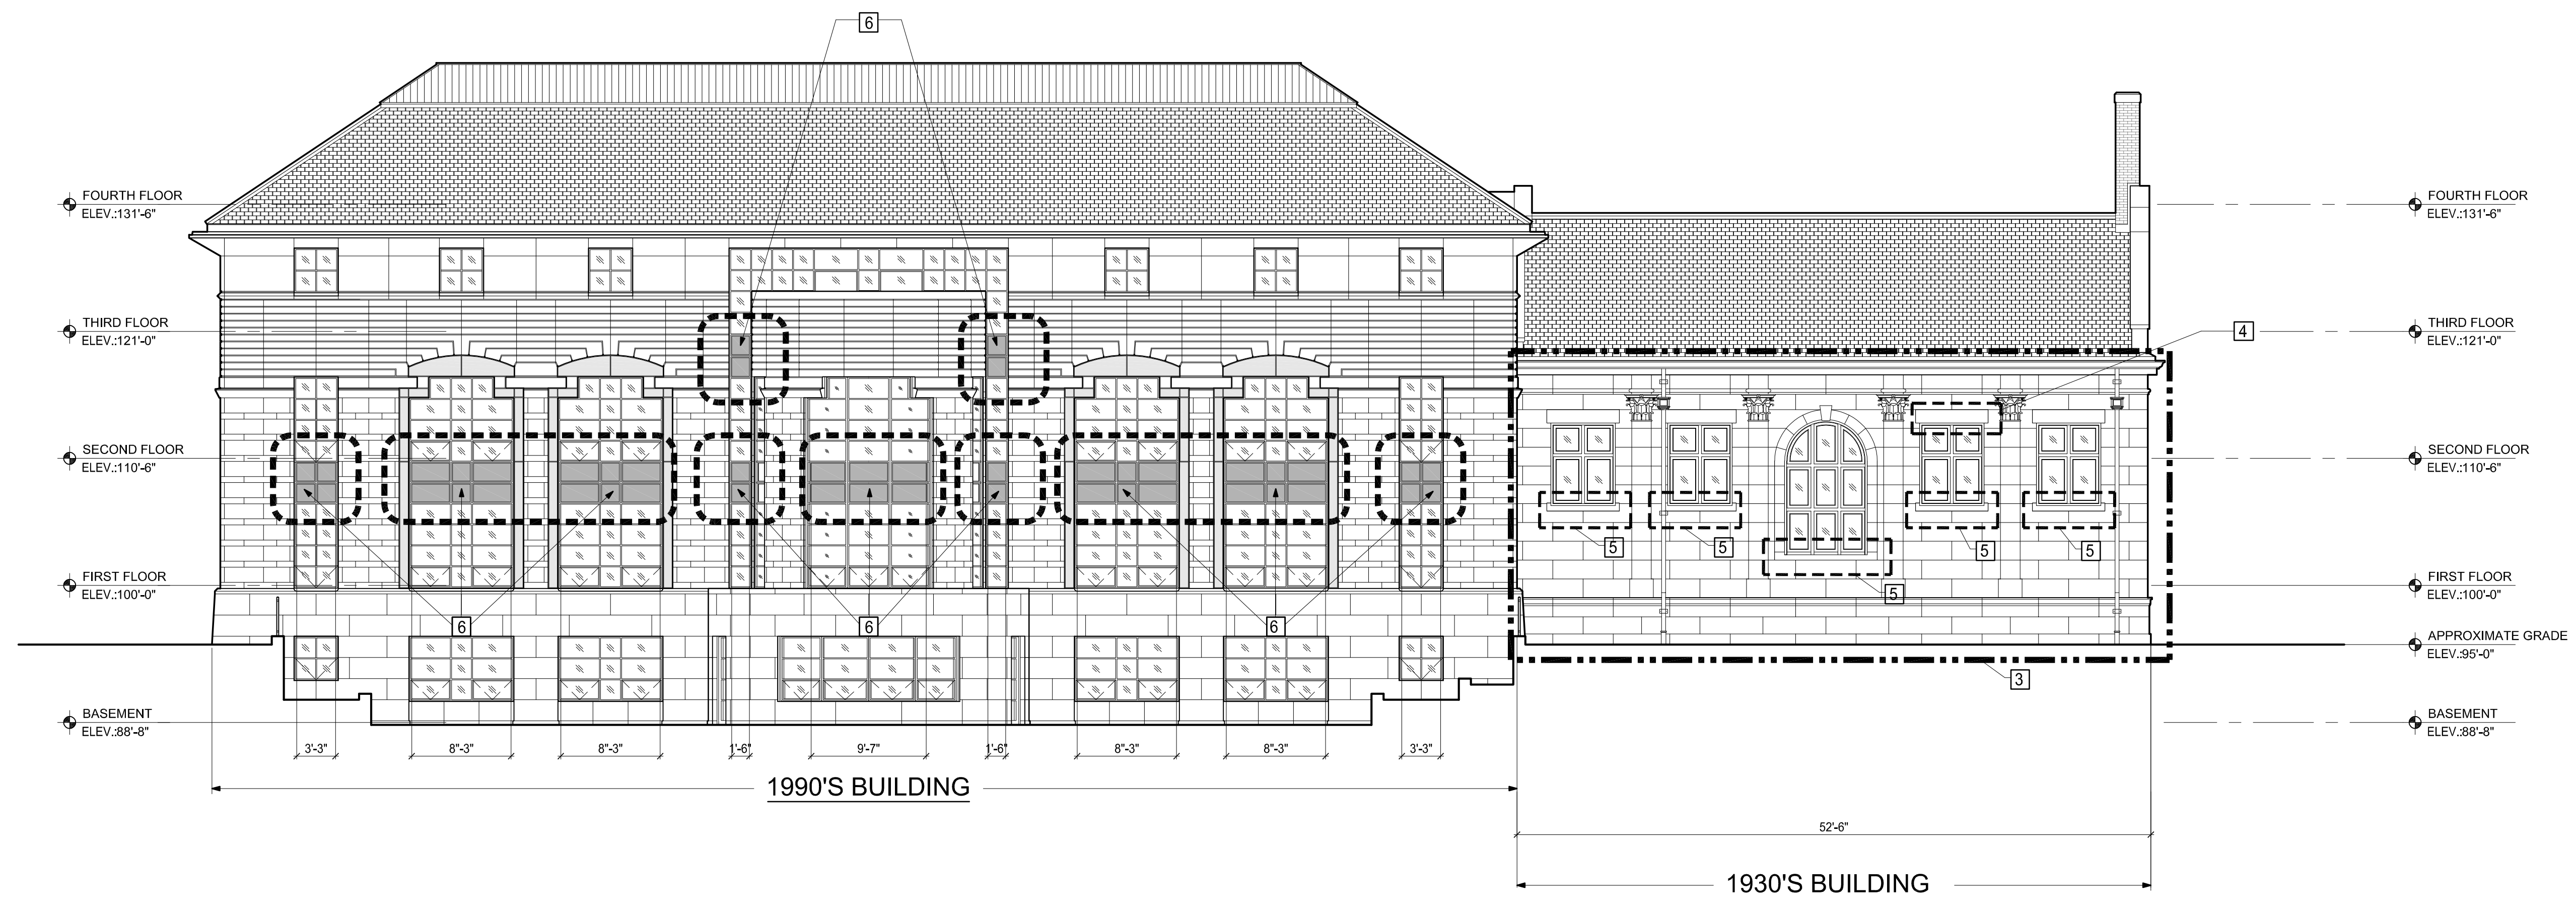
**3 WEST EXTERIOR ELEVATION**  
SCALE: 1/8"=1'-0"

1. ROUTE AND CLEAN EXISTING CRACKS IN ANY SANDSTONE (1890'S BUILDING) DETAIL OR ELEMENT, AND FILL CRACKS WITH INJECTION RESTORATION REPAIR MORTAR. TOTAL QUANTITY OF 50 LINEAL FEET IN SELECT AND RANDOM LOCATIONS ACROSS ALL ELEVATIONS AS SELECTED BY ARCHITECT. REFER TO UNIT PRICES - SPECIFICATION 01 22 00.

2. REPLACE EXISTING SEALANT AND MORTAR JOINTS OF THE EXTERIOR GRANITE STONE STAIRS AT MAIN ENTRANCE OF THE 1890'S LIBRARY BUILDING. CUT, REMOVE AND DISPOSE OF 100% ALL EXISTING VERTICAL AND HORIZONTAL JOINT SEALANTS, INCLUDING UNDERLYING MORTAR A MINIMUM OF 1-1/2-INCHES OR UNTIL SOUND MORTAR FROM ALL GRANITE STONE STAIRS. APPLY NEW POINTING MORTAR TO WITHIN 1/2-INCH OF THE SURFACE AND APPLY POLYURETHANE SEALANT TO ALL GRANITE STONE JOINTS. STAIRS SHALL BE POWER WASHED CLEANED. SEE ENLARGE PLAN 1/ A401 AND DETAIL 5a & 5b / A4-01.

3. ROUTE AND CLEAN EXISTING CRACKS IN ANY ARCHITECTURAL CAST STONE (1930S BUILDING) DETAIL OR ELEMENT, AND FILL CRACKS WITH INJECTION RESTORATION REPAIR MORTAR. TOTAL QUANTITY OF 25 LINEAL FEET IN SELECT AND RANDOM LOCATIONS ACROSS ALL ELEVATION SELECTED BY THE ARCHITECT. SEE DETAIL 1a & 1b/ A4-01. REFER TO UNIT PRICE - SPECIFICATION 01 22 00.

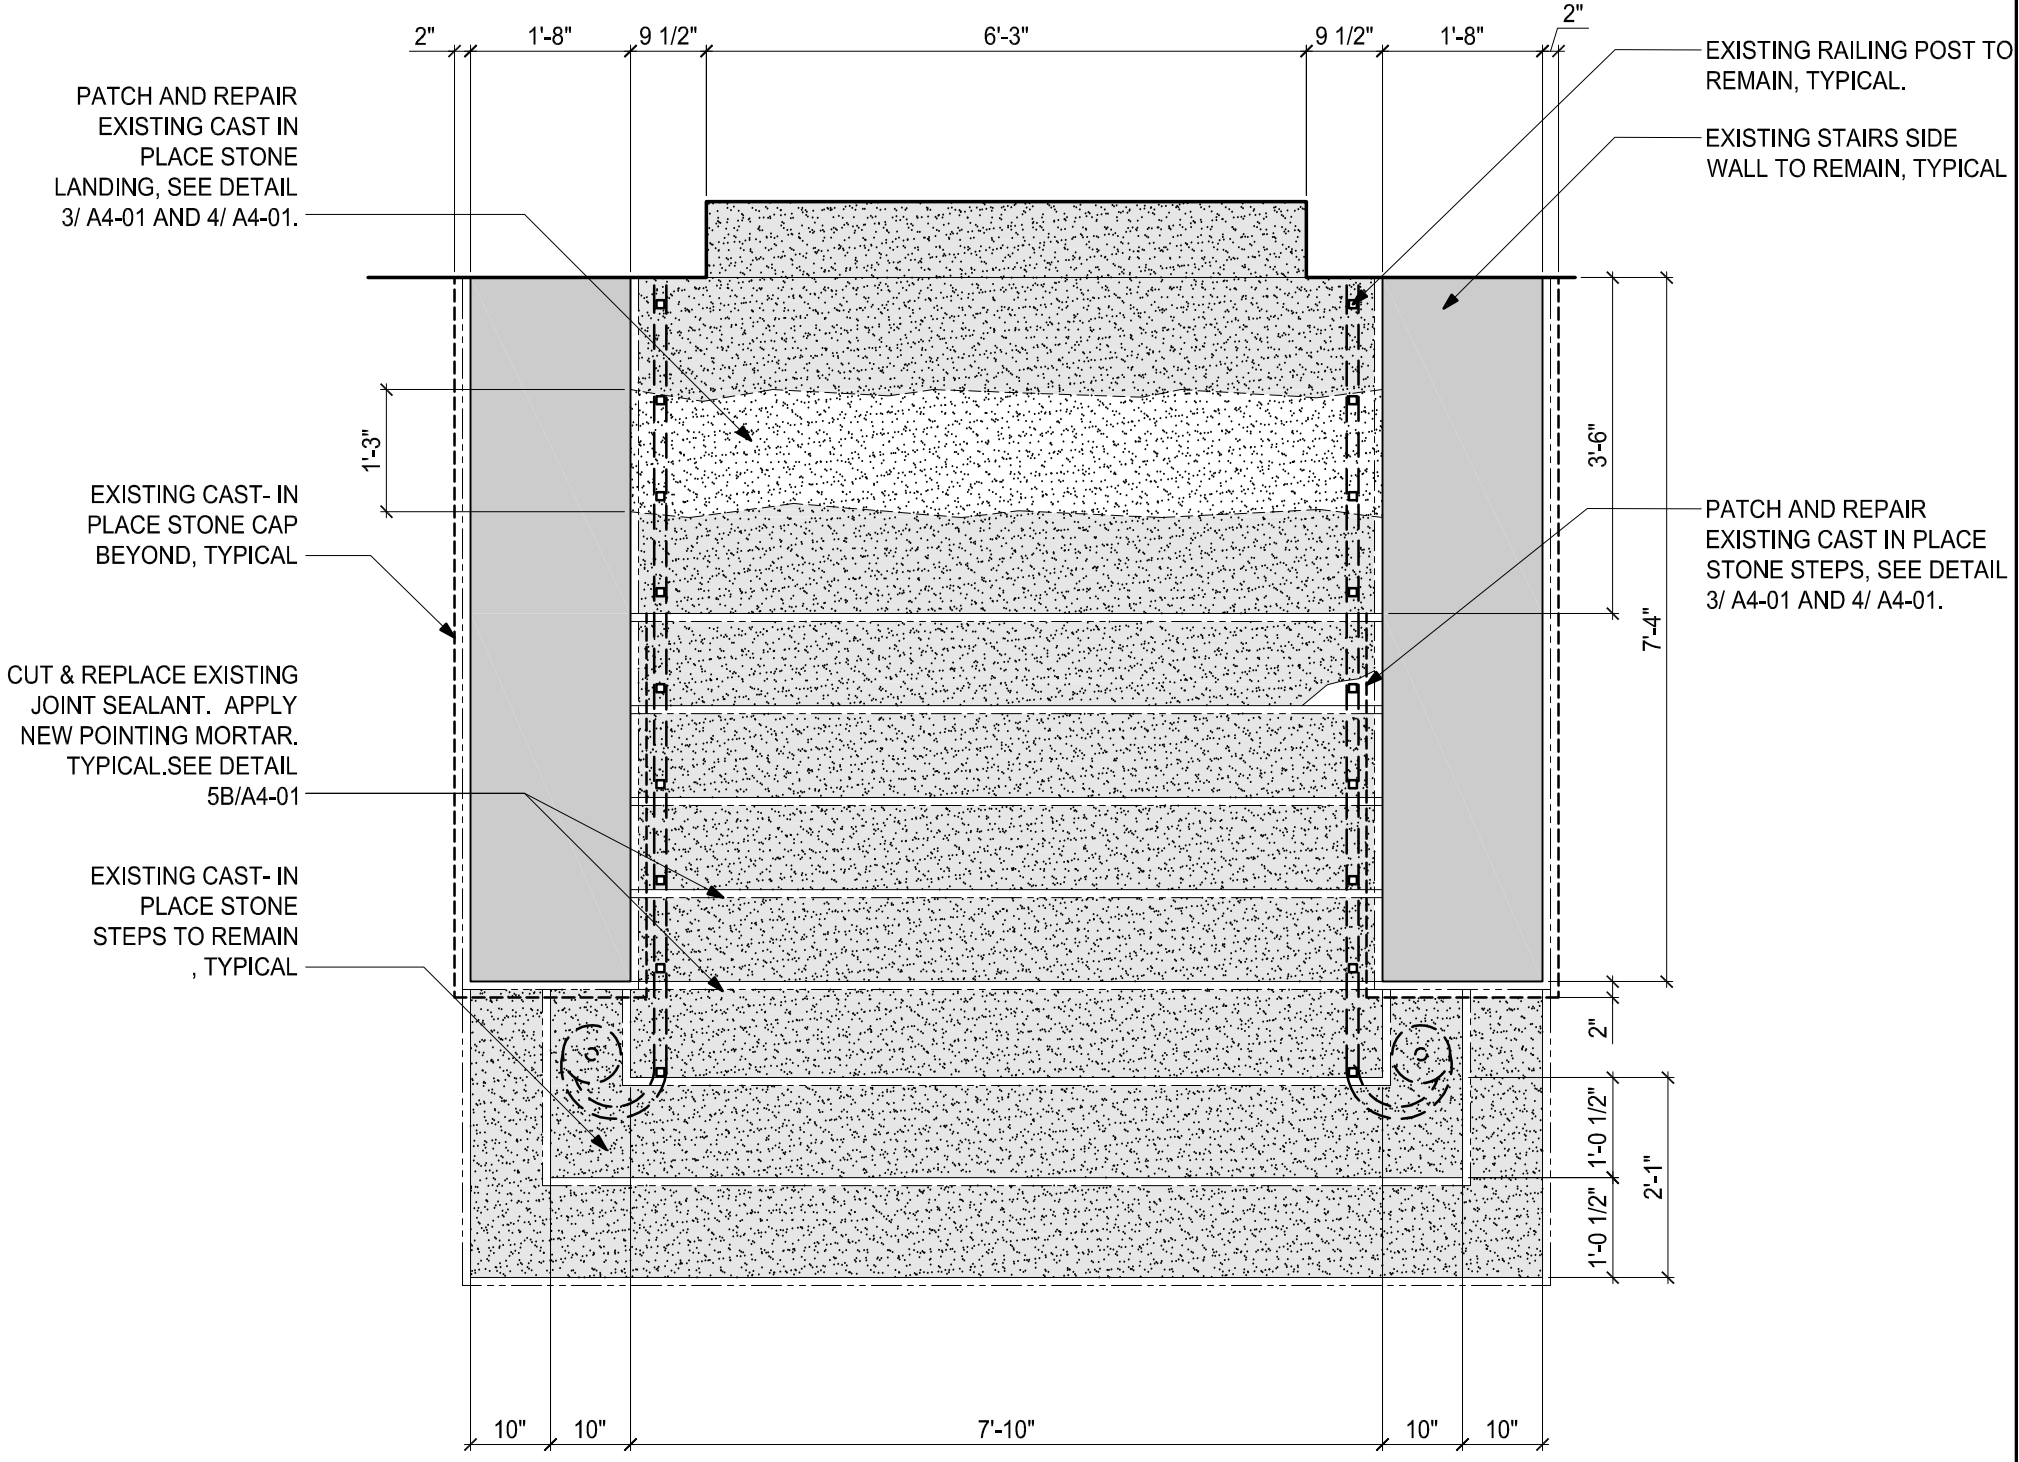
**1** 1930'S BUILDING EXIT STAIRS REPAIR PLAN  
SCALE: 1/2"=1'-0"

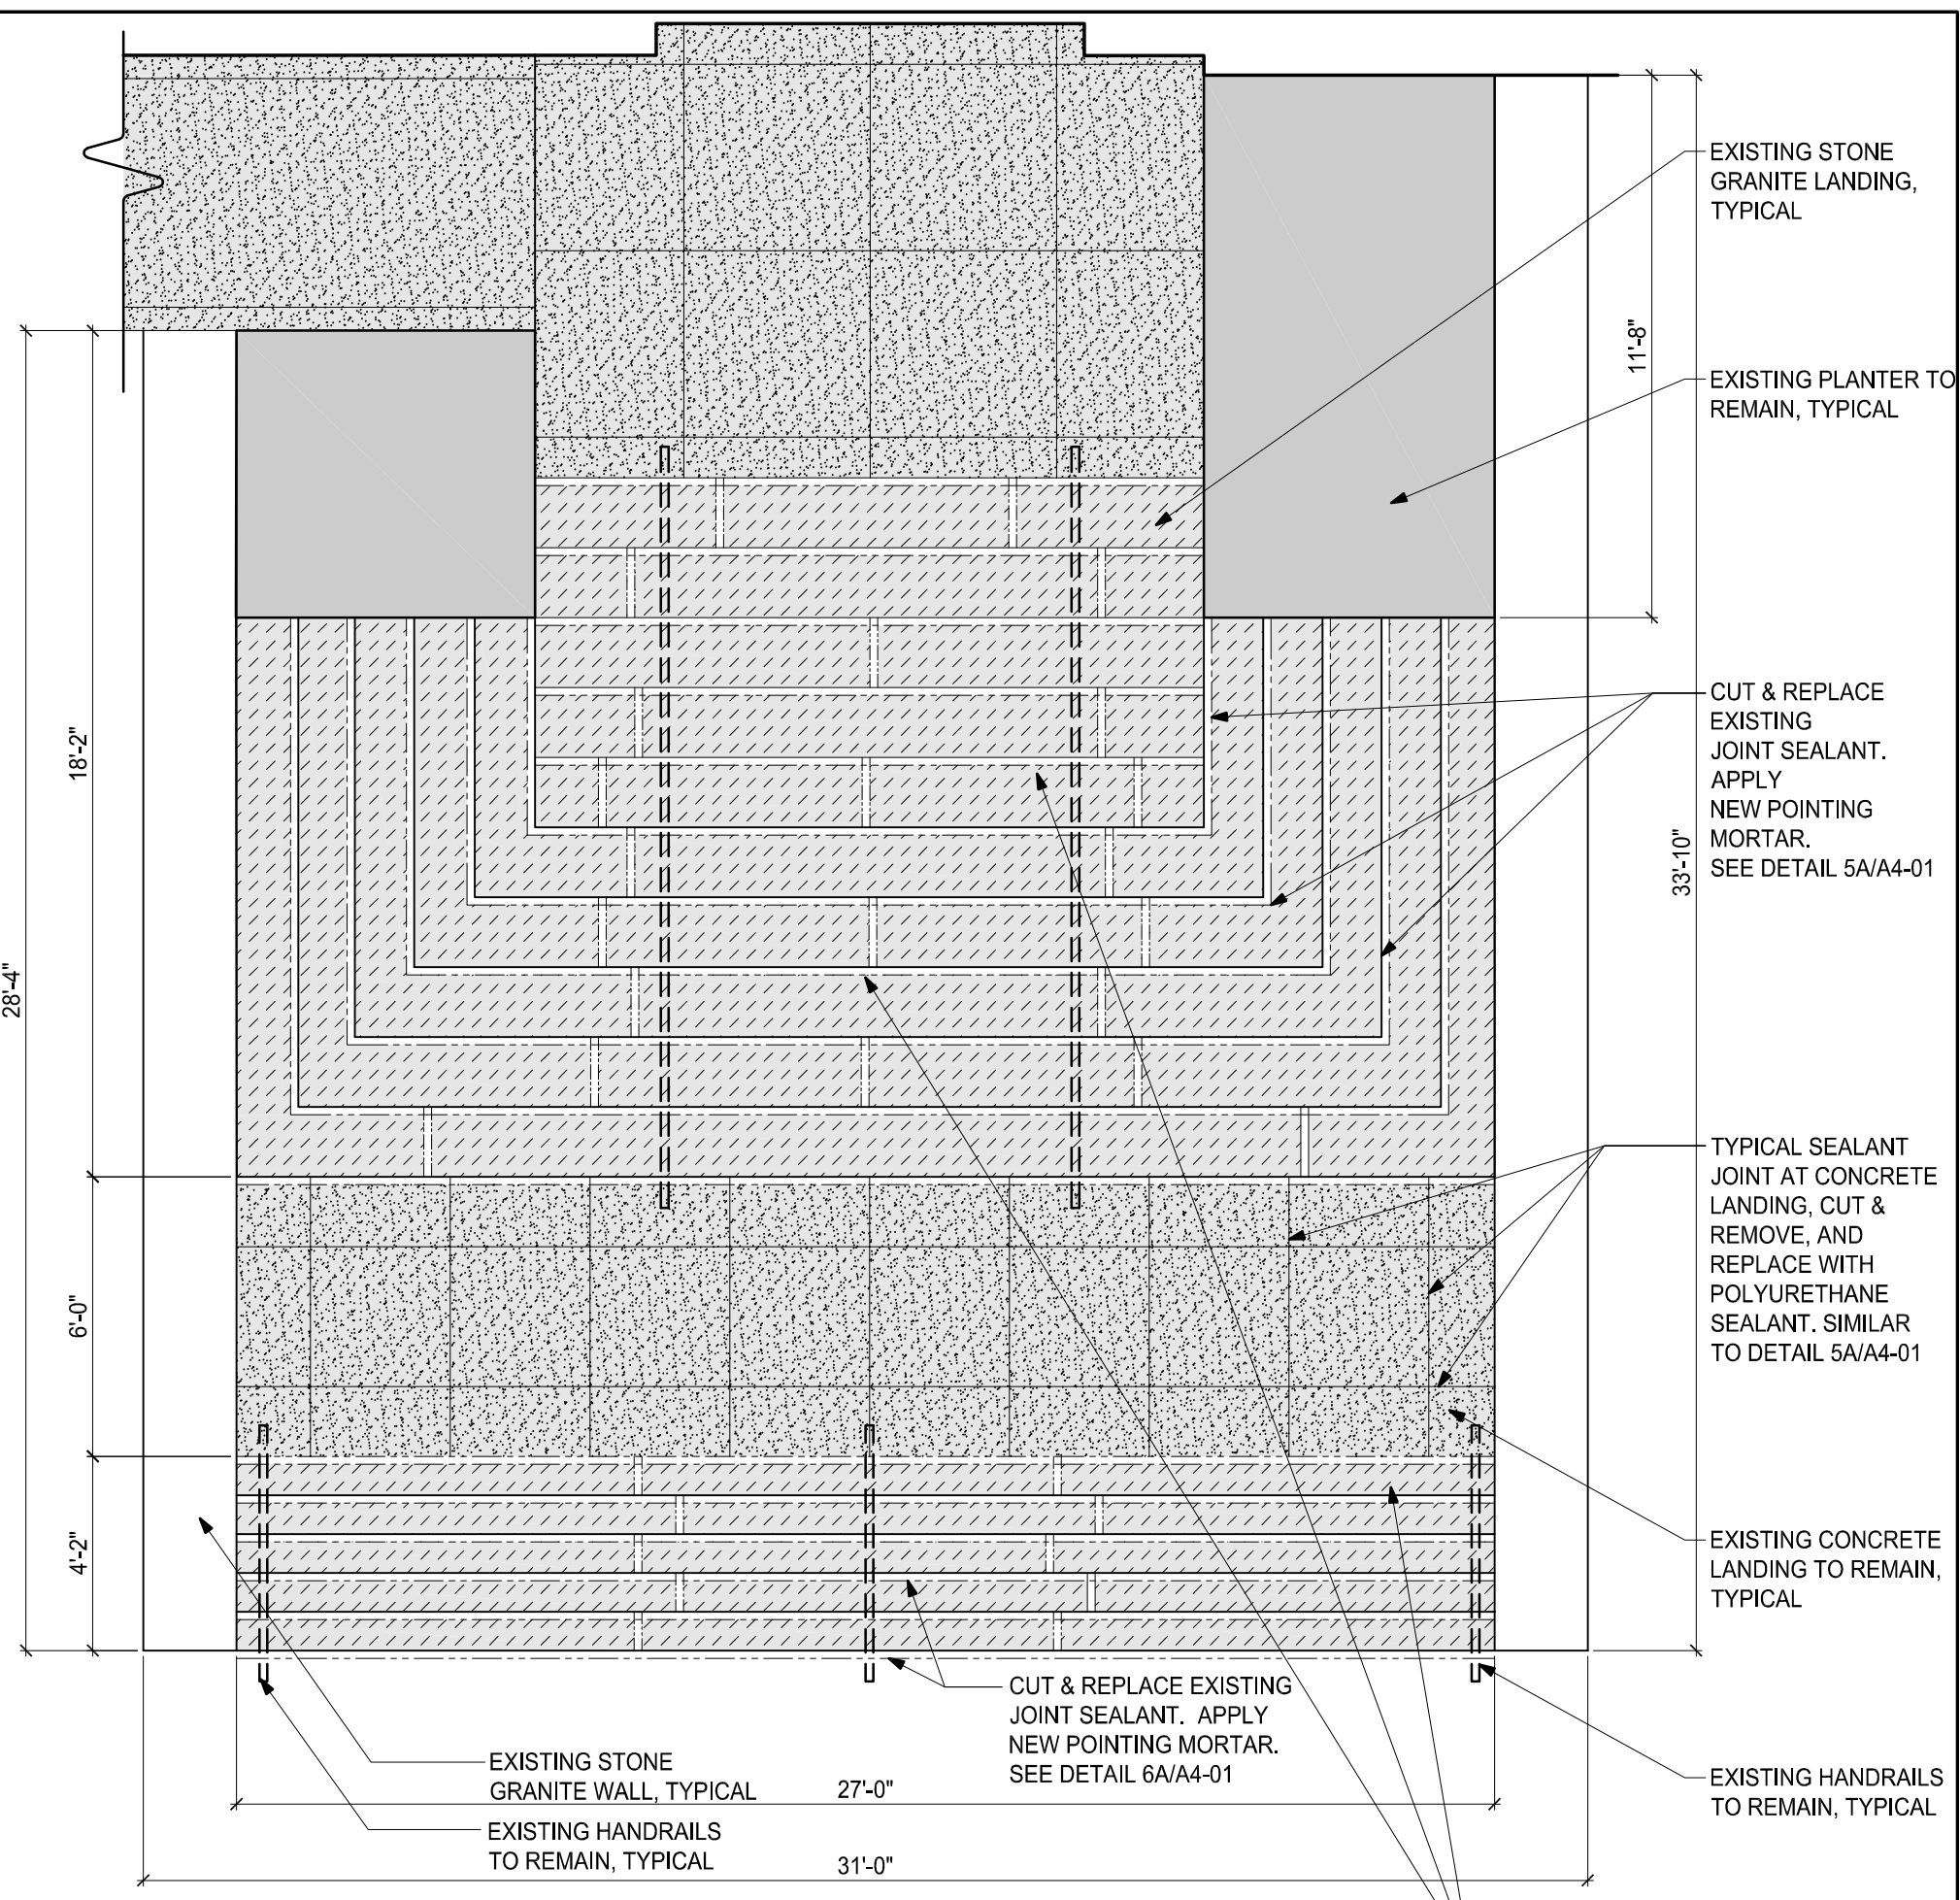
**2** MAIN ENTRY STAIRS REPAIR PLAN  
SCALE: 1/4"=1'-0"

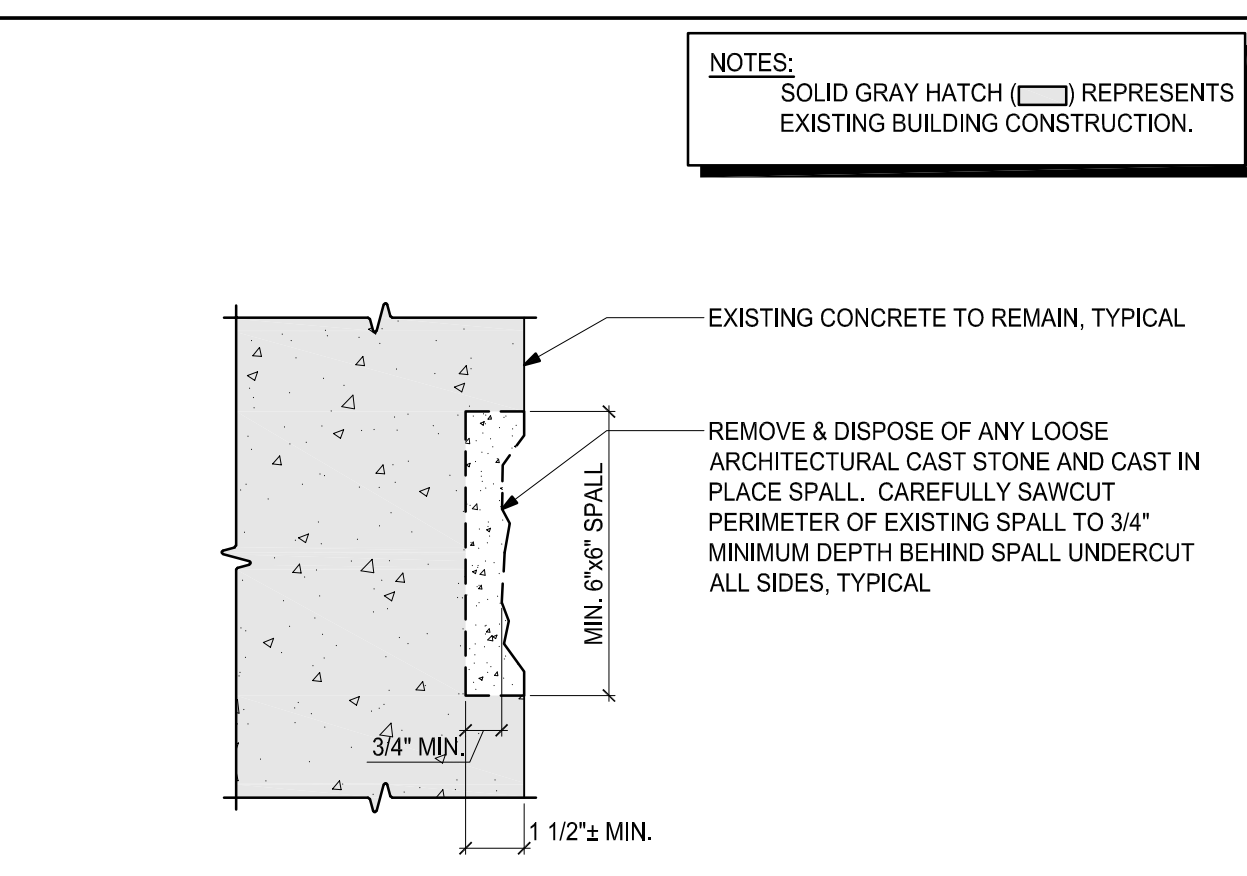
**3** TYPICAL ARCHITECTURAL CAST STONE SPALL REPAIR DEMOLITION DETAIL  
SCALE: 3"=1'-0"

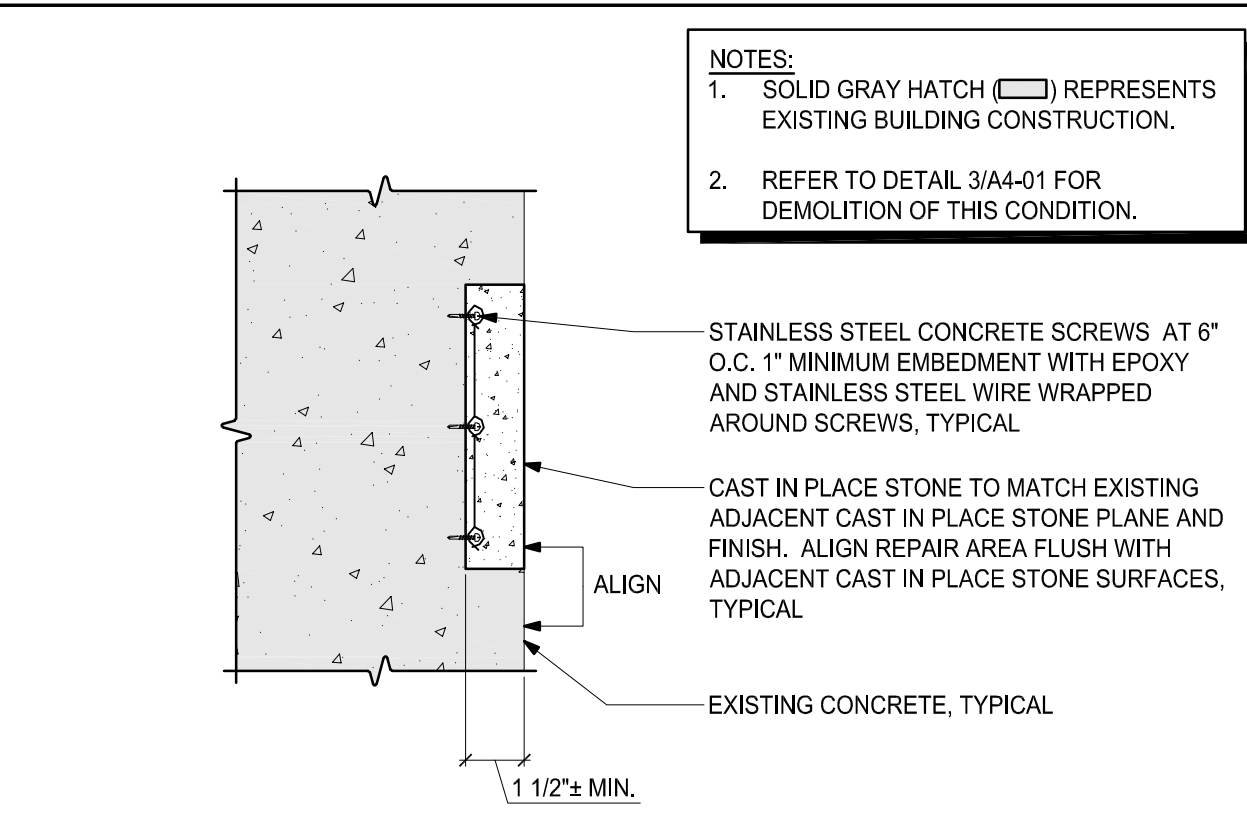
**4** TYPICAL ARCHITECTURAL CAST STONE SPALL REPAIR DETAIL  
SCALE: 3"=1'-0"
