# ROBBINS LIBRARY

## EXTERIOR ENVELOPE REPAIRS - PHASE IA BID NO.19-58

ROBBINS LIBRARY  
TOWN OF  
ARLINGTON  
700 MASSACHUSETTS AVENUE  
ARLINGTON MA, 02476

EXTERIOR  
ENVELOPE  
REPAIRS -  
PHASE IA  
BID NO. 19-58

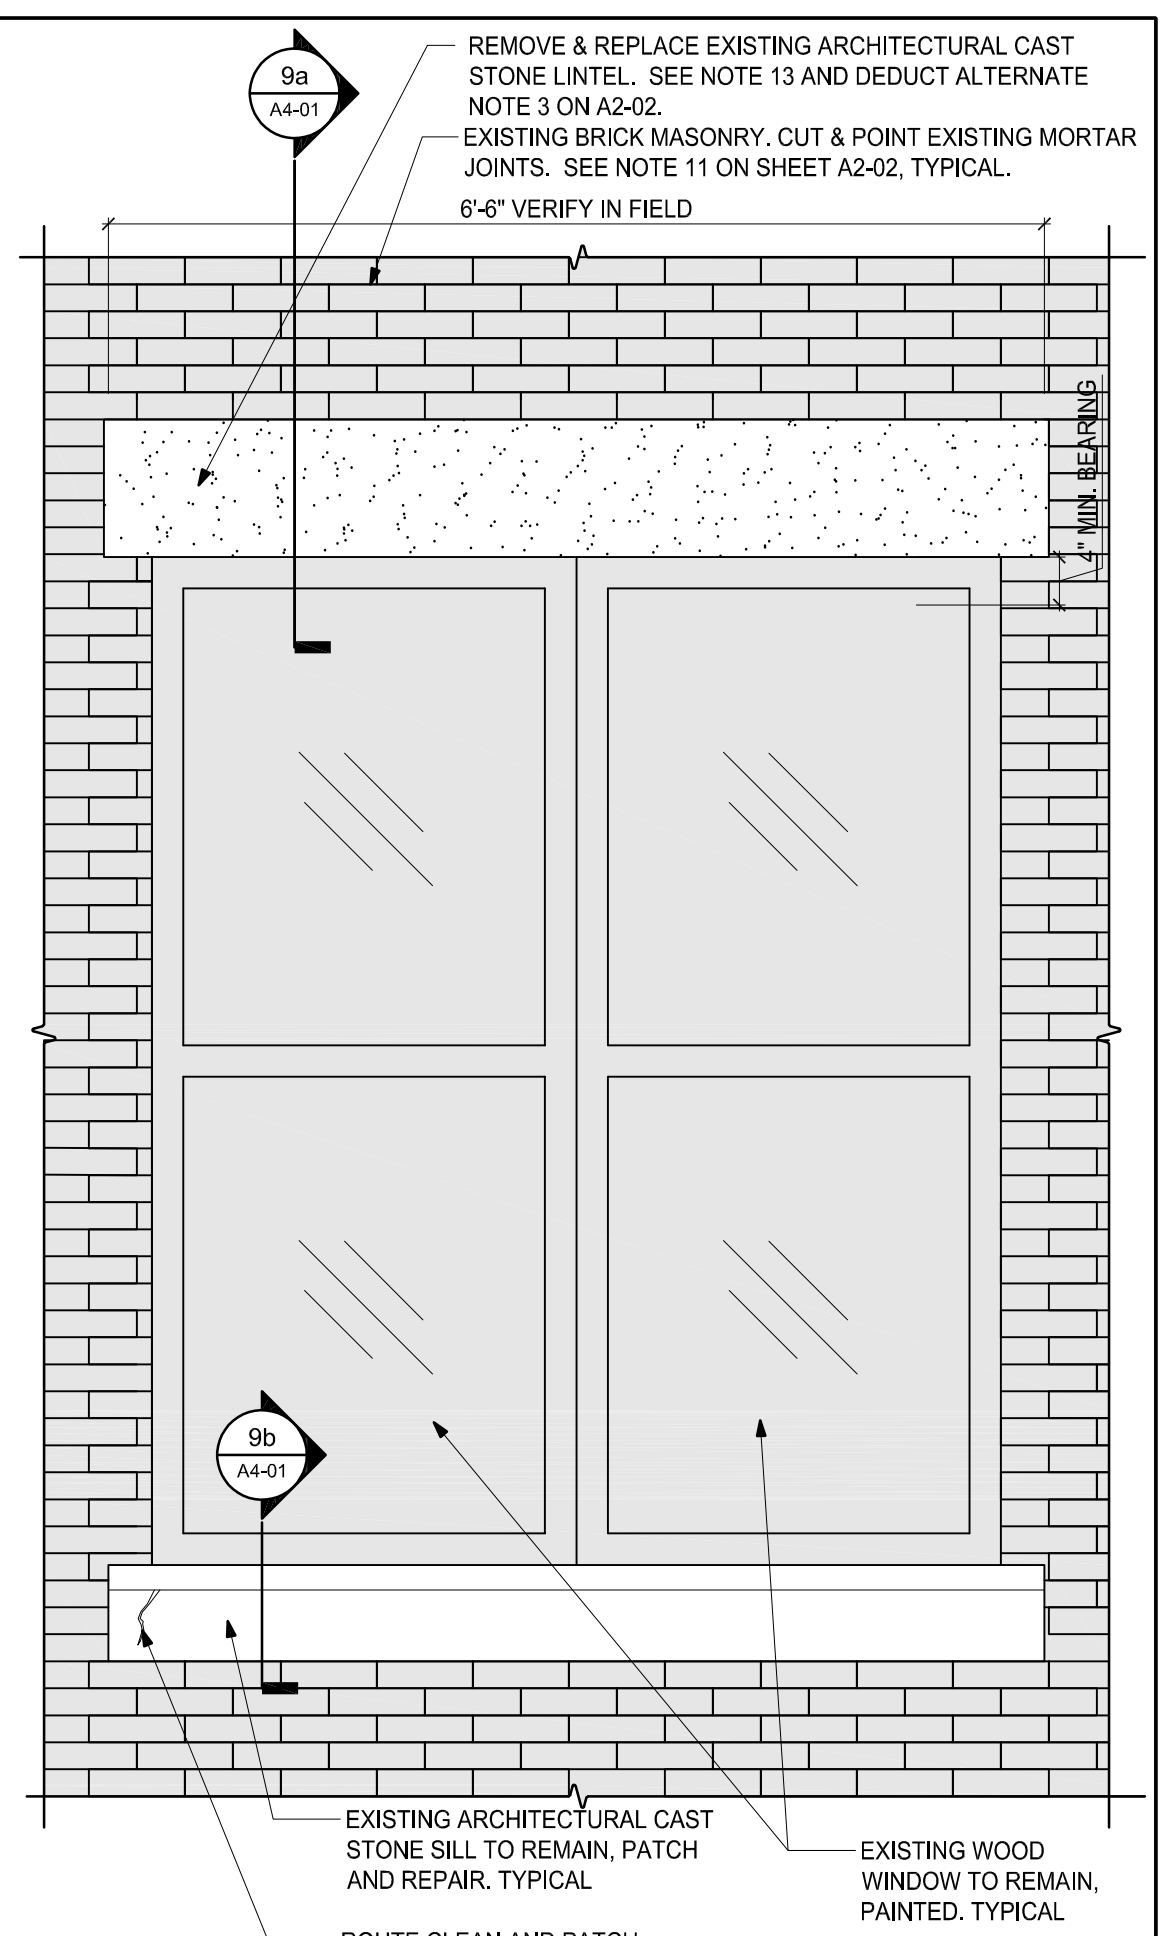
**6** ARCHITECTURAL CAST STONE LINTEL ENLARGED ELEVATION  
SCALE: 3/4"=1'-0"

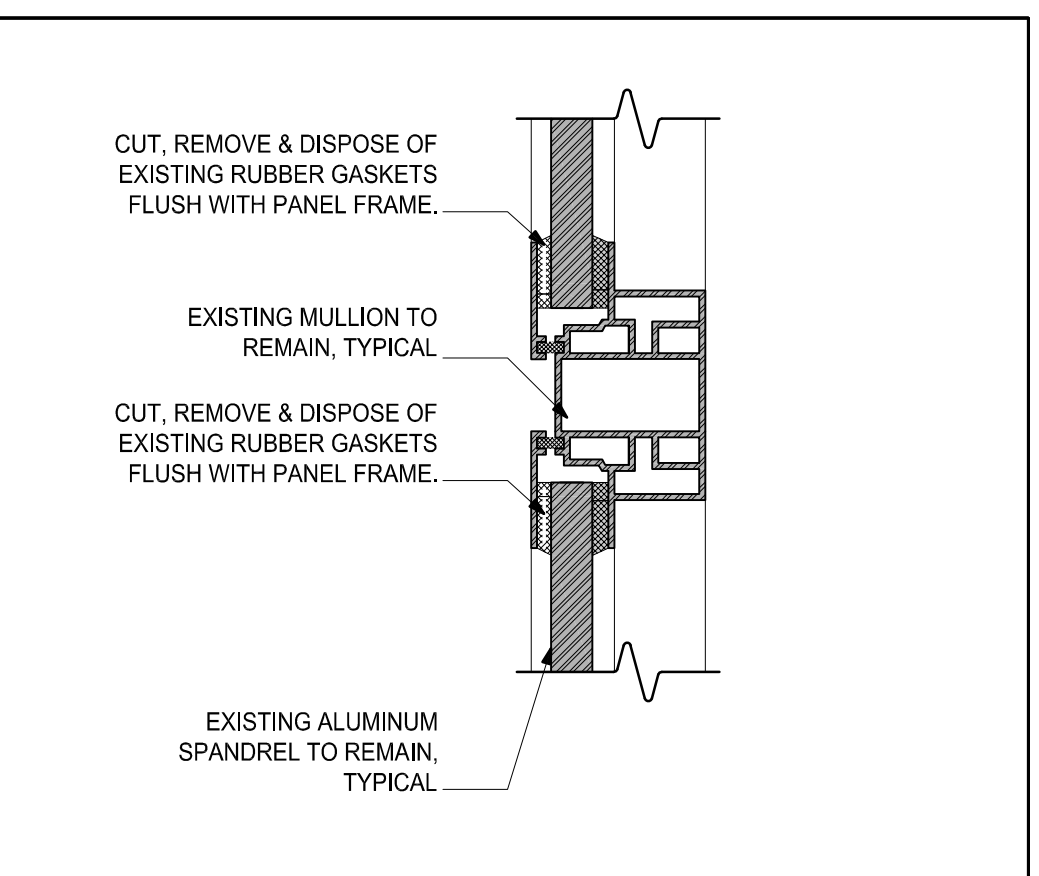
**7a** ALUMINUM SPANDREL TYPICAL DEMOLITION DETAIL  
SCALE: 3"=1'-0"

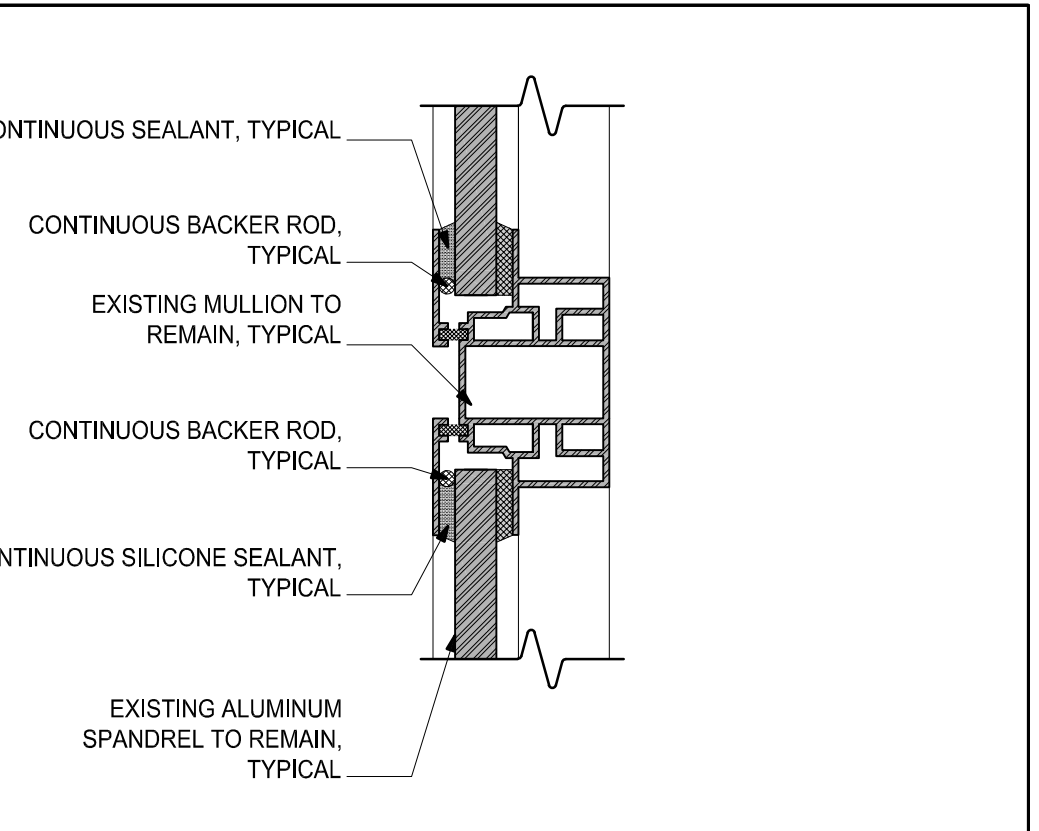
**7b** ALUMINUM SPANDREL TYPICAL DETAIL  
SCALE: 3"=1'-0"

- b. APPLY NEW BACKER ROD WHERE GASKETS ARE MISSING BETWEEN THE PANEL AND FRAME.
    - c. CLEAN AND PRIME SURFACES AND APPLY NON-SAG SINGLE COMPONENT SILICONE SEALANT. COLOR TO BE SELECTED BY ARCHITECT FROM FULL RANGE OF CUSTOM COLORS.

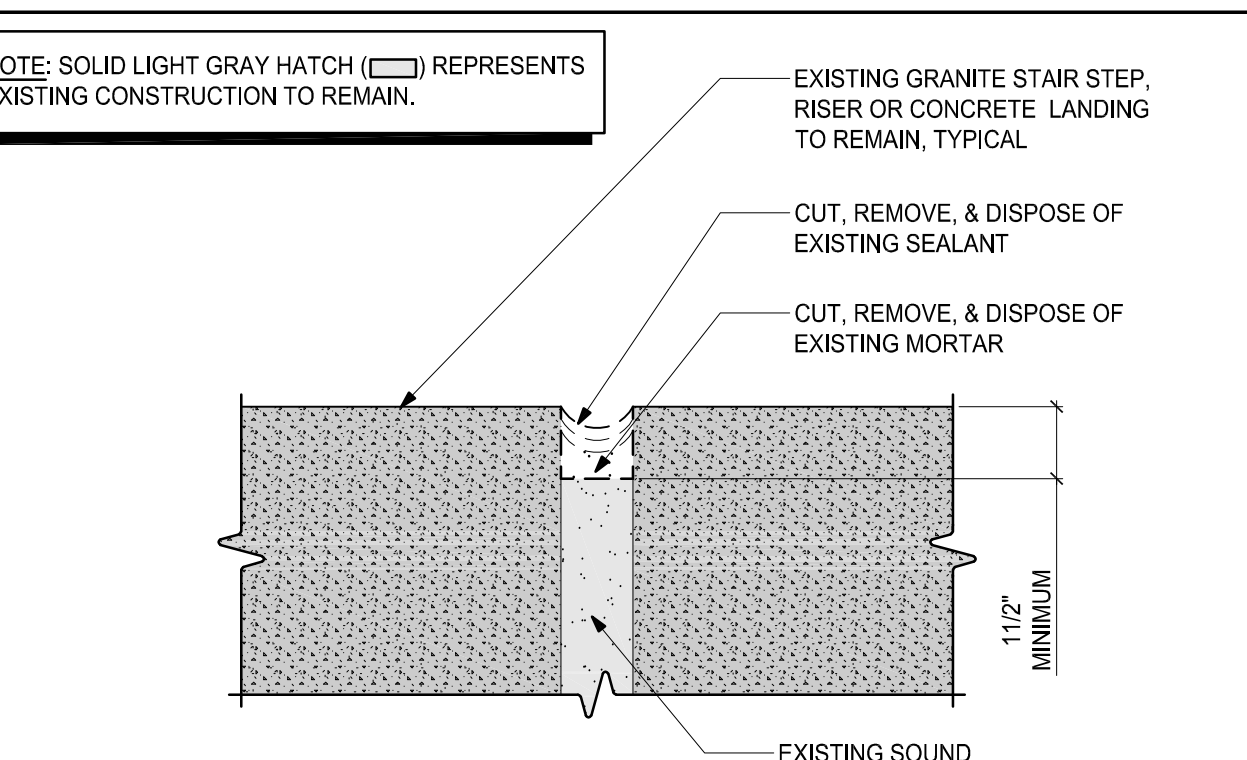
**5A** TYPICAL POINTING DEMOLITION OF GRANITE AND CAST IN PLACE STONE STAIR JOINT DETAIL  
SCALE: 3"=1'-0"

2. REPLACE EXISTING SEALANT AND MORTAR JOINTS OF THE EXTERIOR GRANITE STONE STAIRS AT MAIN ENTRANCE OF THE 1890'S LIBRARY BUILDING. CUT, REMOVE AND DISPOSE OF 100% ALL EXISTING VERTICAL AND HORIZONTAL JOINT SEALANTS, INCLUDING UNDERLYING MORTAR A MINIMUM OF 1-1/2-INCHES OR UNTIL SOUND MORTAR FROM ALL GRANITE STONE STAIRS. APPLY NEW POINTING MORTAR TO WITHIN 1/2-INCH OF THE SURFACE AND APPLY POLYURETHANE SEALANT TO ALL GRANITE STONE JOINTS. STAIRS SHALL BE POWER WASHED CLEANED. SEE ENLARGE PLAN 1/A4-01 AND DETAIL 5a & 5b / A4-01.

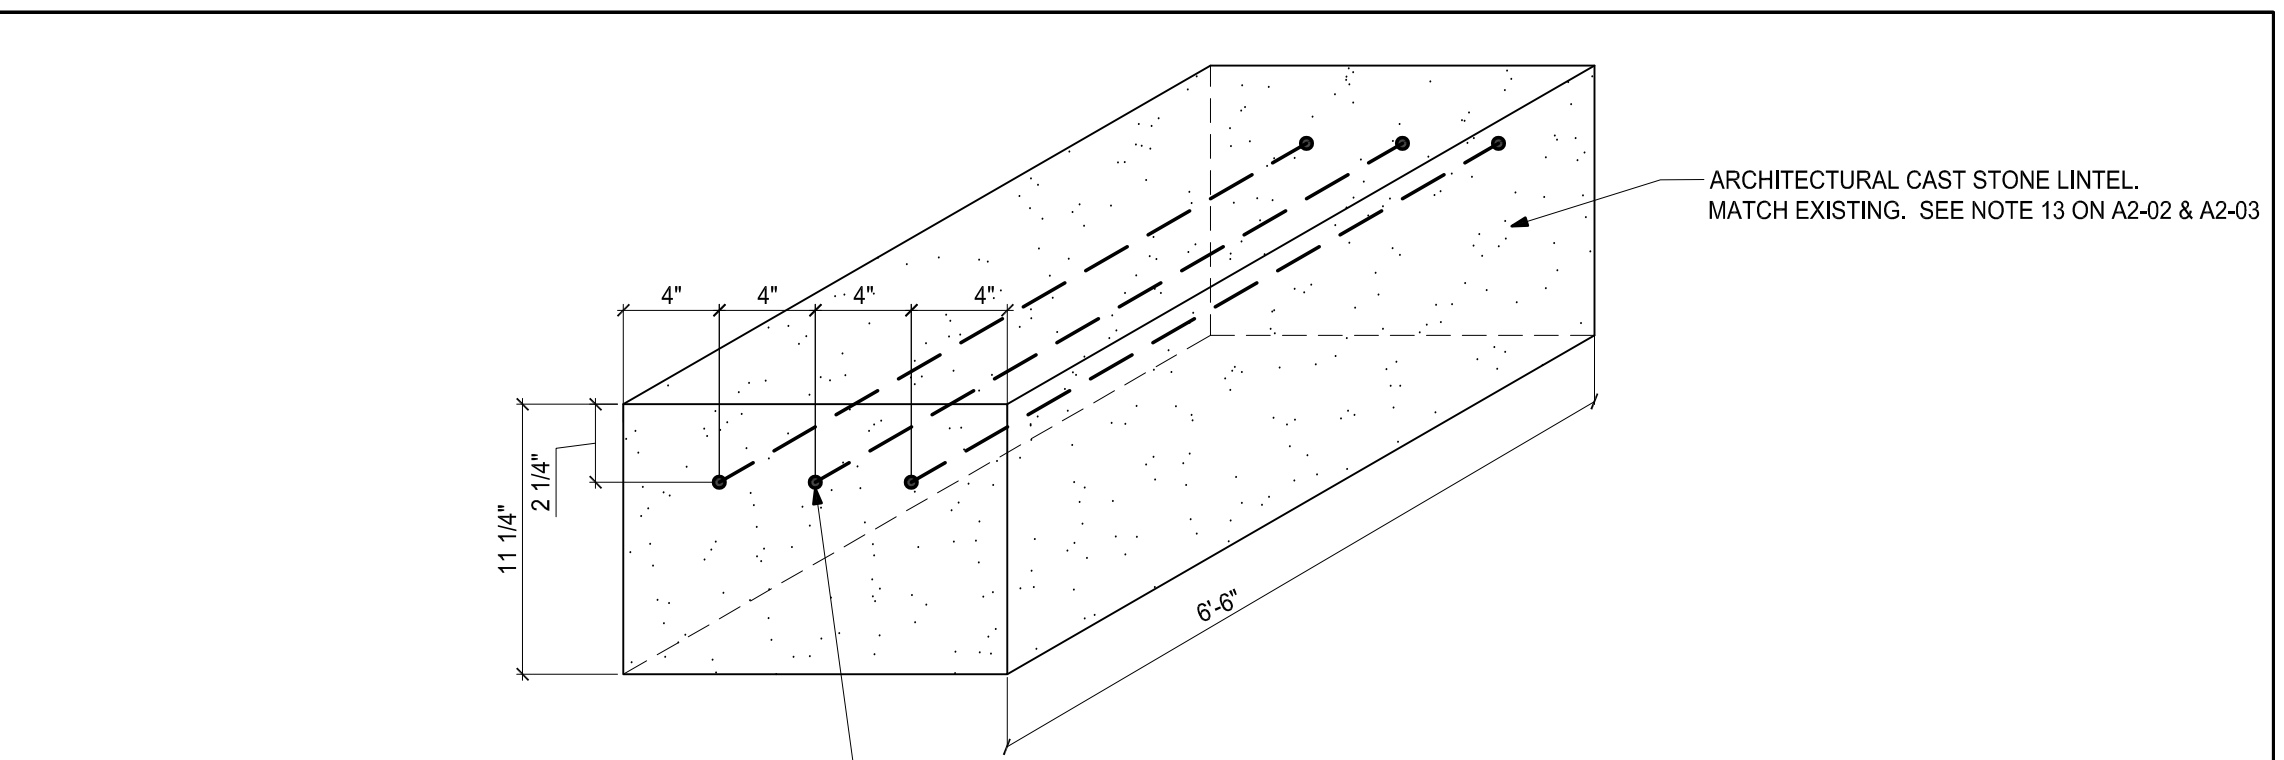
**8** ARCHITECTURAL CAST STONE LINTEL ISOMETRIC DETAIL  
SCALE: 1-1/2"=1'-0"

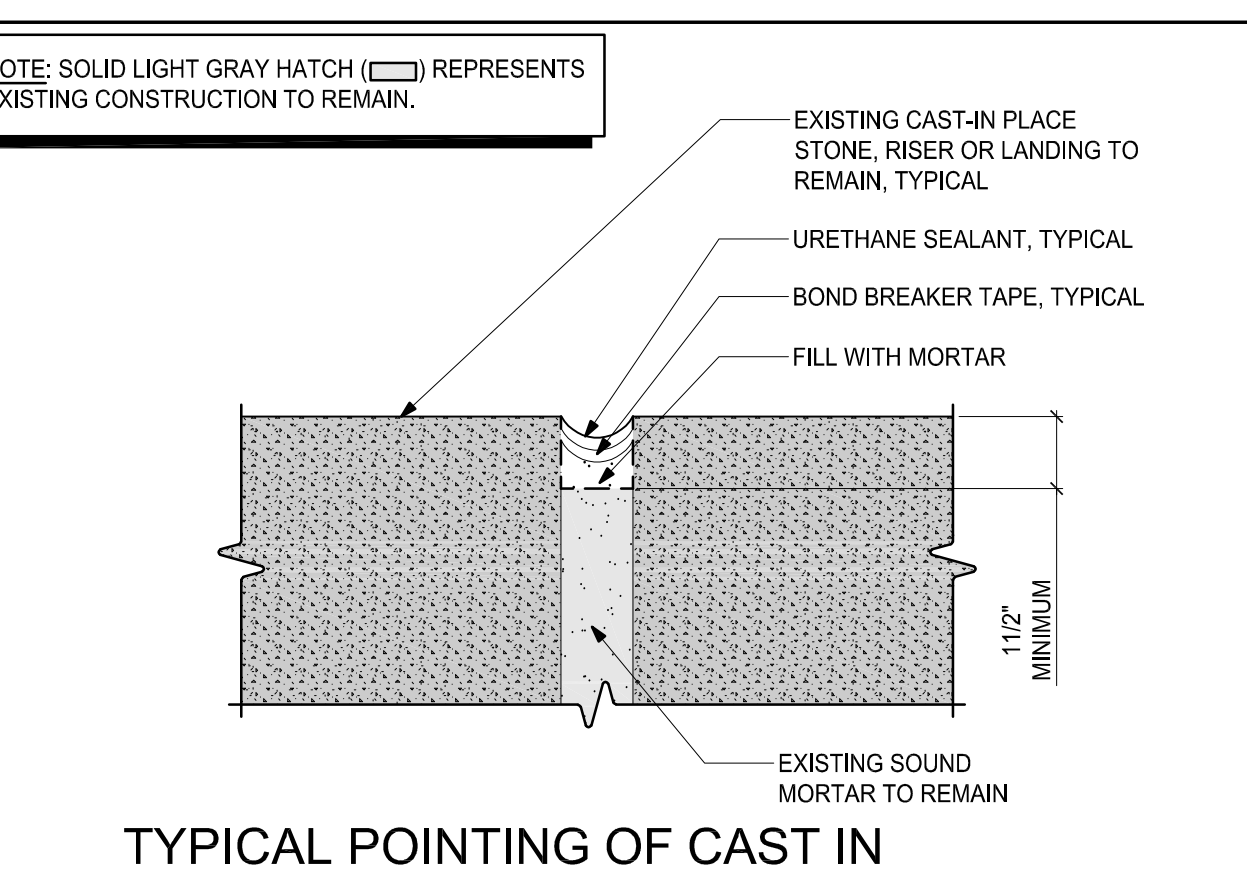
**5B** TYPICAL POINTING OF CAST IN PLACE AND GRANITE STONE JOINT DETAIL  
SCALE: 3"=1'-0"

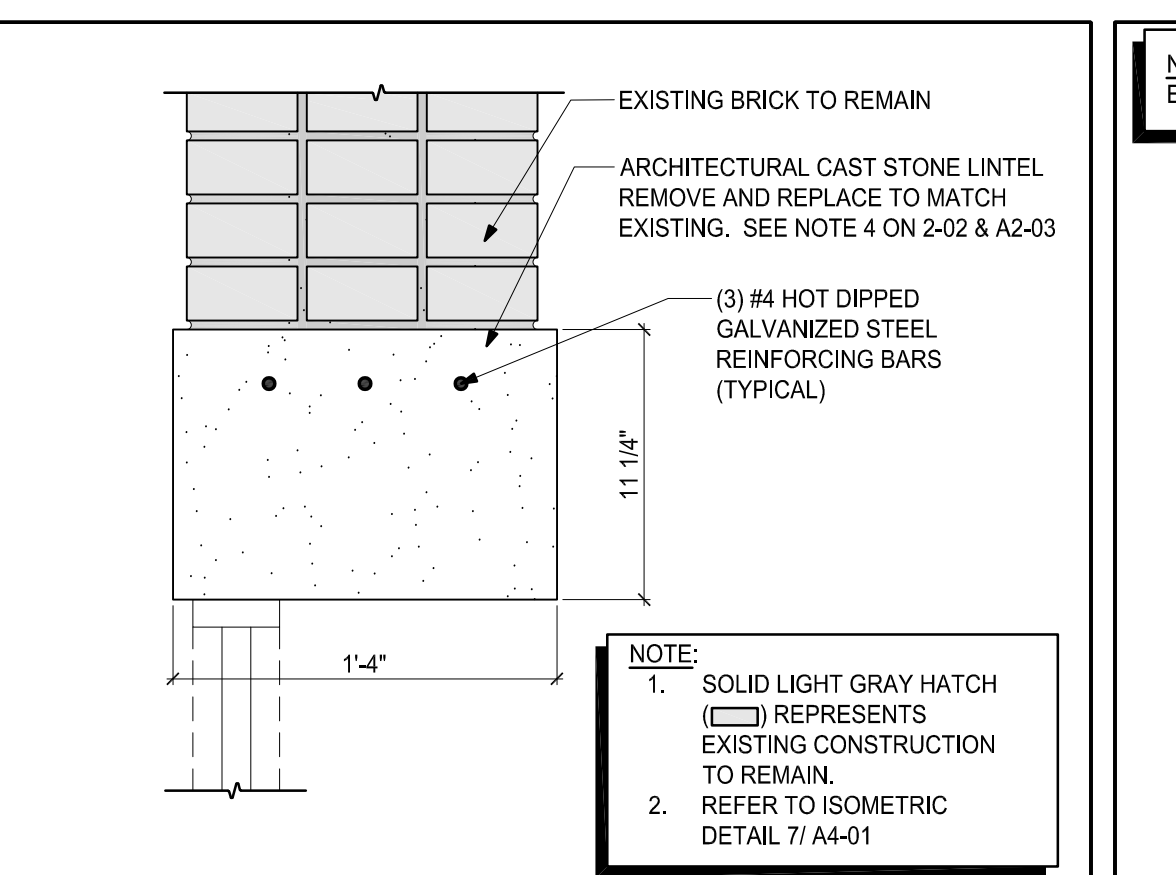
**9A** ARCHITECTURAL CAST STONE LINTEL REPLACEMENT DETAIL  
SCALE: 1-1/2"=1'-0"

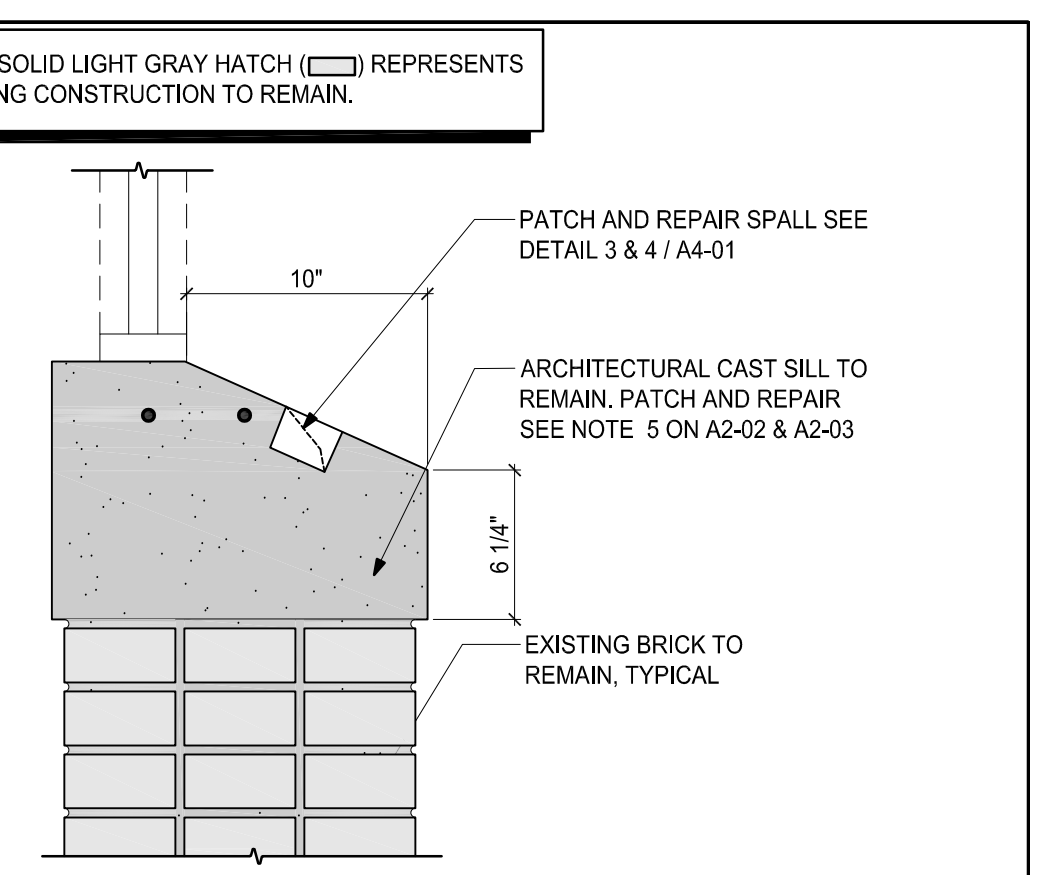
**9B** ARCHITECTURAL CAST STONE SILL REPAIR DETAIL  
SCALE: 1-1/2"=1'-0"

5. CUT OUT AND DISPOSE SPALLS, CHIPS AND DELAMINATIONS IN THE ARCHITECTURAL CAST STONE WINDOW SILL. CUT OUT A MINIMUM 1/2" DEEP & SQUARE OFF ALL EDGES. CLEAN SURFACE & APPLY SINGLE COMPONENT, CEMENTITIOUS MINERAL BASED REPAIR MORTAR TOTAL QUANTITY OF 208 CUBIC INCHES IN SELECT AND RANDOM LOCATIONS ACROSS ALL ELEVATION SELECTED BY THE ARCHITECT. REFER TO UNIT PRICE - SPECIFICATION 01 22 00.
